**DESIGN/DEVELOPMENT REVIEW COMMISSION
DESIGN REVIEW DISTRICT
HISTORIC/CONSENT AGENDA
EVALUATION SHEET
Case #3**

ADDRESS: 1500 Main Street

NATURE OF REQUEST: Request for Certificate of Design Approval for exterior changes and preliminary certification for the Bailey Bill

SYLVAN BUILDING DORMERS SURVEY

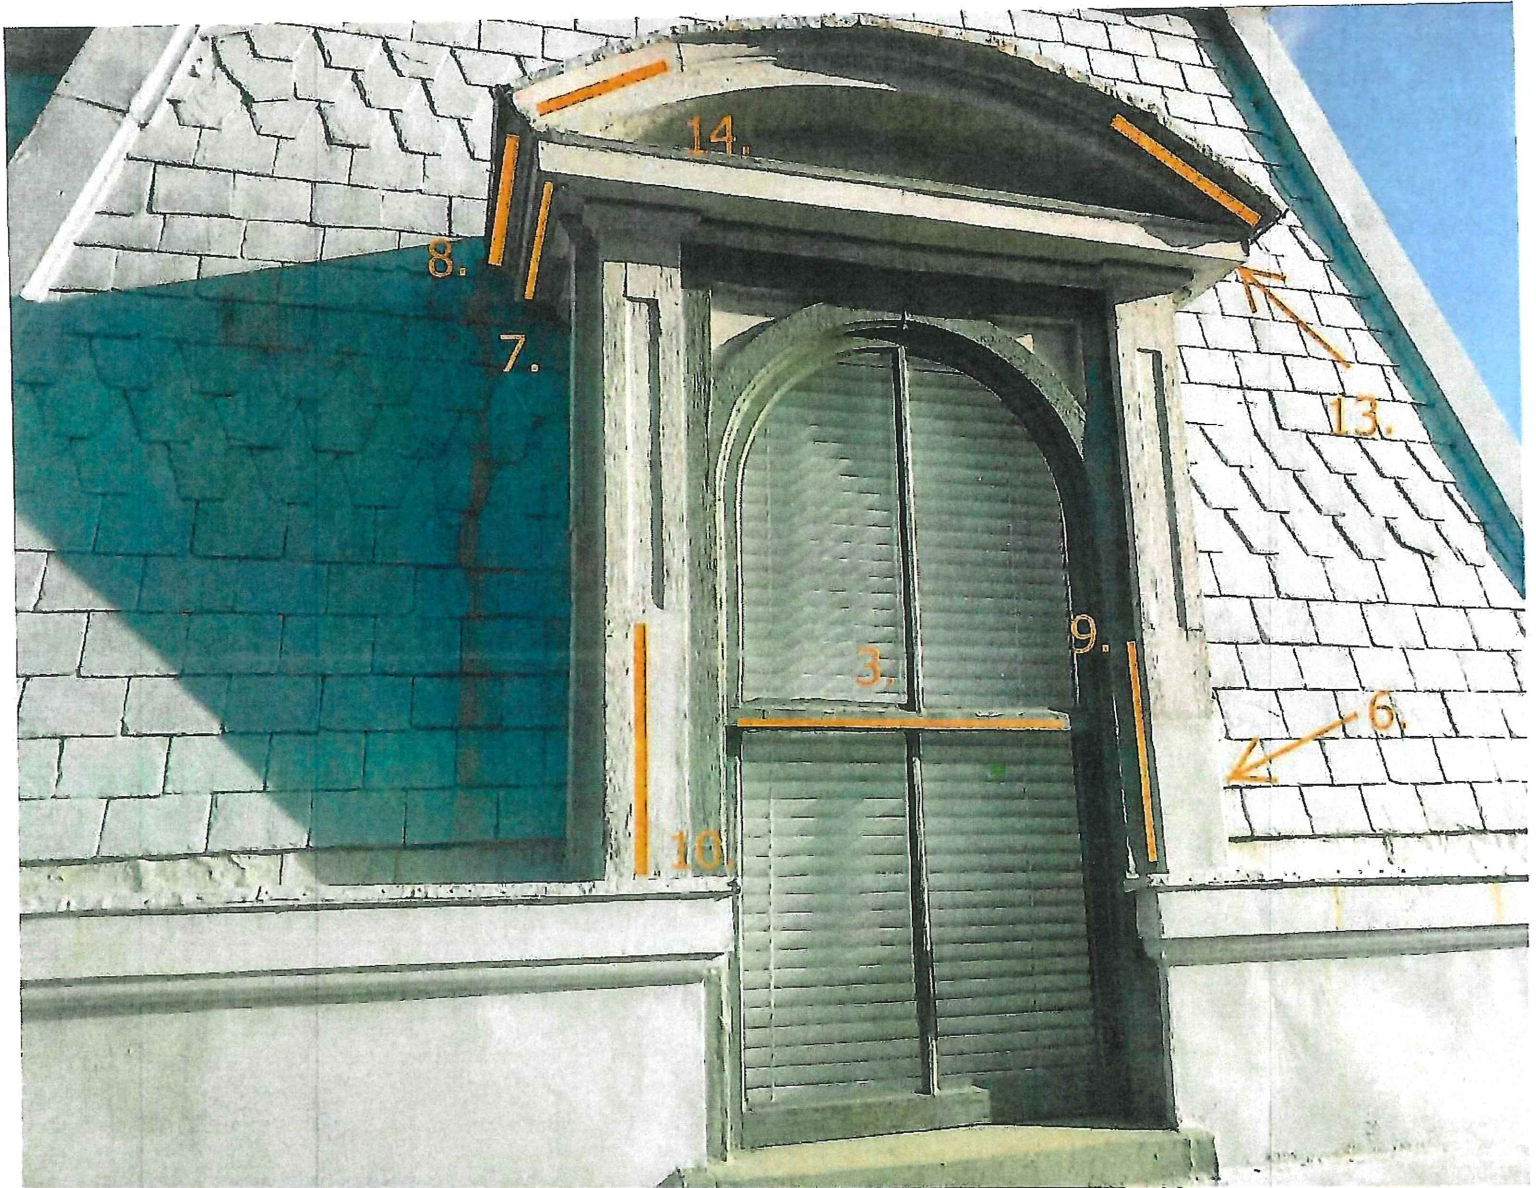
SYLVAN BUILDING DORMER TWO

Areas lined with red are rotten and needs replacing.
Numbers above correspond with detail picture

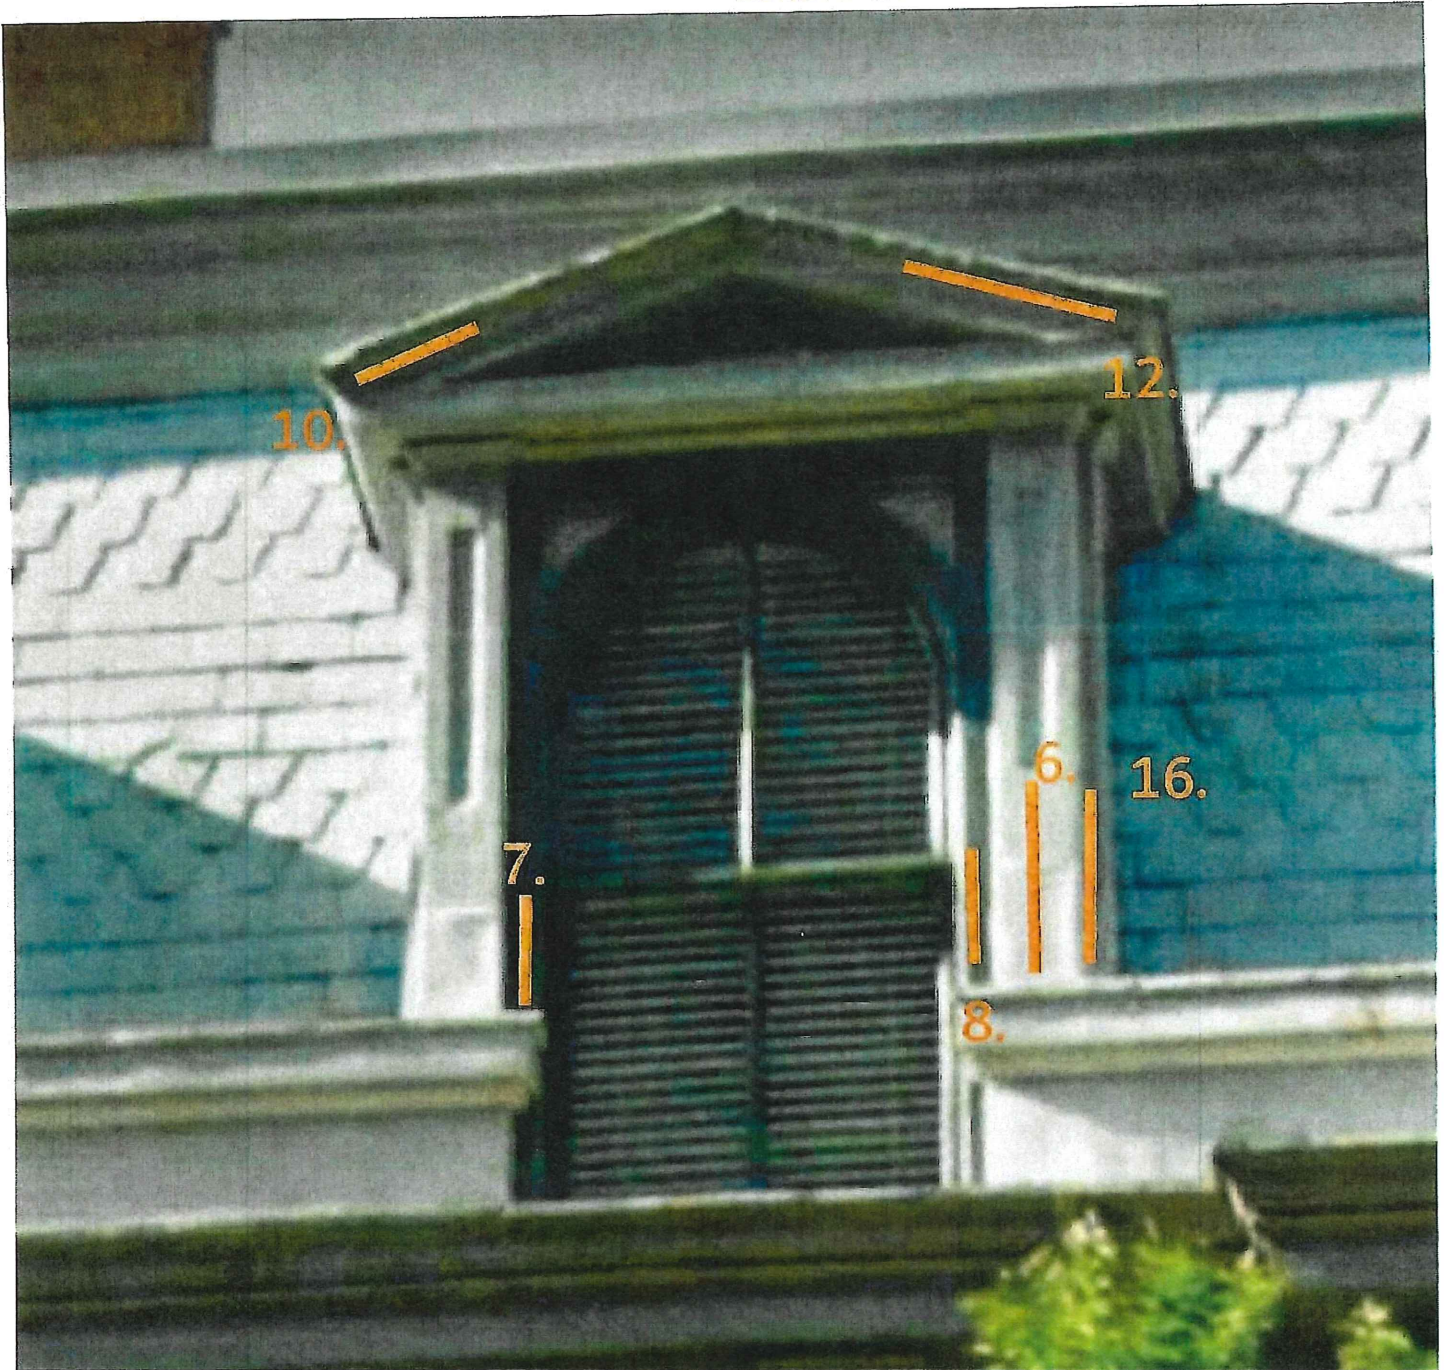
SYLVAN BUILDING DORMER THREE

METAL PATCH

Areas lined in red are rotten and it is recommended that they be replaced. Length of red line is how much needs replacing.

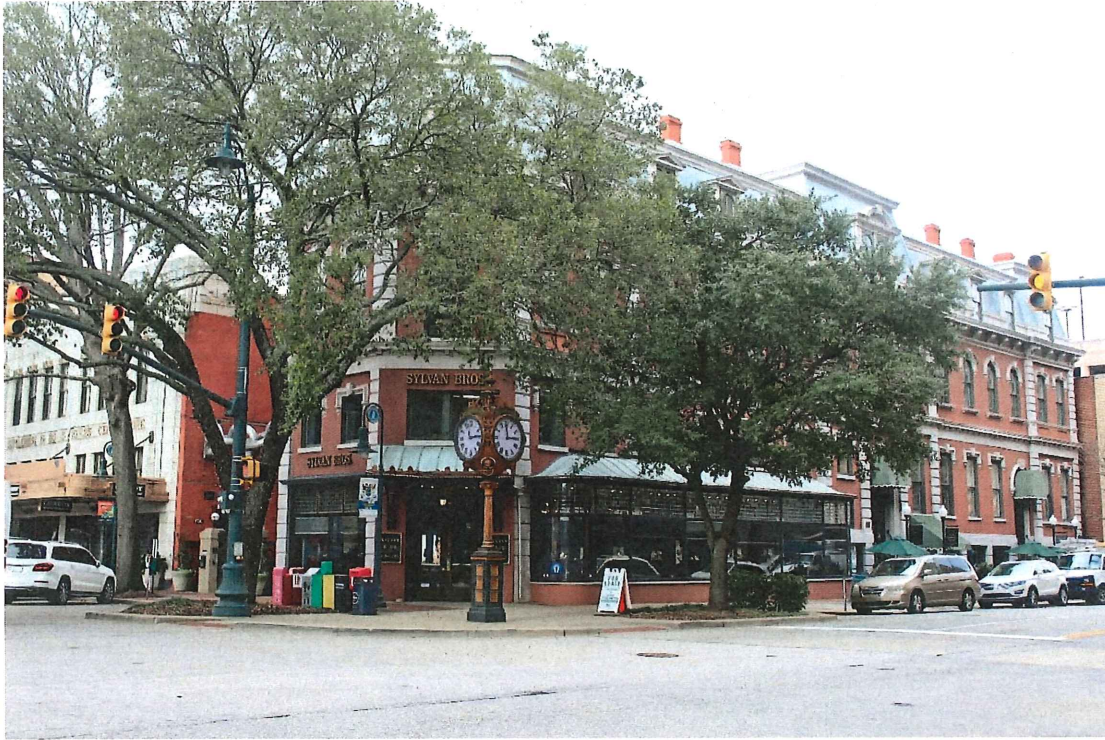
The dormer windows appear in poor condition.

Photo 1 – Southwest oblique

The third floor dormer windows will be repaired, or where too deteriorated, replaced with new wood windows that match the existing profiles and glazing. See attachment #1 for detailed information and locations regarding window repairs.

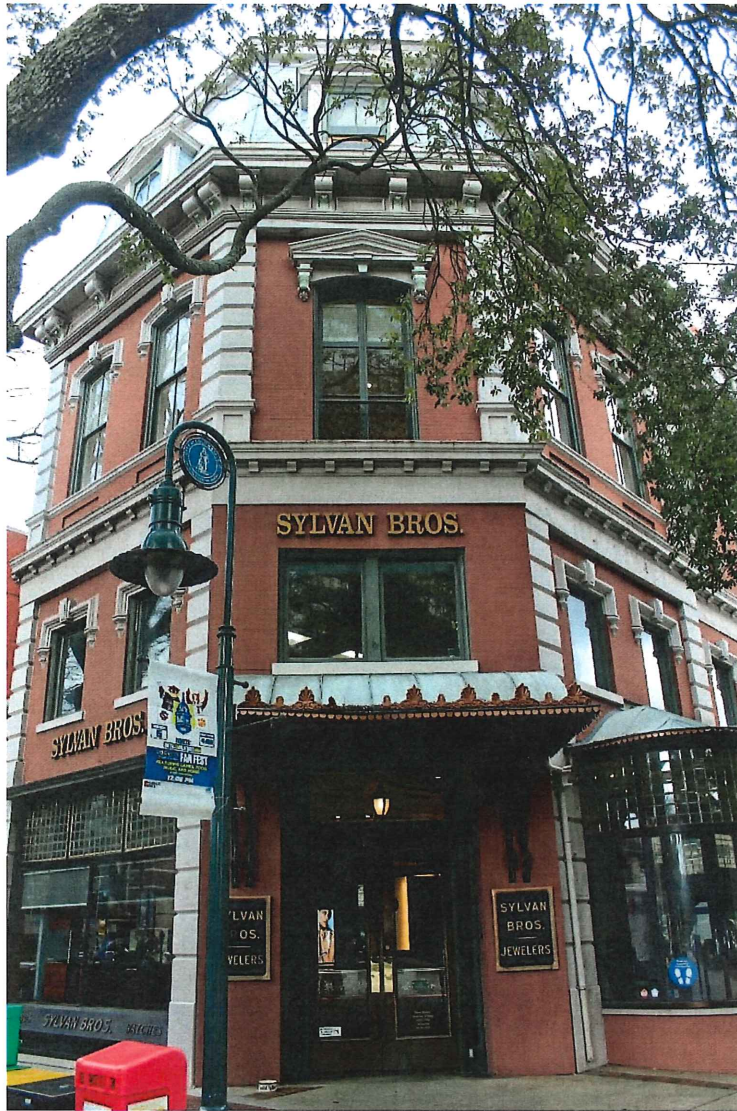
Photo 2 – Corner entrance, looking northeast

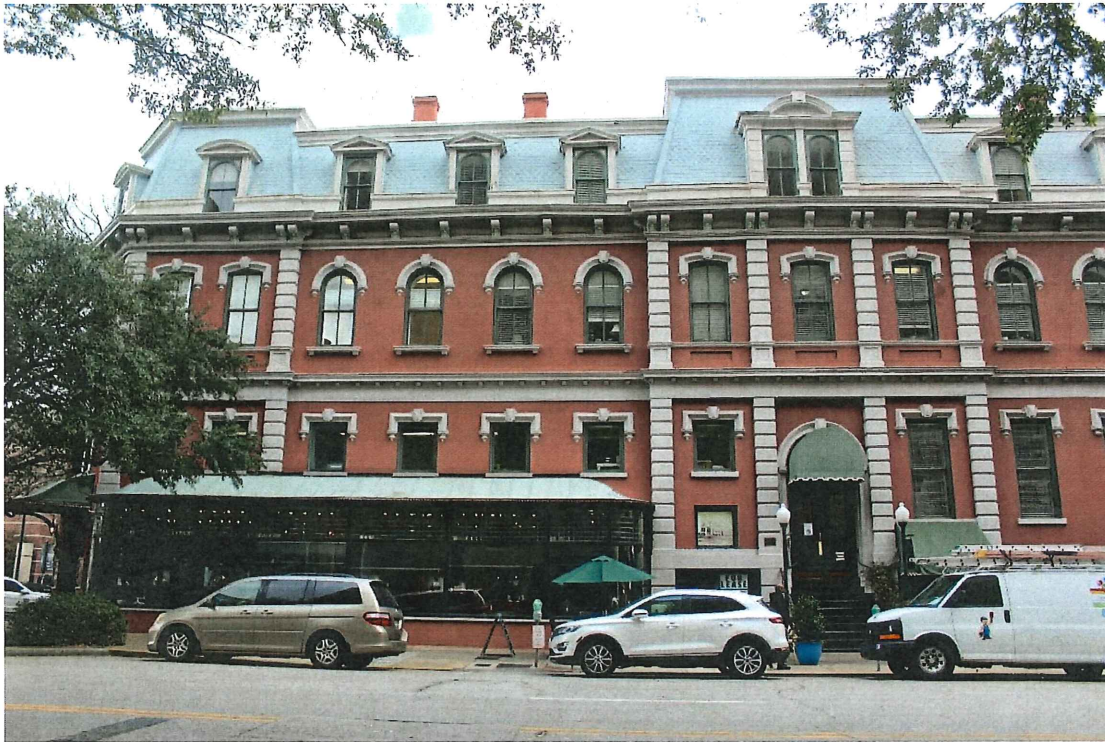
Photo 3 – West end of south elevation, looking north
