DESIGN/DEVELOPMENT REVIEW COMMISSION
DESIGN REVIEW DISTRICT
HISTORIC/REGULAR AGENDA
EVALUATION SHEET
Case #1

ADDRESS: 1237 Gadsden Street

NATURE OF REQUEST: Request for preliminary certification for the Bailey Bill and Certificate of Design Approval for exterior changes

Epes-Fitzgerald Paper Company
1237 Gadsden St. Columbia, SC
Bailey Bill Photographs – 7/12/2023
West Gervais Street Historic District

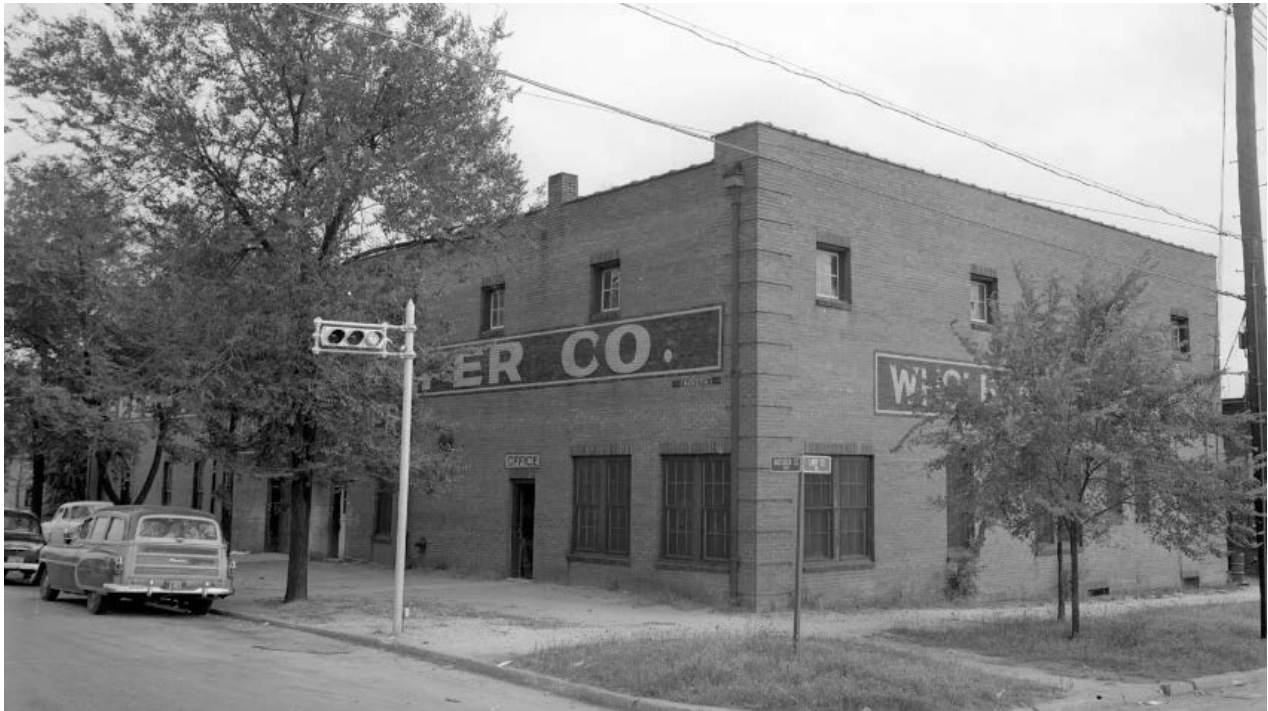
1959--1237 Gadsden Street

Currently, the oldest photo of the east elevation dates to 1959. This photo shows the location of original door and window openings including two single door openings still in place today. This photo will be used as the documentary evidence for the reestablishment of windows and retention of the original single door openings still in place.

Unless new evidence uncovers a different original configuration, staff recommends keeping the two door openings, as recorded on the historic photo. These non-original doors themselves could be secured or dry-walled over on the interior, if desired; likewise, there may be appropriate replacement doors with part glass which could be used as a reference to the originals but still be non-operational. The south elevation historically featured very few openings (aside from a freight opening which has been bricked in for many years) so an addition on this elevation will entail little loss of historic materials and is an appropriate location for it.

Thus far no feature seems deteriorated enough to require replacement. For windows and doors that have been altered over the years, as mentioned above, staff recommends that the new features reflect the characteristics, including the header and sill height, of original features as seen in the 1959 photo.

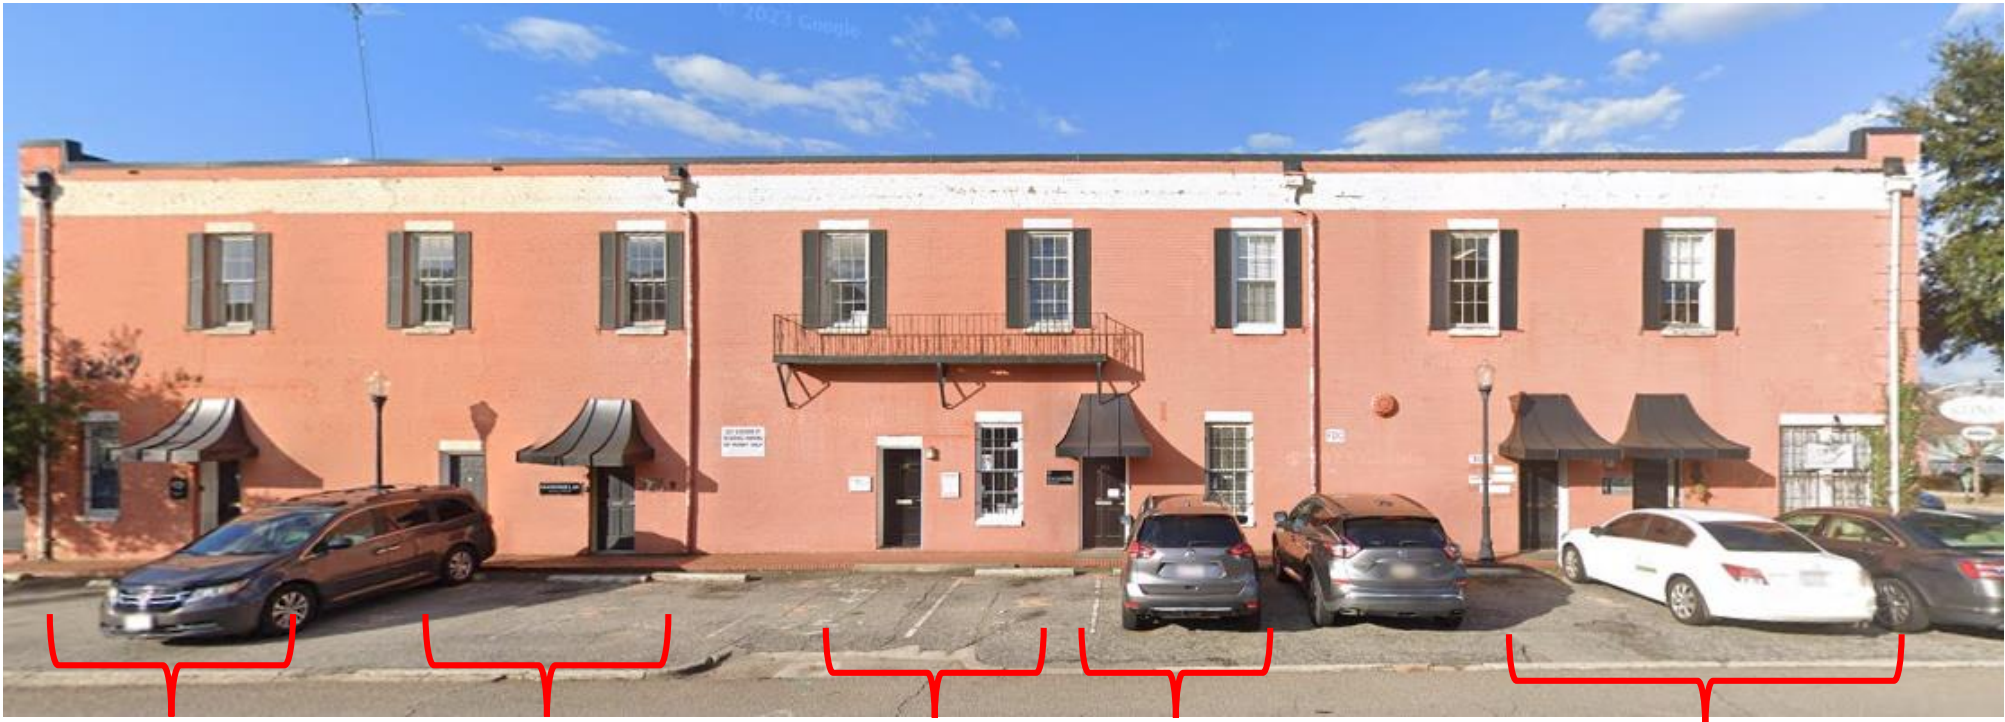
Location of original roll-up warehouse door

Location of original windows

Location of original single door and window- **RETAIN both openings**

Location of original single door and 2 double windows- **RETAIN door and re-establish missing double window**

As stated earlier, two door openings on the east elevation should be retained based upon evidence from the building's architecture and historic photos. The doors would not be required to be operable.

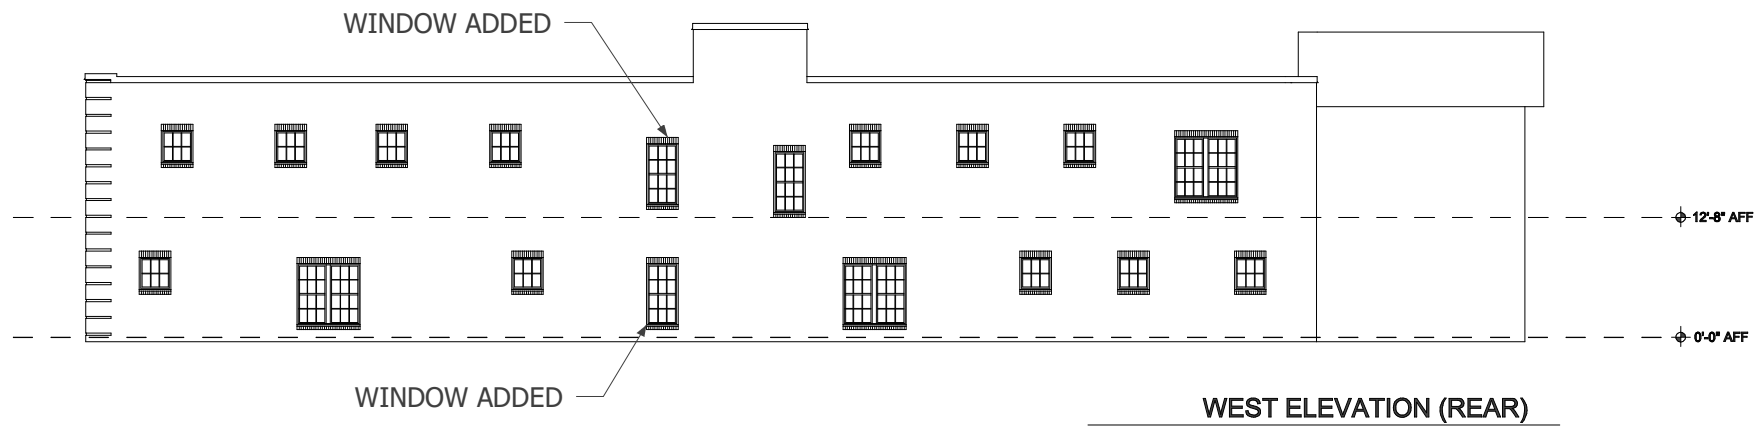
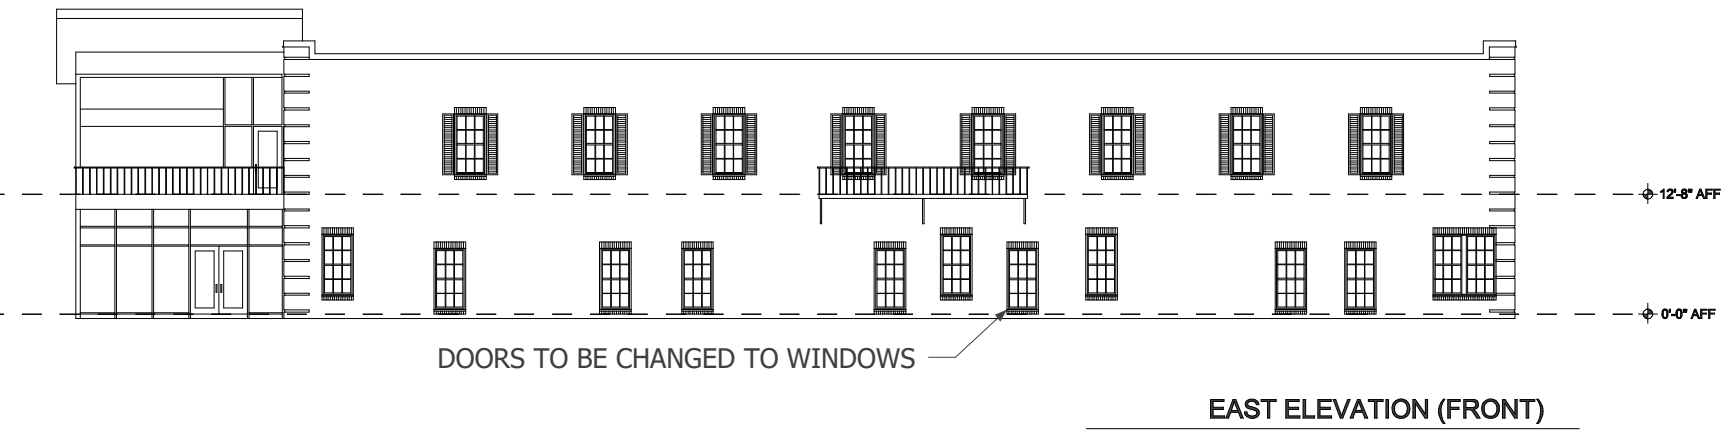
A2.0

LIGHT WELLS WILL BE ADDED TO THE FRONT AND REAR ELEVATIONS TO BRING LIGHT INTO THE BASEMENT

Light wells will be excavated on the east facade and west elevation to allow light to access the basement level hotel rooms.

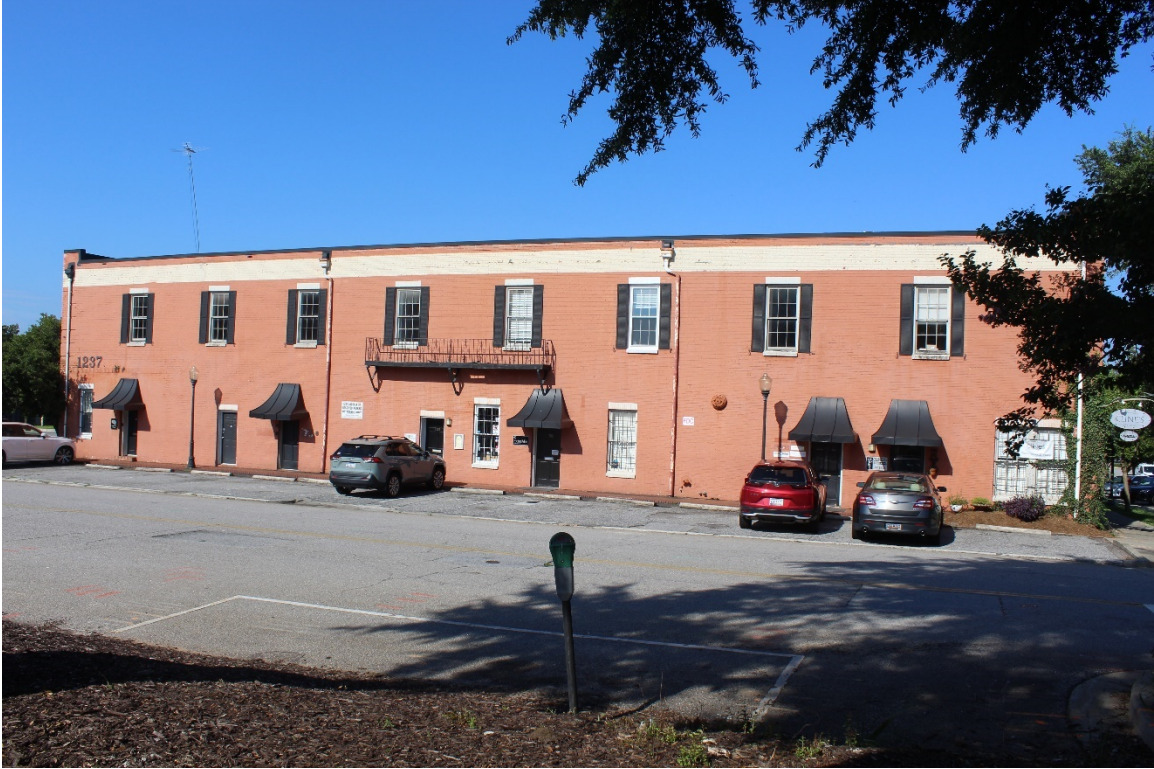
Photo 1 – East façade

The building is a bit unusual as it does not have an articulated main entrance; instead, the structure seems to have been built so that several single door entries provided access along the east elevation, making this a primary façade. The proposal to change all of the doors to windows on this elevation would therefore alter the understanding of how the building originally functioned.

Currently, the building houses multiple tenants, which is reflected through the use of seven single-leaf doors located across the east facade. Each is a six-panel wood door, six of which feature a flared, seamed metal awnings above them. Moving south to north, the second and fourth bay doors are not covered.

Staff recommends the retention of two historic door openings on the east elevation. The proposed addition on the south elevation is appropriately located on a non-primary façade but will be designed and detailed further. This will come back to the DDRC for approval.

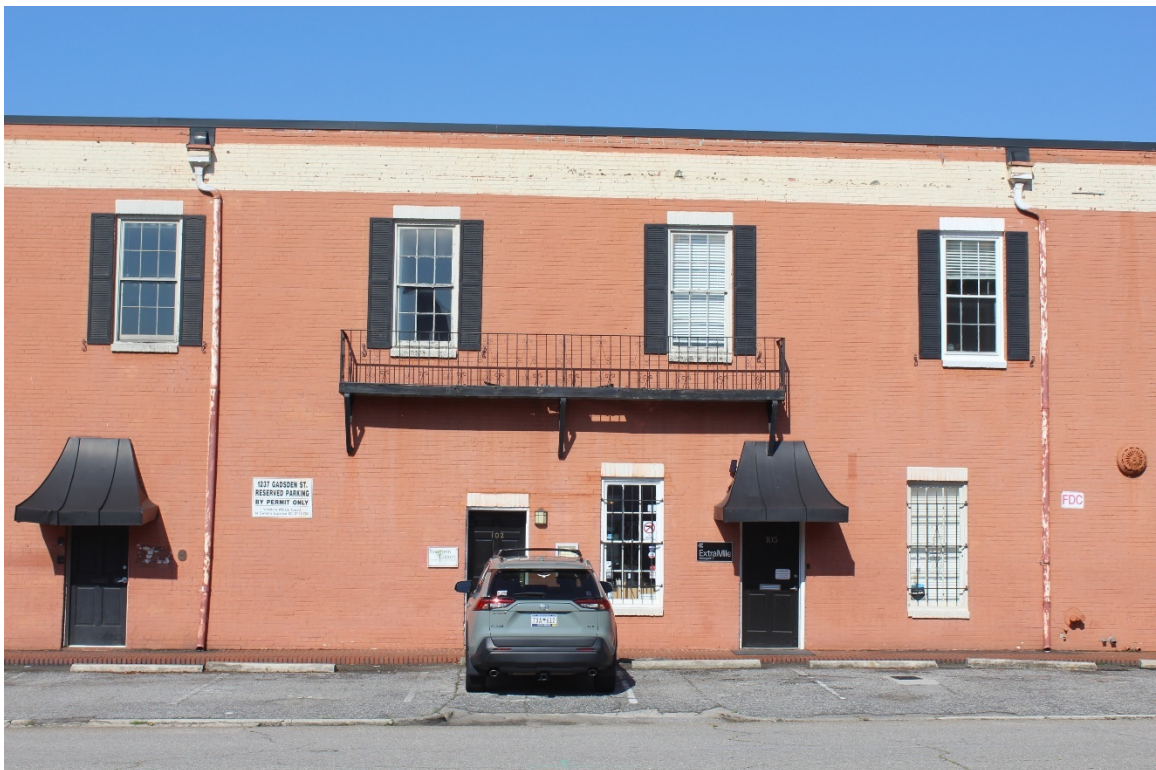
A wrought-iron balcony was added to the center two bays of the second floor on the east facade. It is supported by three brackets and the railing features a decorative diamond-

Photo 3 – Single leaf doors with flared awnings, balcony, center of east façade

The existing balcony will remain in place. No work will occur on this feature.

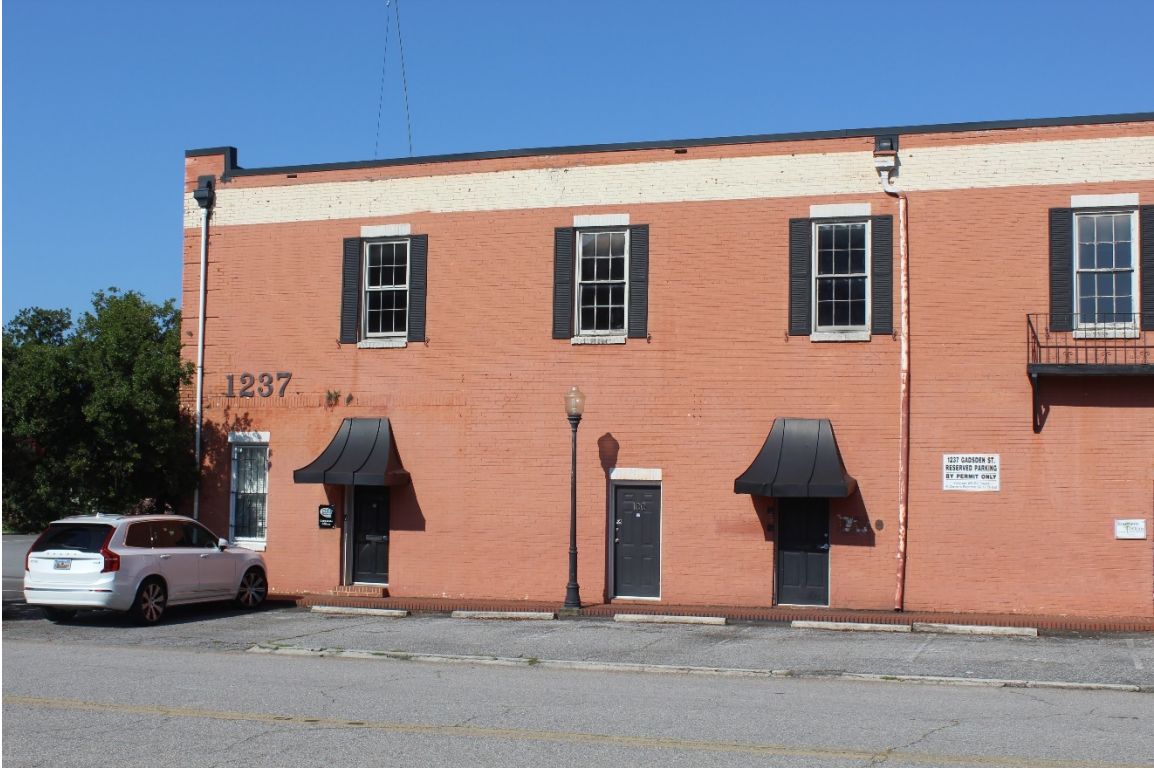
Photo 4 – South end of east façade

Scarring of a wide freight opening is visible on the south end of the east facade.

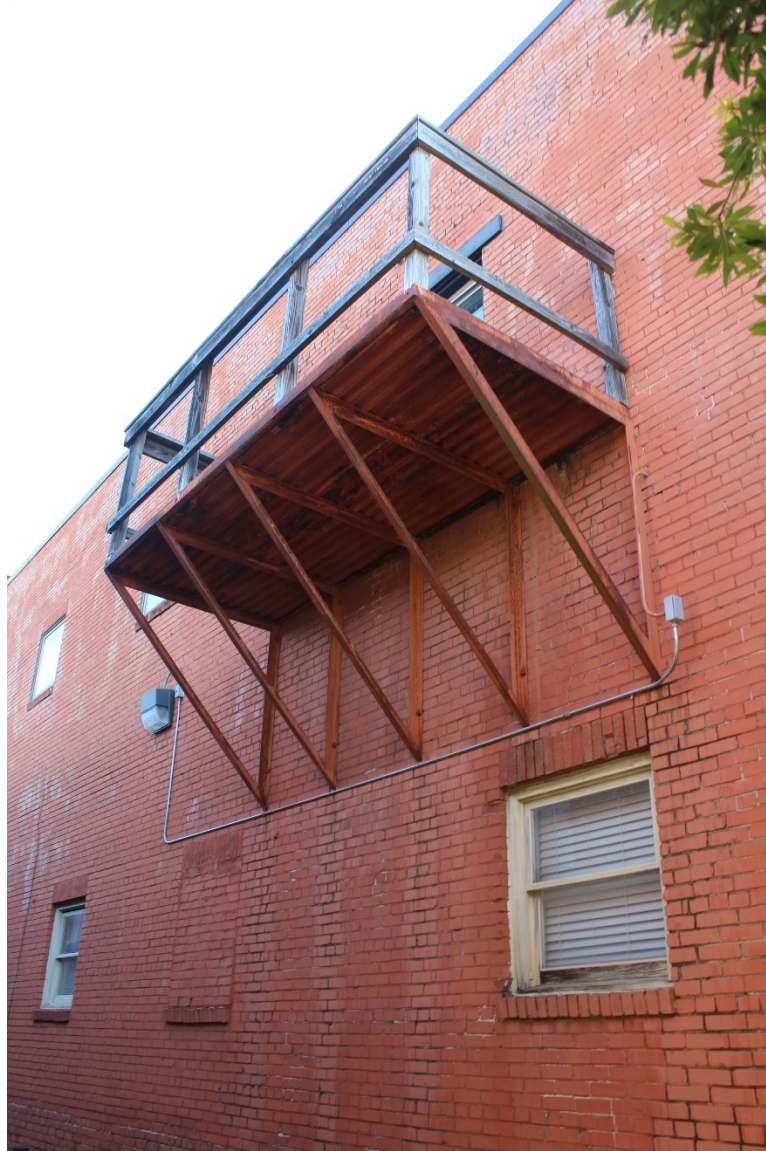
The secondary elevations primarily have aluminum direct set windows. These date to the 1990s renovation and are located on the second floor of the west and south elevations. The first floor of the west elevation features small, one-over-one wooden double hung windows

Photo 6 – Replacement and in-filled windows, bracketed metal balcony, west elevation

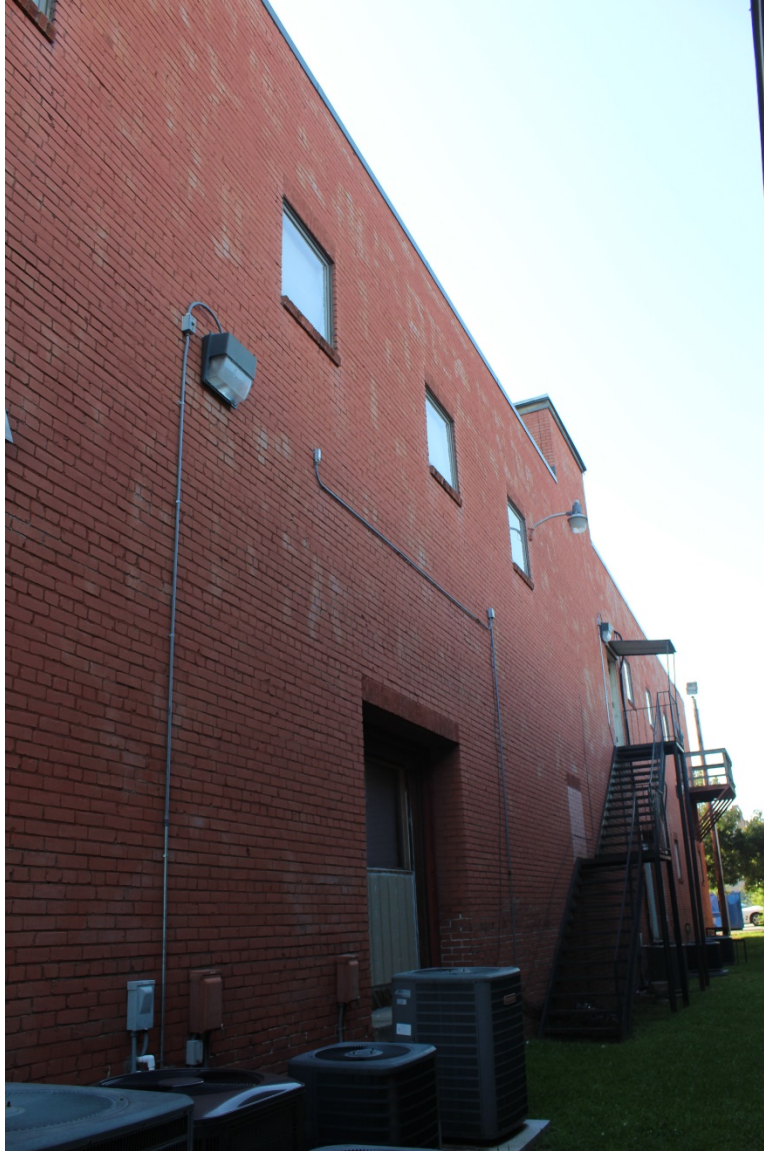
The west elevation has a set of fully glazed wooden storefront doors at the center of the elevation. A freight opening near the north end is in-filled with a picture window and vertical wooden siding.

Photo 8 – West elevation with replacement windows and door openings, looking south

New windows will occupy the openings on the west elevation.

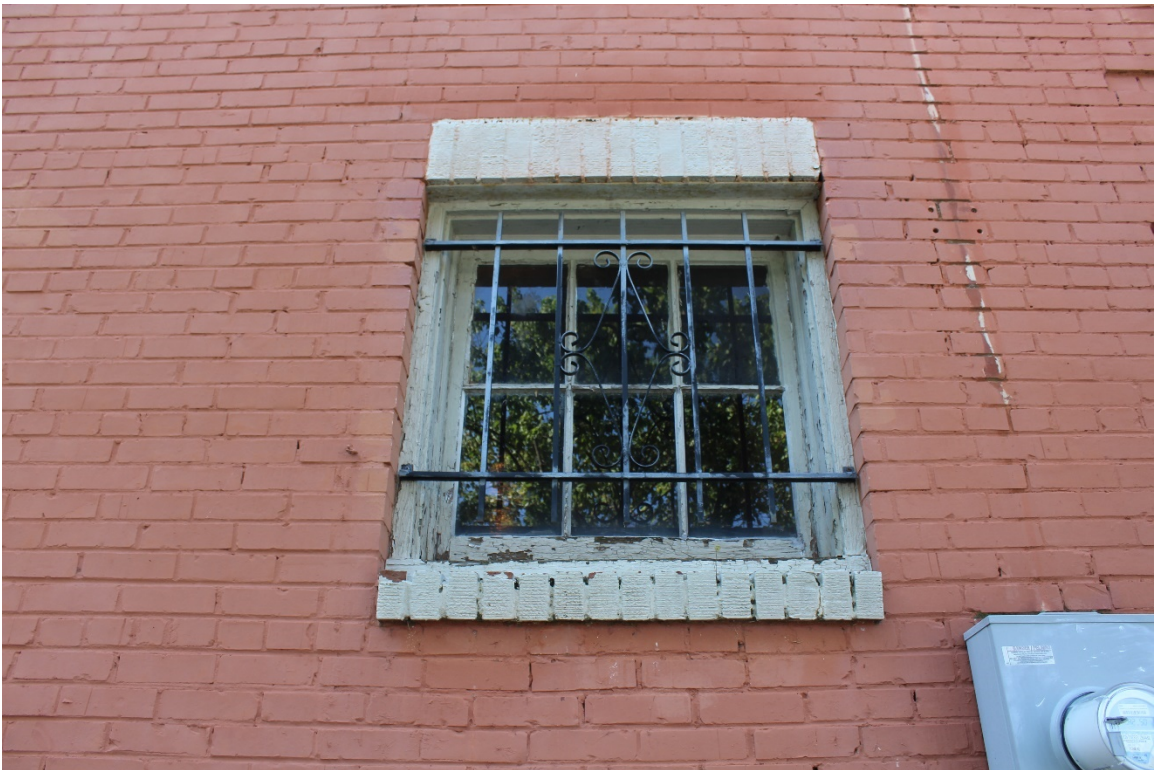
The building features wooden six-over-six double hung windows, some of which are paired, and some that are shorter and narrower than most. Additionally, the building features a fixed six-light wooden window on the west end of the north elevation's first floor. Historically, this window type was located across the east facade's second floor. The existing windows on the second floor are six-over-six double hung windows flanked by black louvered shutters.

Photo 10 – Original six-light window, north elevation

The existing windows on the north elevation will remain as they exist with no work occurring on them.

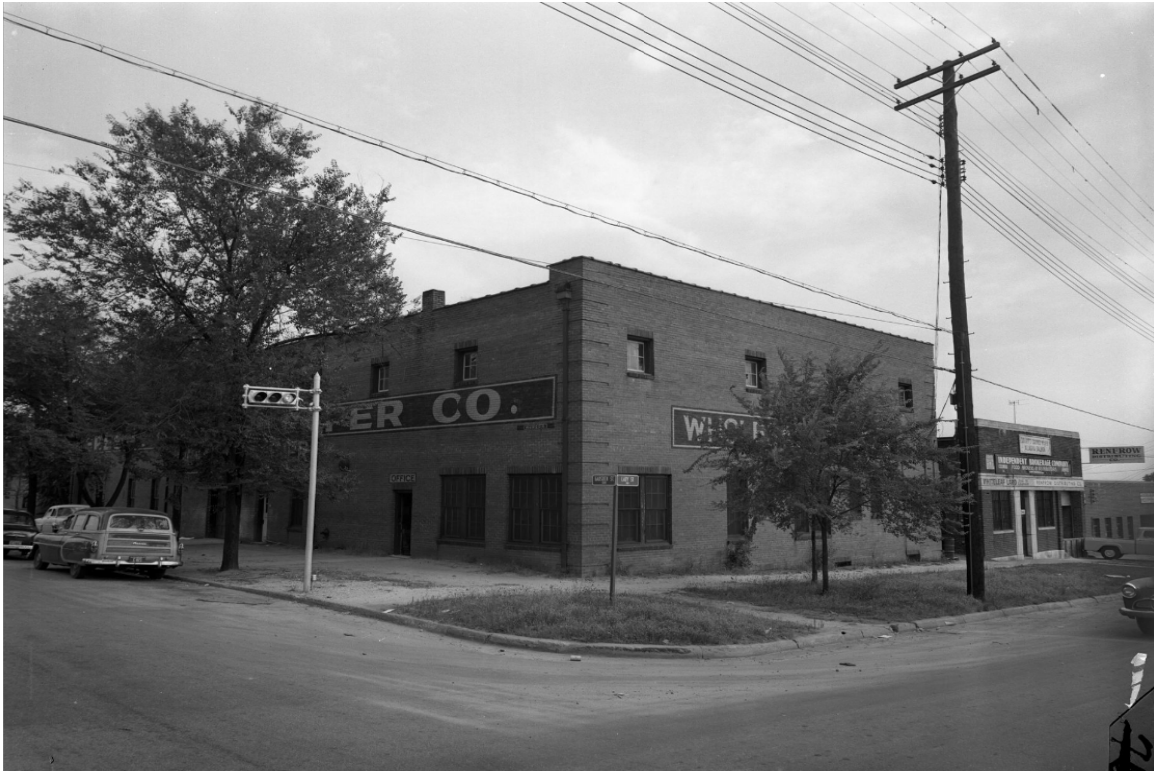
Historically, the building exhibited an unpainted, red brick finish with "Epes-Fitzgerald Paper Co." painted between the first and second levels on the east facade and "wholesaler" on the north elevation.

Photo 11 – “Epes-Fitzgerald Paper Company,” 6.17.1959, *The State* Newspaper Photo Archive
