D/DRC Case

**DESIGN/DEVELOPMENT REVIEW COMMISSION
DESIGN REVIEW DISTRICT
HISTORIC/CONSENT AGENDA
EVALUATION SHEET
Case #3**

ADDRESS: 1003 Elmwood Avenue

NATURE OF REQUEST: Request for preliminary certification for the Bailey Bill

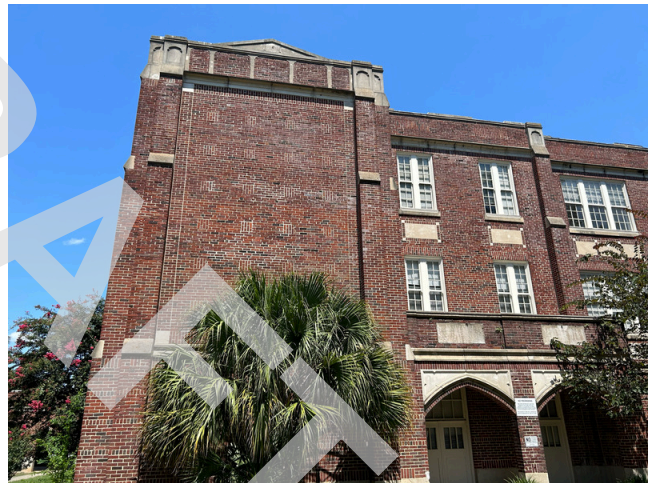
16. Exteriors - typical brick masonry in good condition

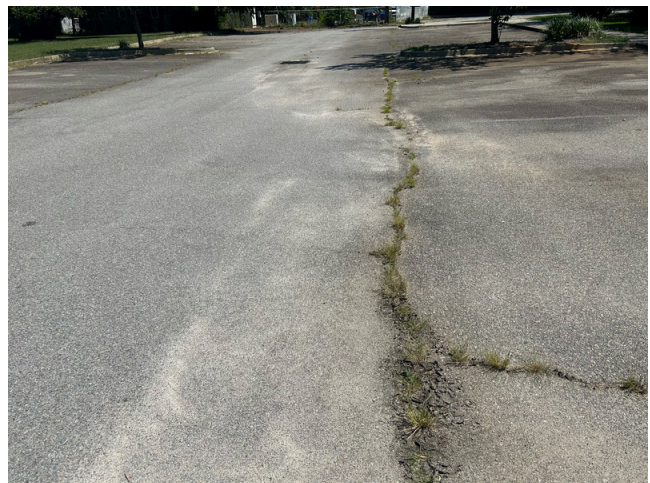
18. Site - asphalt at north parking lot (note vegetative growth)

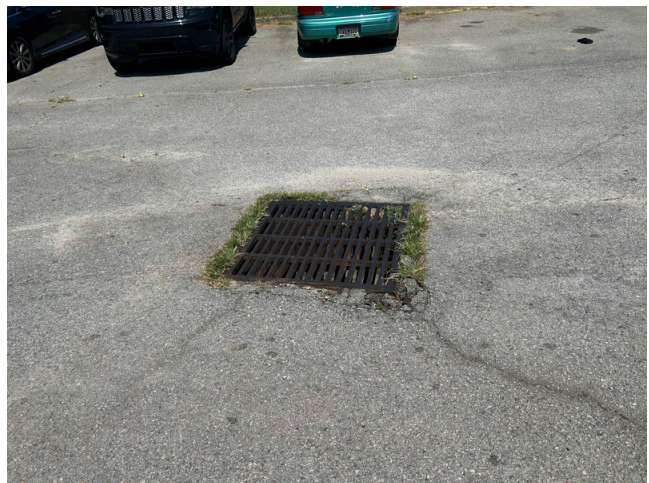
24. Site - area drain at drive lane (note vegetative growth)

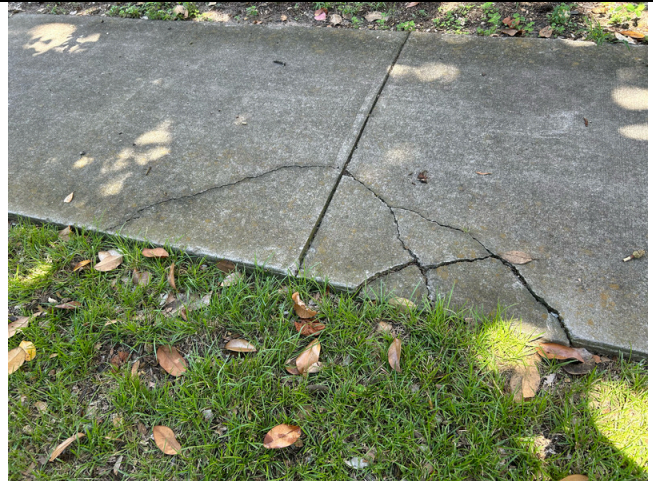
38. Site - sidewalk distress

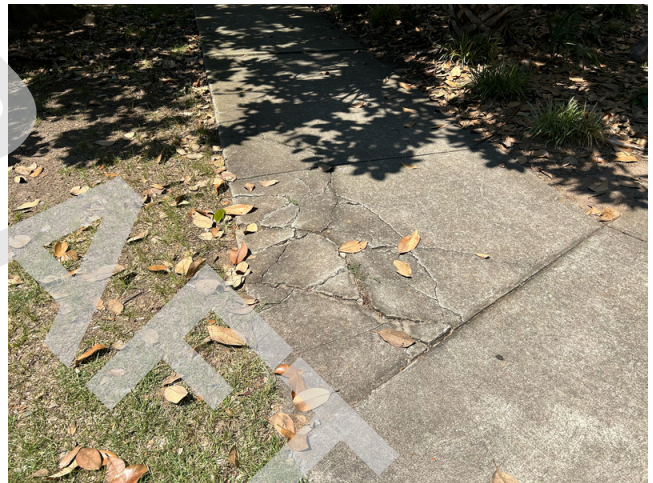
40. Site - sidewalk distress

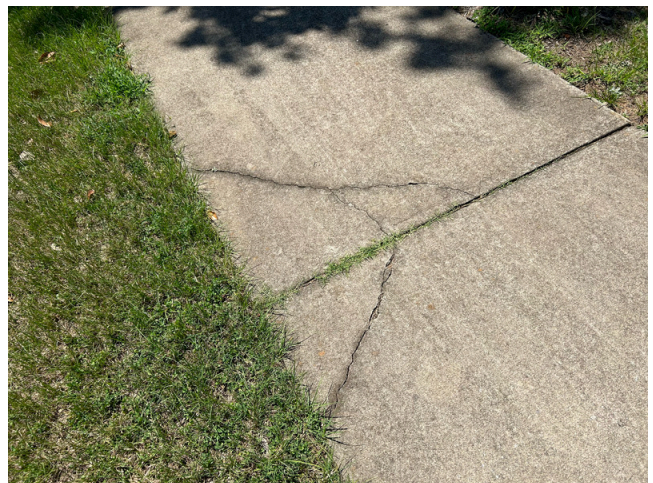
42. Site - sidewalk distress

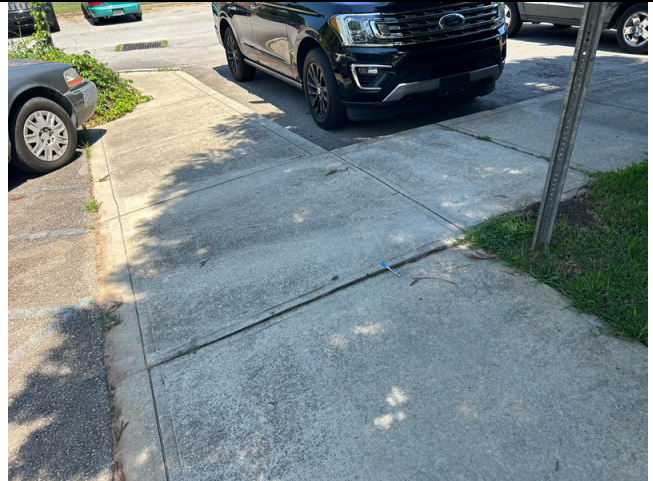
44. Site - sidewalk distress

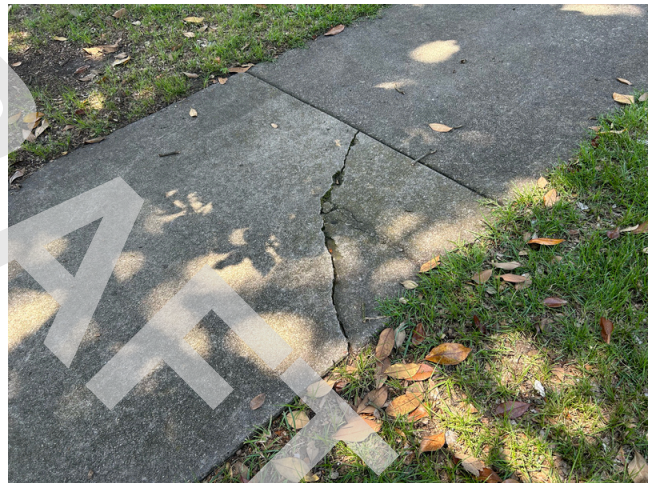
46. Site - sidewalk distress

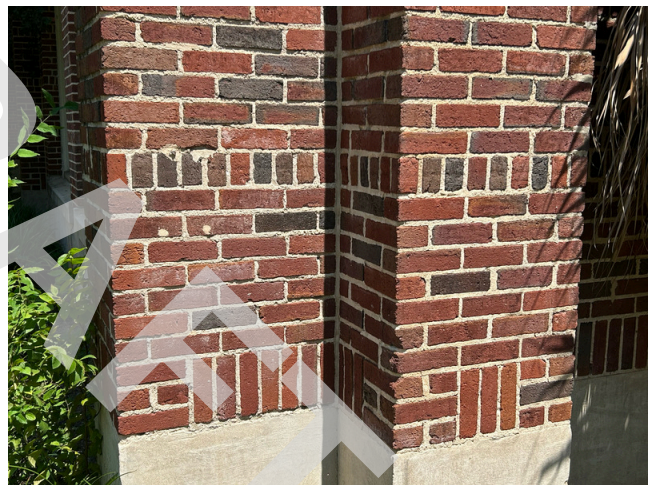
70. Exteriors - typical brick masonry in good condition

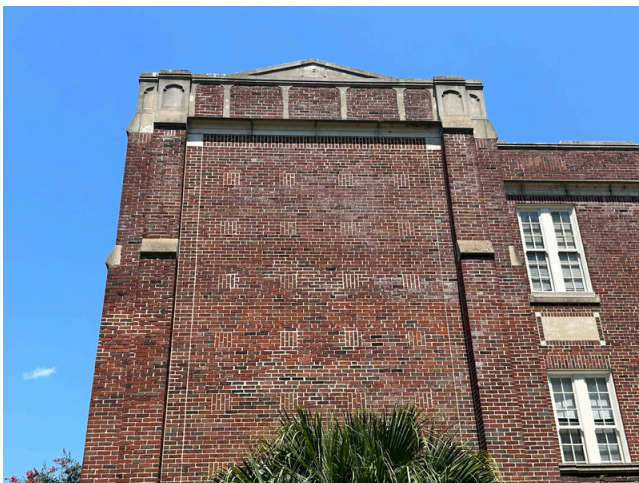
71. Exteriors - typical brick masonry in good condition

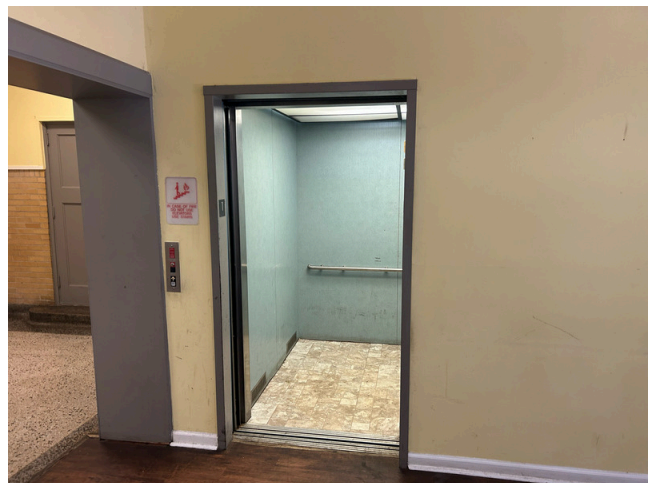
72. Elevator - cab finishes

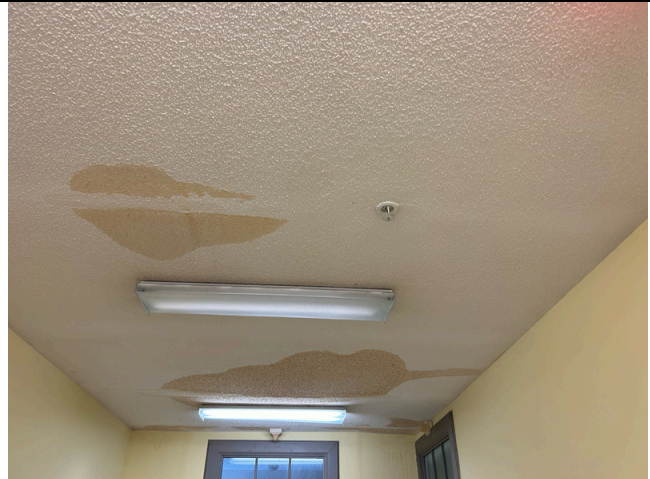
110. interiors - old plumbing leak / stained ceiling in corridor

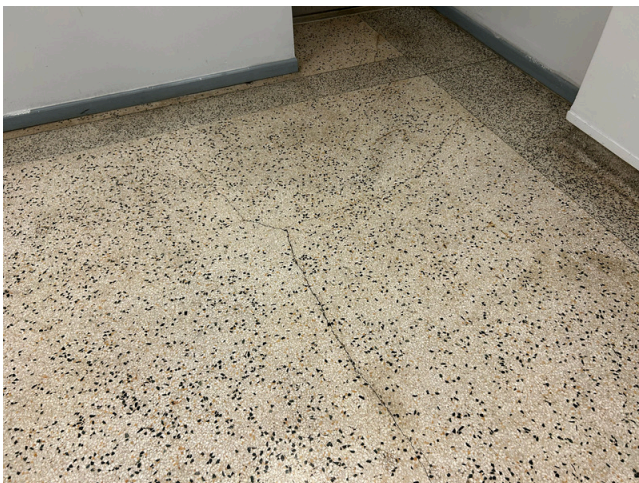
113. Interiors - typical terrazzo condition at common corridor

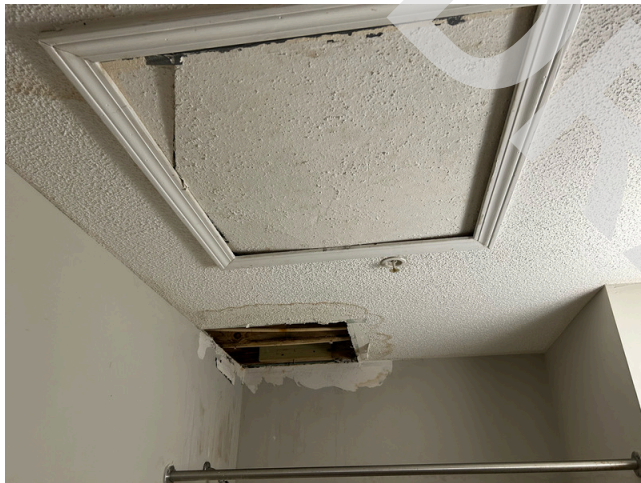
129. Interiors - unit 105 / old plumbing leak damage

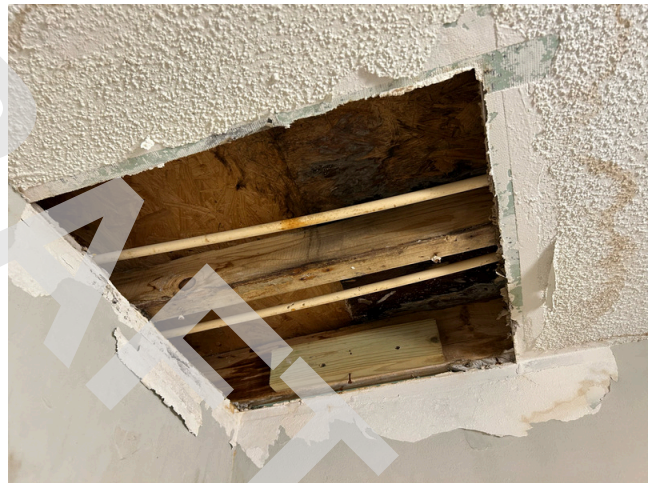
130. Interiors - unit 105 / old plumbing leak damage
