**DESIGN/DEVELOPMENT REVIEW COMMISSION
DESIGN REVIEW DISTRICT
HISTORIC/CONSENT AGENDA
EVALUATION SHEET
Case #3**

ADDRESS: 1500 Main Street

NATURE OF REQUEST: Request for Certificate of Design Approval for exterior changes and preliminary certification for the Bailey Bill

SYLVAN BUILDING DORMERS SURVEY

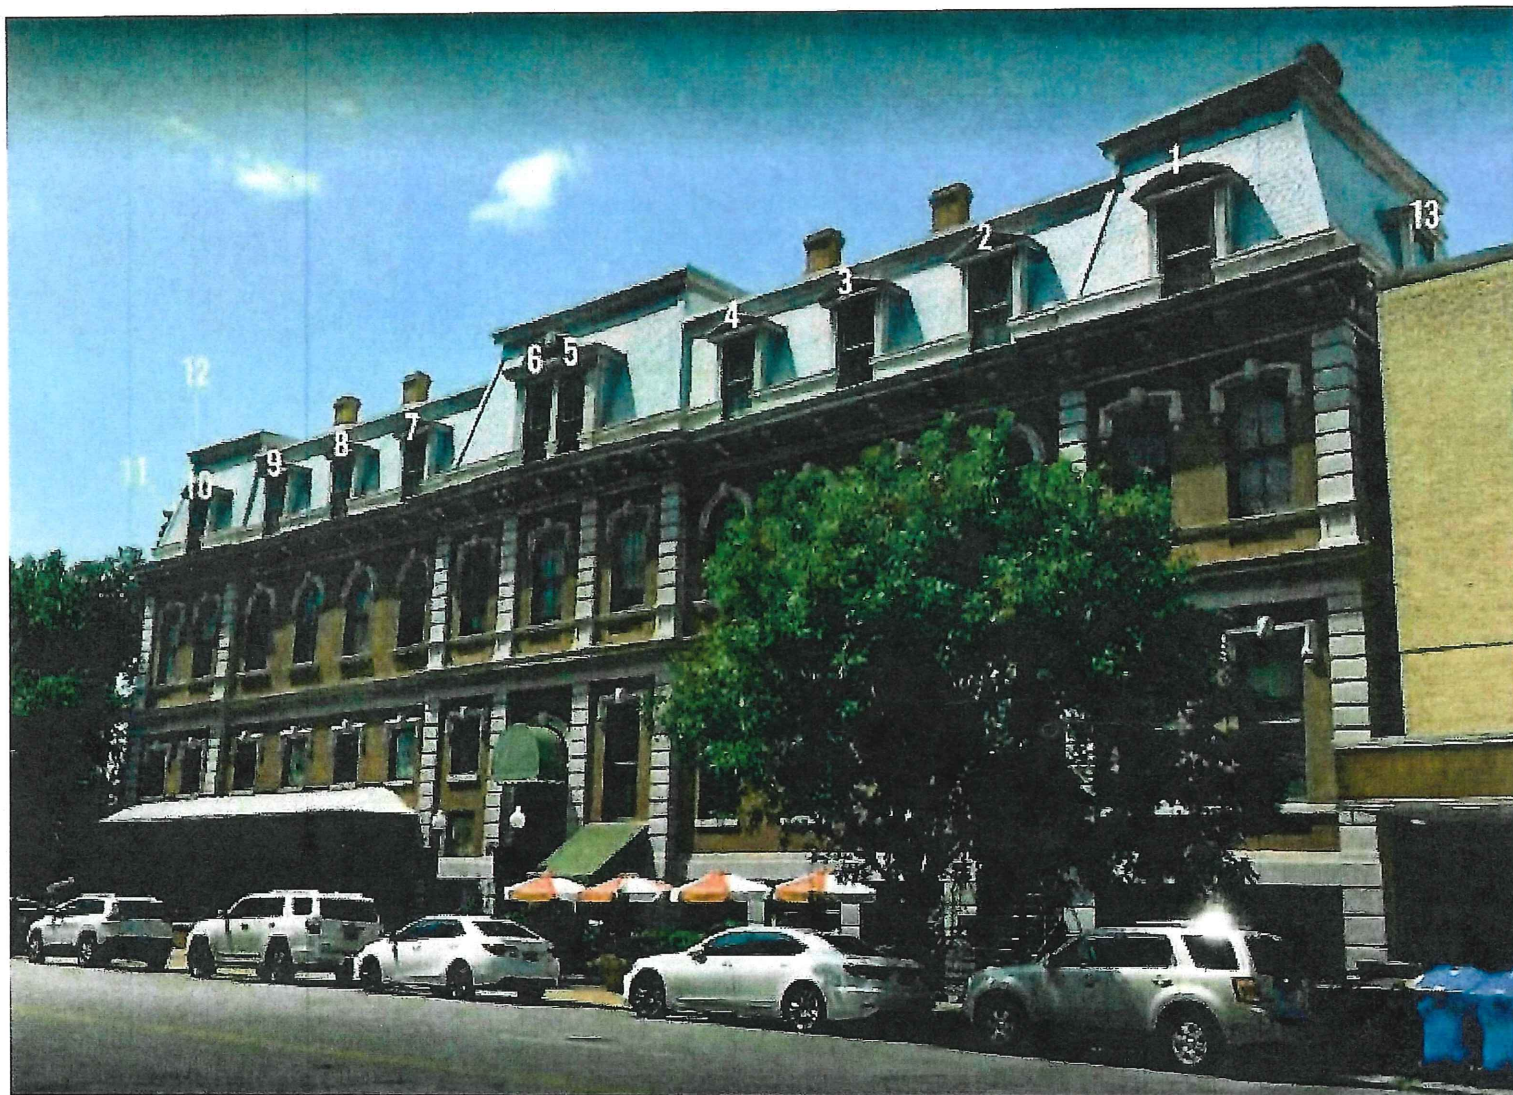
SYLVAN BUILDING DORMER ONE

Areas lined with red are rotten and needs replacing.
Numbers above correspond with detail picture

Due to areas of poor condition, the dormers require large scale repairs. The dormers will use wood to replace deteriorated pieces and be repainted the existing color. See attachment #1 for additional information and details regarding the scope of the dormer repairs.

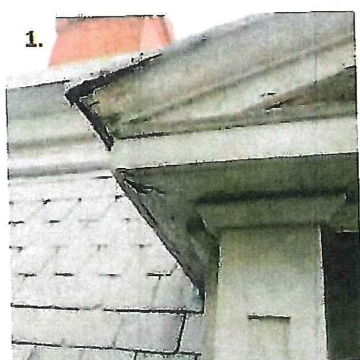
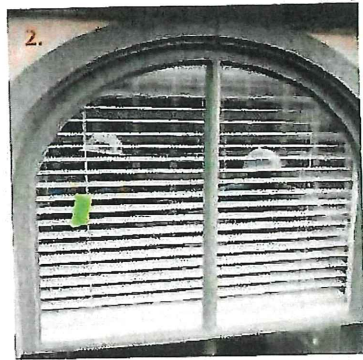
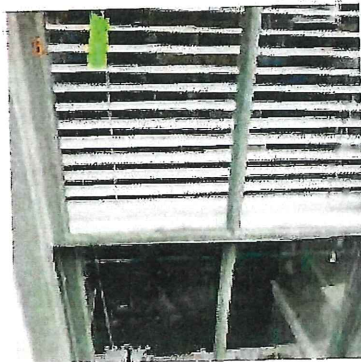
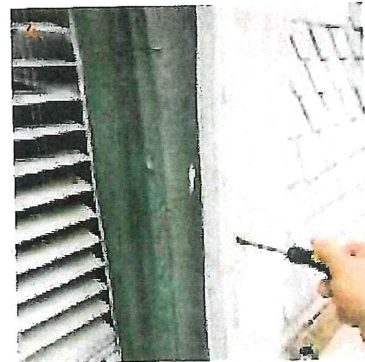
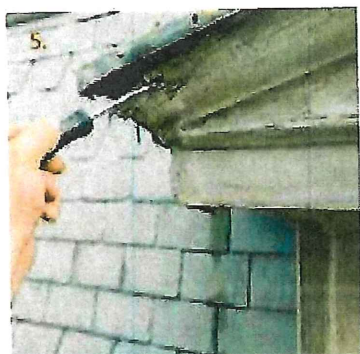
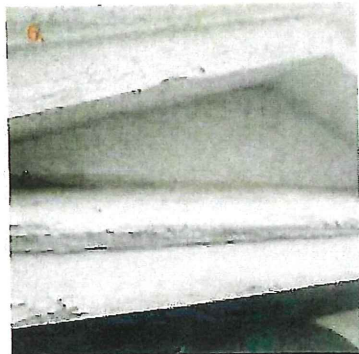
SYLVAN BUILDING DORMER THREE

Areas lined in red are rotten and it is recommended that they be replaced. Length of red line is how much needs replacing.

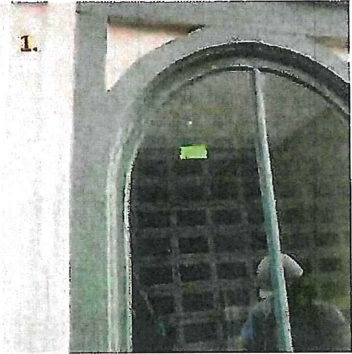
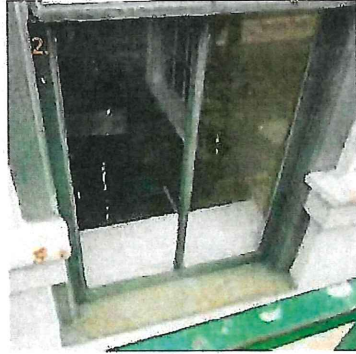
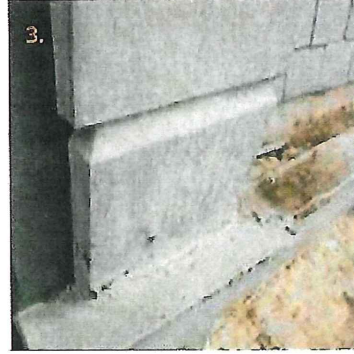
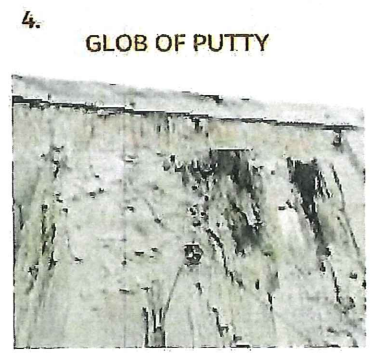
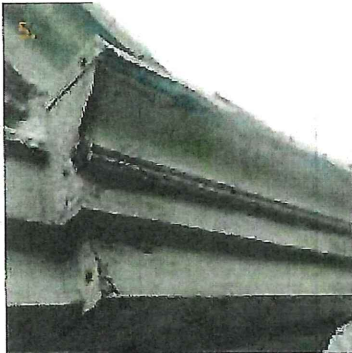
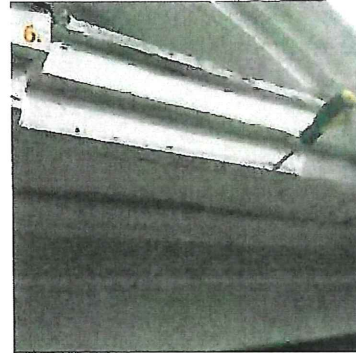
SYLVAN BUILDING DORMER FIVE

The dormer windows appear in poor condition.

The third floor dormer windows will be repaired, or where too deteriorated, replaced with new wood windows that match the existing profiles and glazing. See attachment #1 for detailed information and locations regarding window repairs.
