D/DRC Case

**DESIGN/DEVELOPMENT REVIEW COMMISSION
DESIGN REVIEW DISTRICT
HISTORIC/CONSENT AGENDA
EVALUATION SHEET
Case #3**

ADDRESS: 1003 Elmwood Avenue

NATURE OF REQUEST: Request for preliminary certification for the Bailey Bill

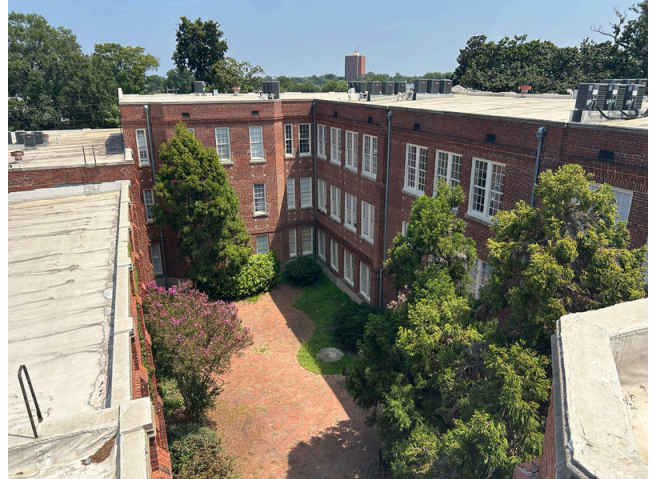
2. exteriors - brick masonry & wood window systems

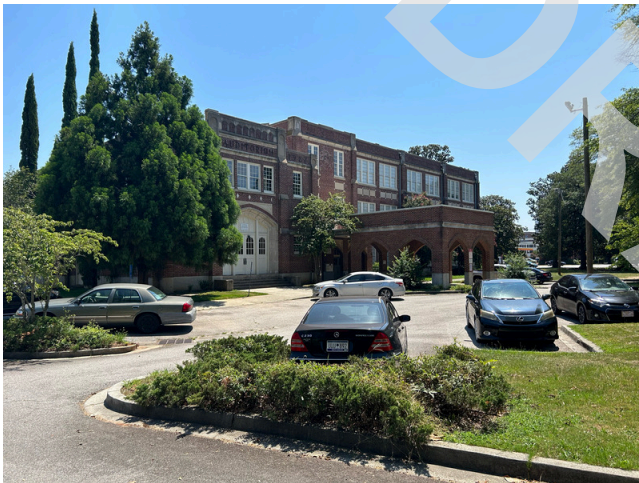
3. Exteriors - overview at west elevation

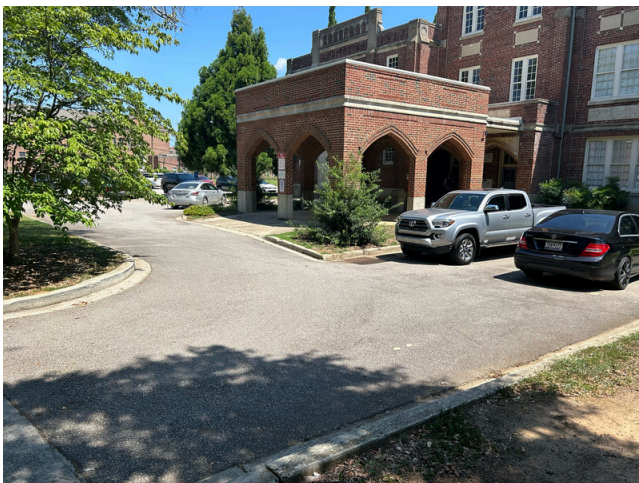
5. Exteriors - overview of main entrance at west elevation

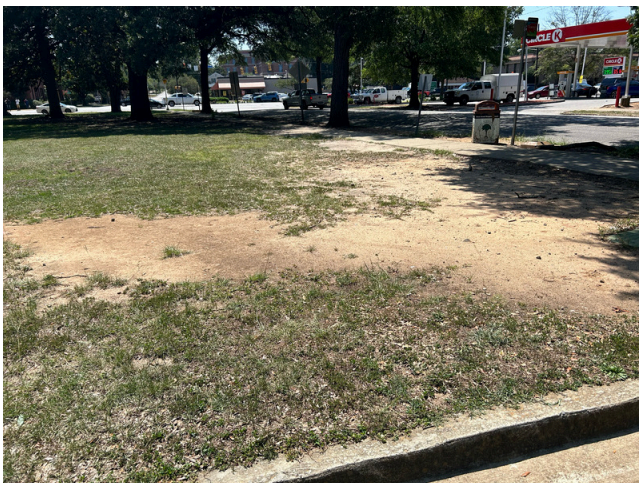
17. Site - bare lawn area at west boundary

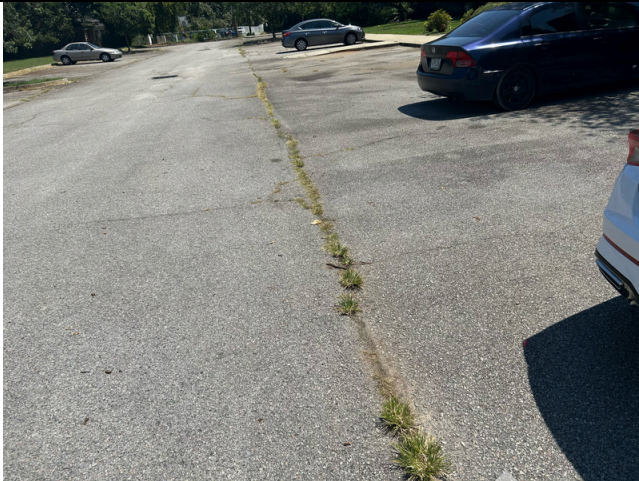
19. Site - asphalt at north parking lot (note vegetative growth)

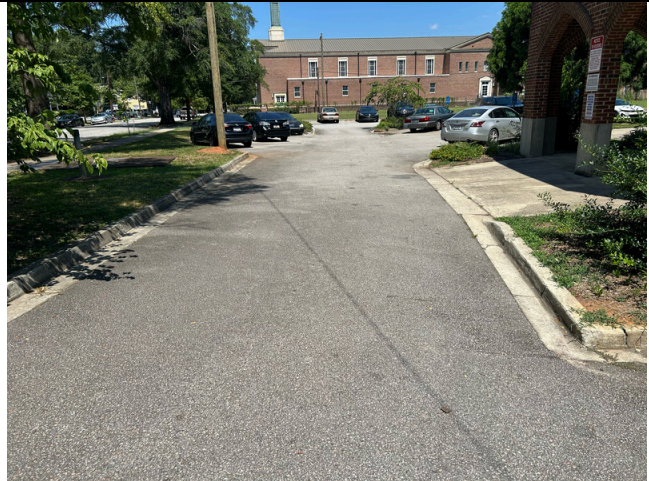
20. Site - asphalt pavement at main entry

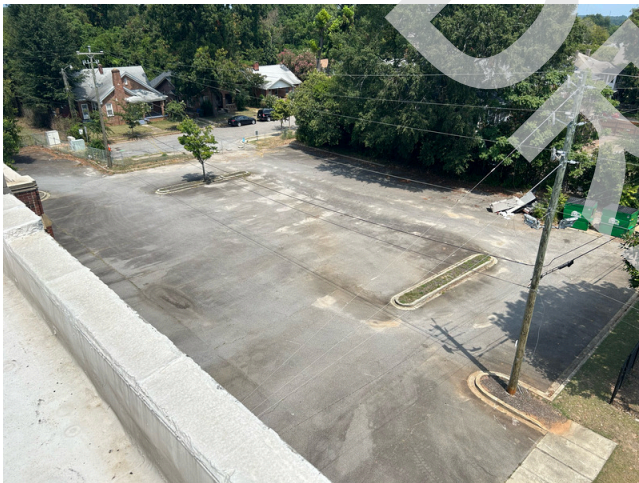
21. Site - asphalt paving at east elevation

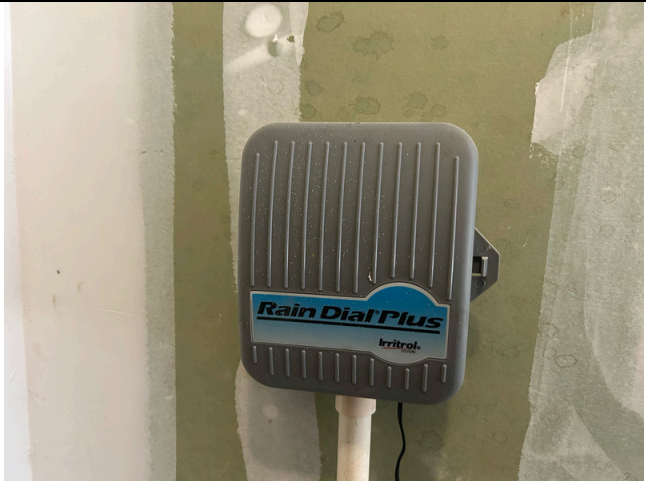
26. Site - irrigation controller

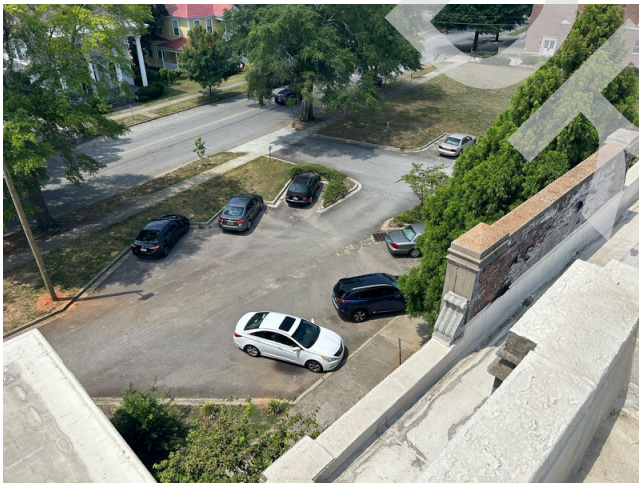
27. Site - office parking at west elevation

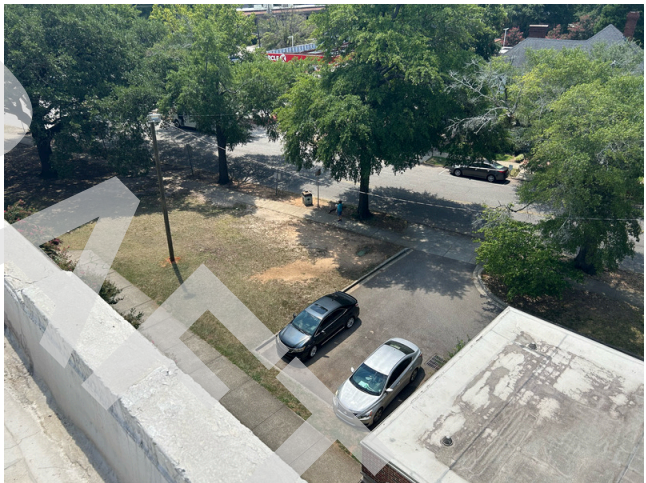
28. Site - office parking at west elevation

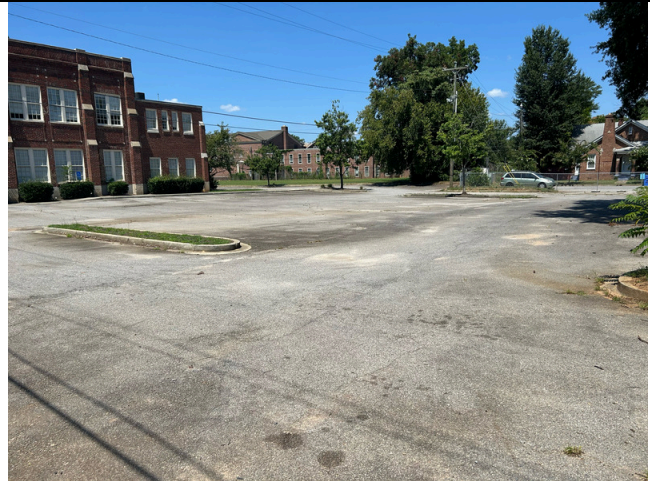
32. Site - parking lot at east elevation to north

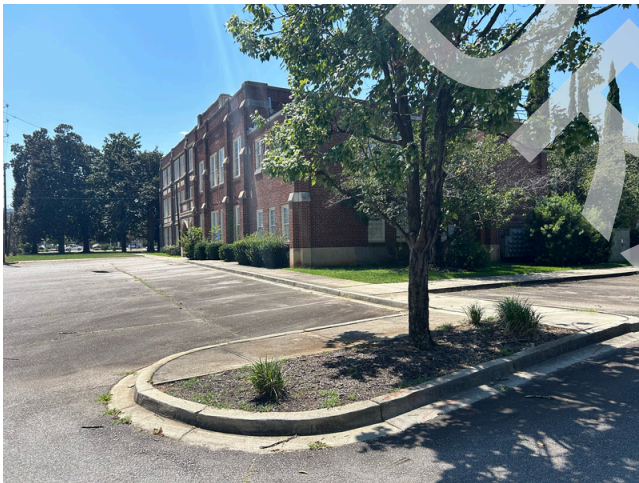
33. Site - parking lot at east elevation to south

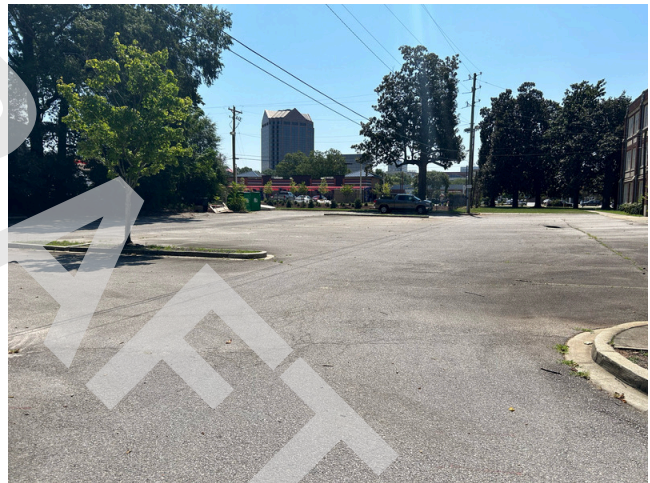
34. Site - parking lot at east elevation to south

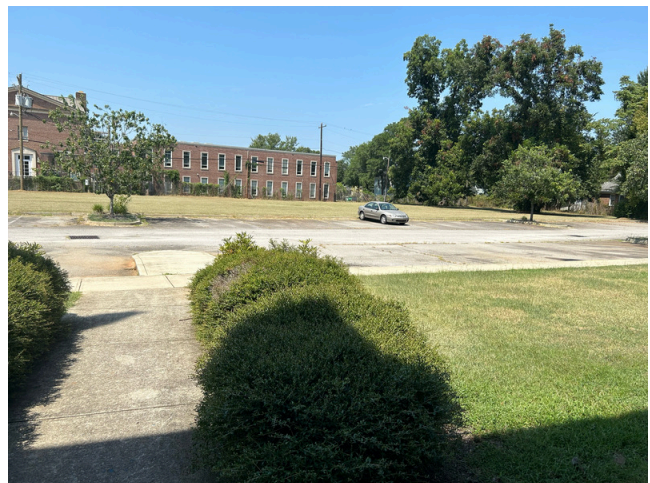
36. Site - rear parking lot

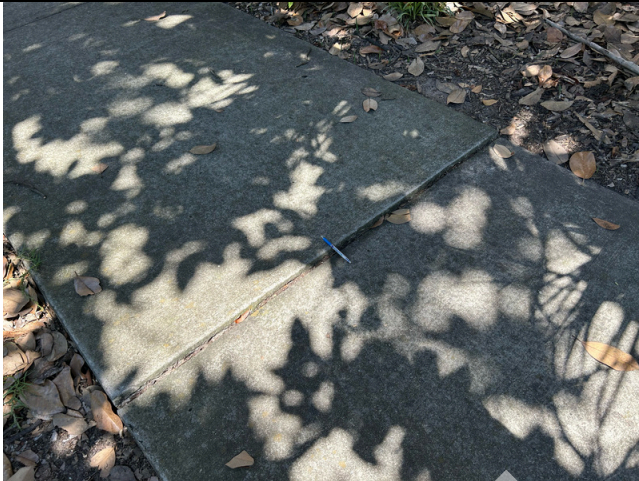
37. Site - sidewalk distress

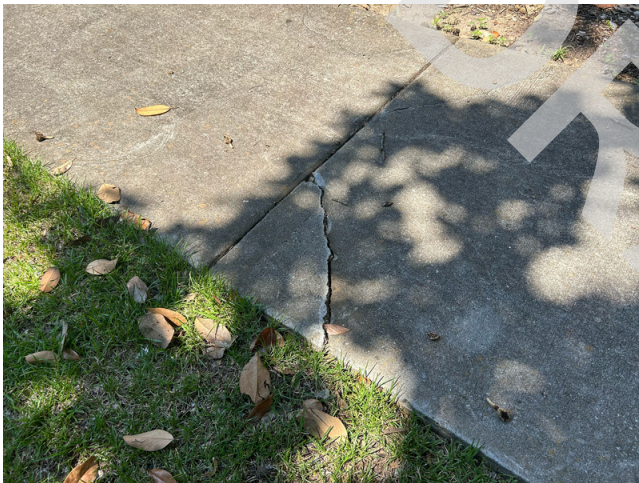
39. Site - sidewalk distress

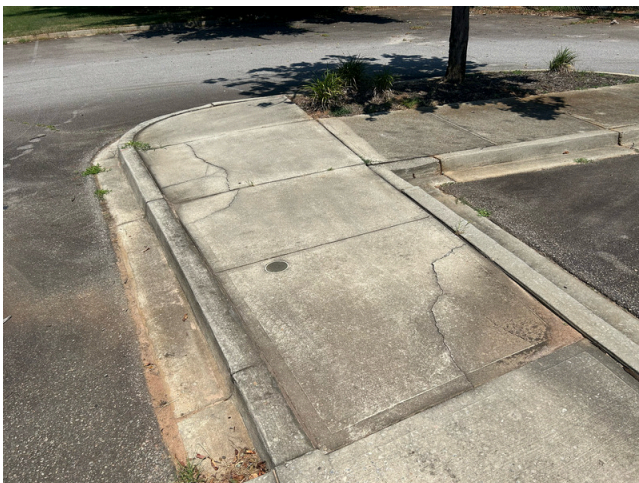
41. Site - sidewalk distress

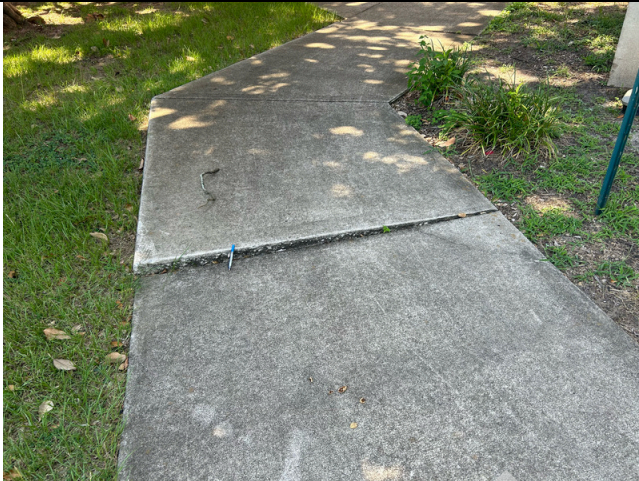
43. Site - sidewalk distress

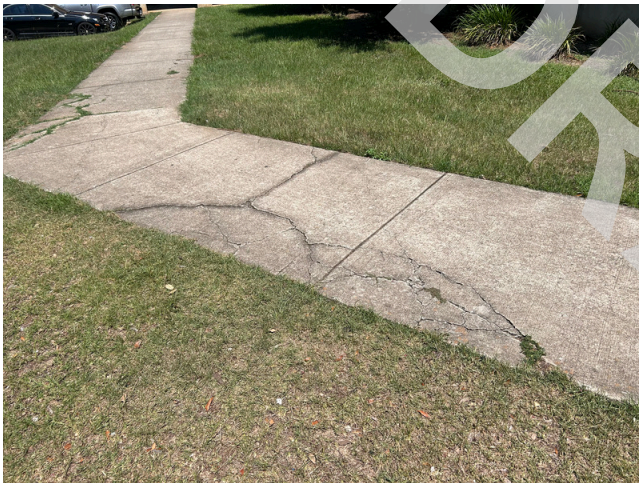
45. Site - sidewalk distress

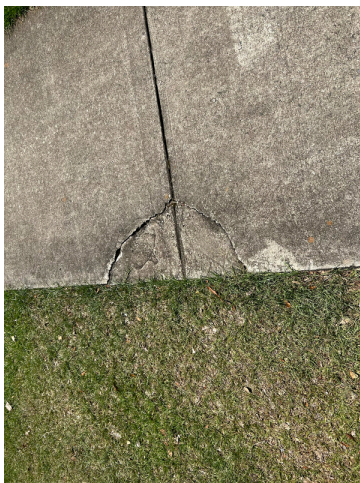
46. Site - sidewalk distress

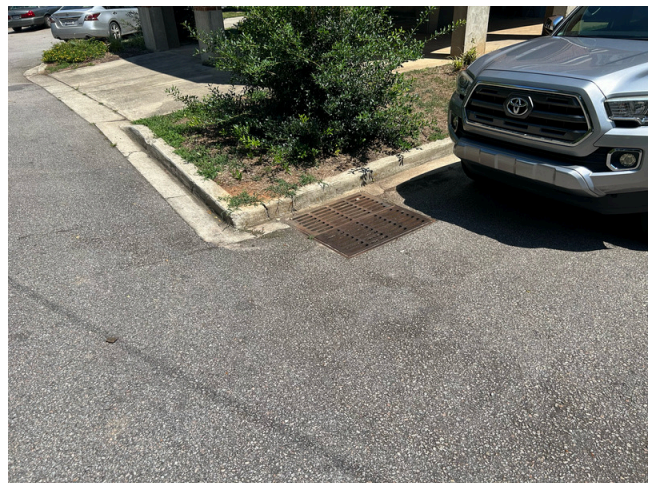
47. Site - sidewalk distress

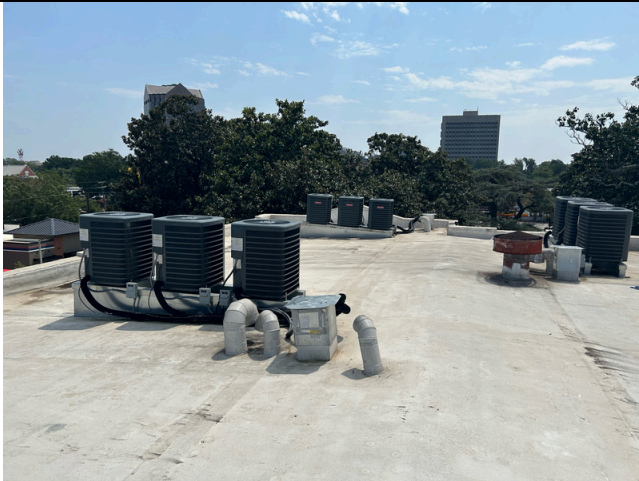
54. MEP - roof top HVAC condenser units

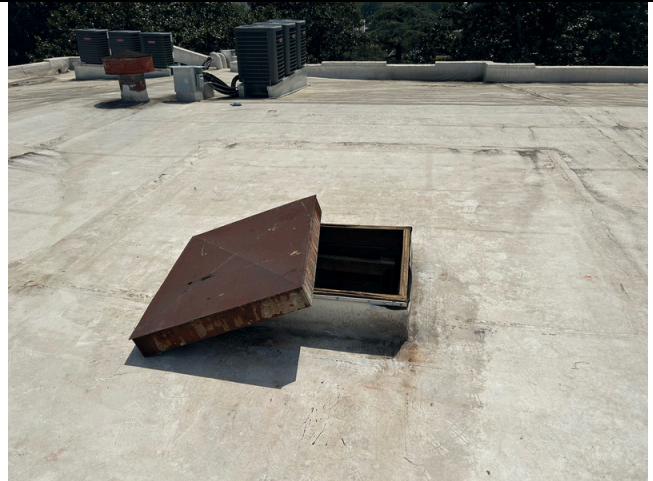
55. MEP - roof top HVAC condenser units
