1200 Main Street National Register Structure TMS# 09013-07-08

#### DESIGN/DEVELOPMENT REVIEW COMMISSION DESIGN REVIEW DISTRICT HISTORIC AGENDA EVALUATION SHEET

ADDRESS:	1200/1202 Main Street
<u>APPLICANT:</u>	Rick Patel, owner
TAX MAP REFERENCE:	09013-07-08
<u>USE OF PROPERTY:</u>	Commercial
<b>REVIEW DISTRICT:</b>	National Register structure
NATURE OF REQUEST:	Request for preliminary certification for the Bailey Bill

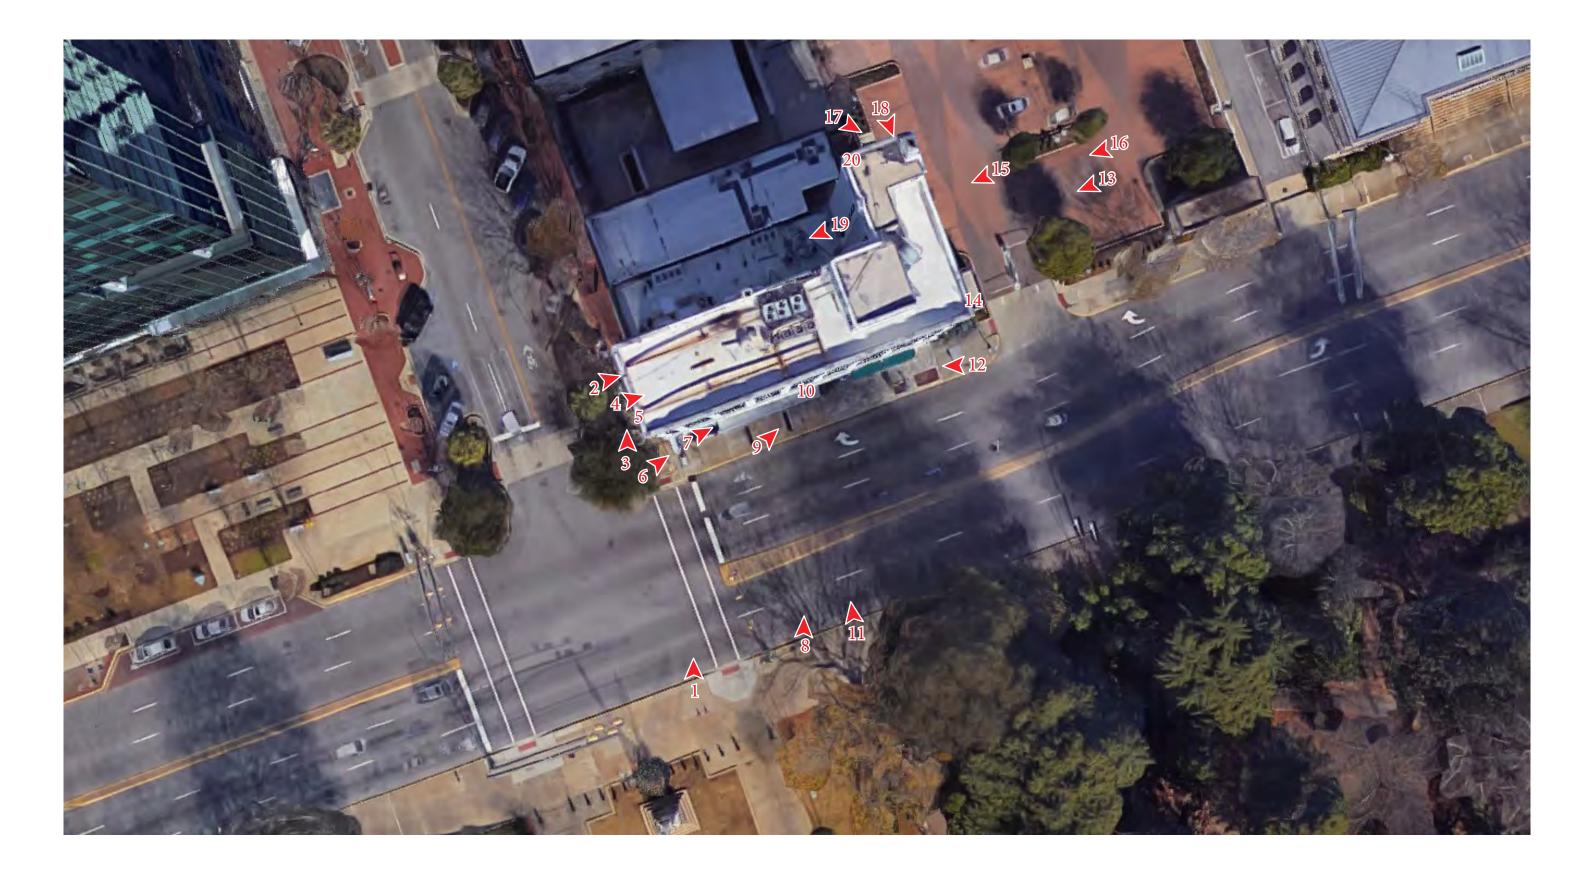
National Park Service Part 1 Certification Photo Key Site Plan

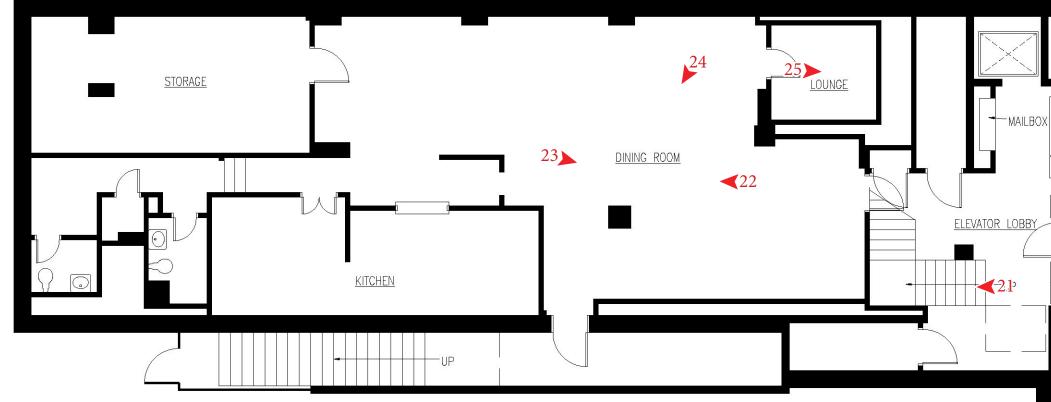
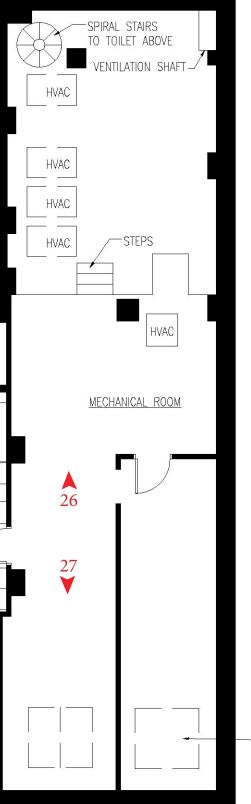
1 EXISTING BASEMENT FLOOR PLAN - 3,506 SF

National Park Service Part 1 Certification Photo Key Basement Floor Plan

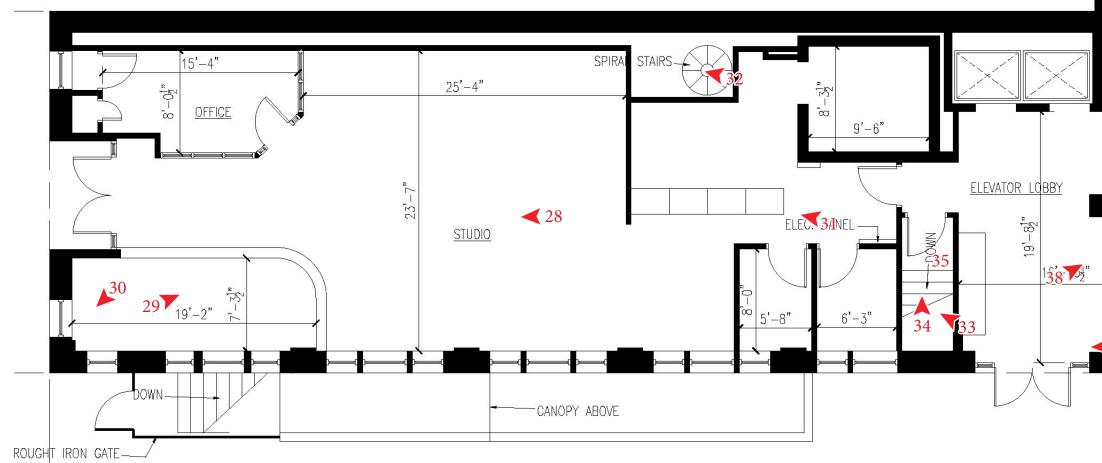
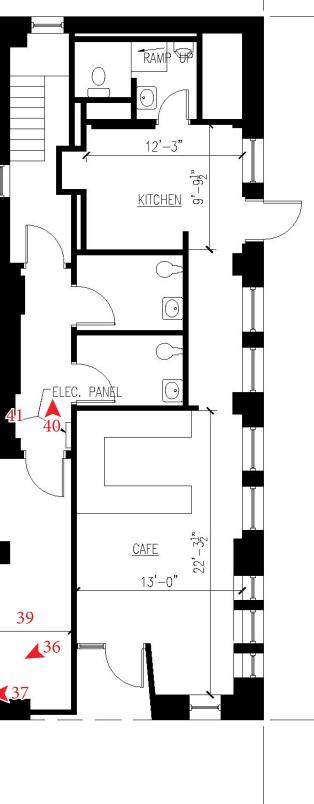
National Park Service Part 1 Certification Photo Key First Floor Plan

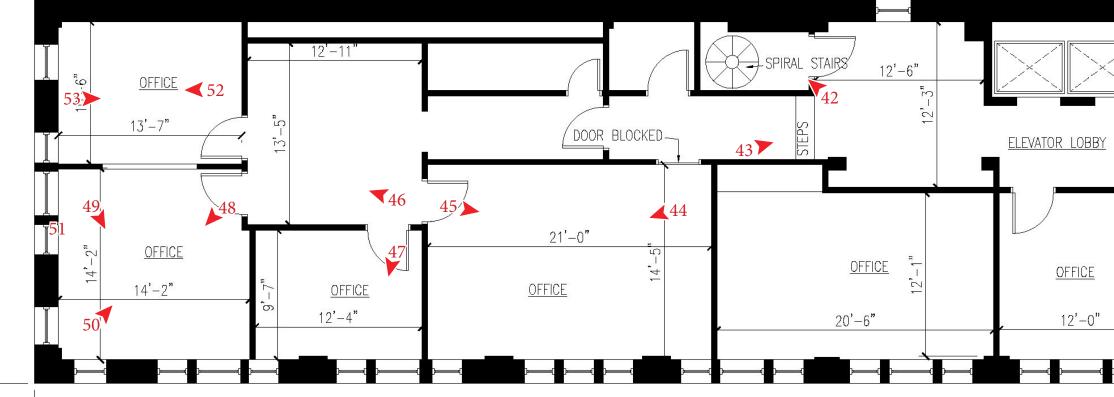
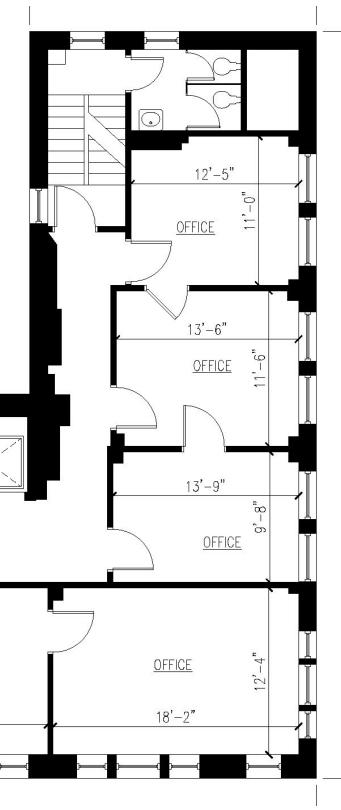
National Park Service Part 1 Certification Photo Key Mezzanine/Second Floor Plan

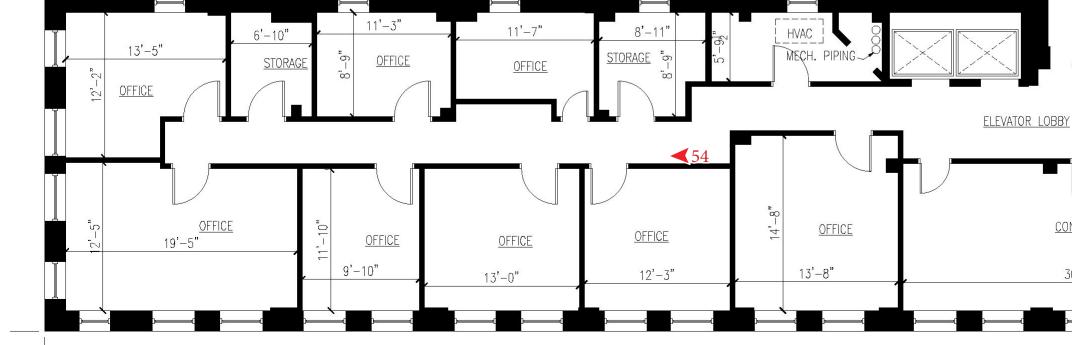
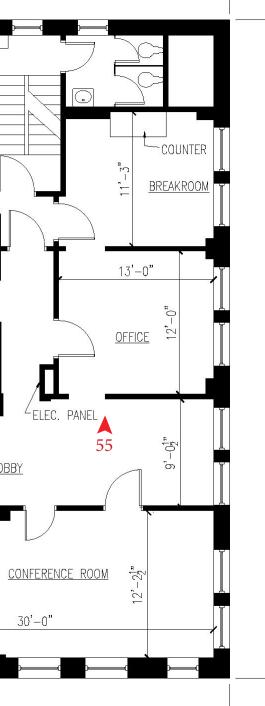
National Park Service Part 1 Certification Photo Key Third Floor Plans

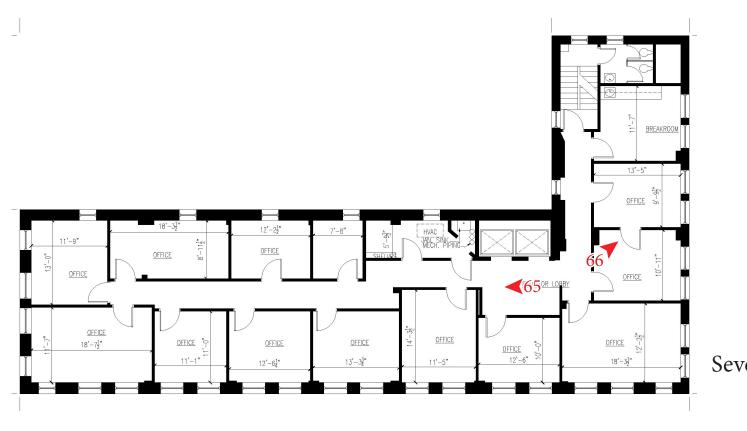
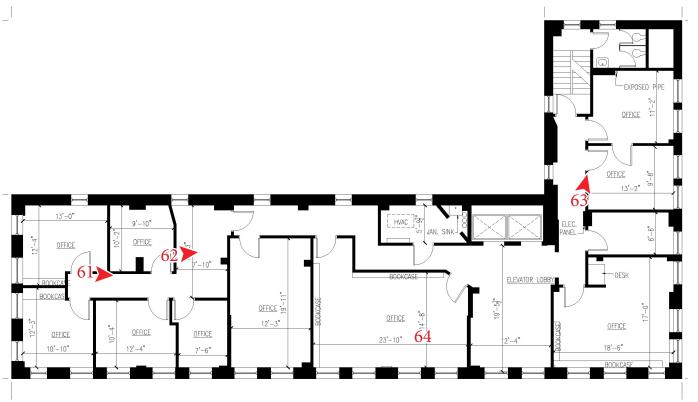
National Park Service Part 1 Certification Photo Key Sixth and Seventh Floor Plans

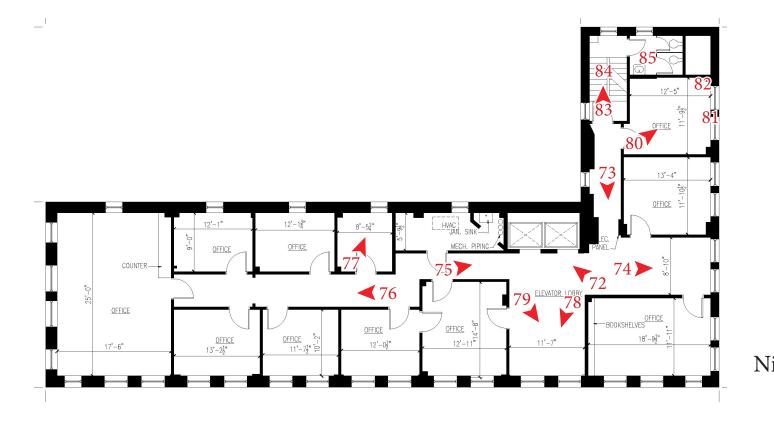
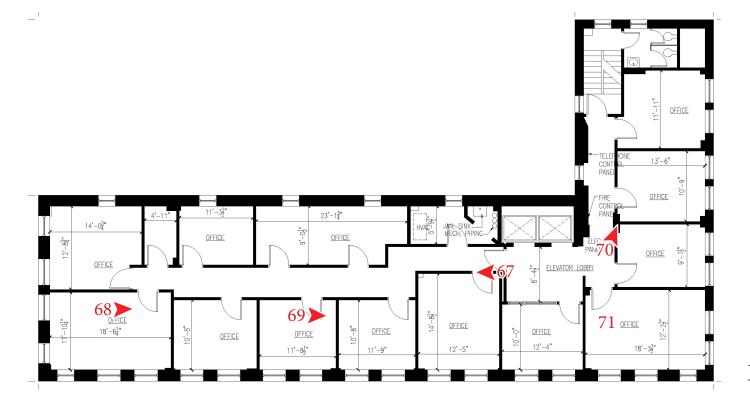
National Park Service Part 1 Certification Photo Key Eighth and Ninth Floor Plans

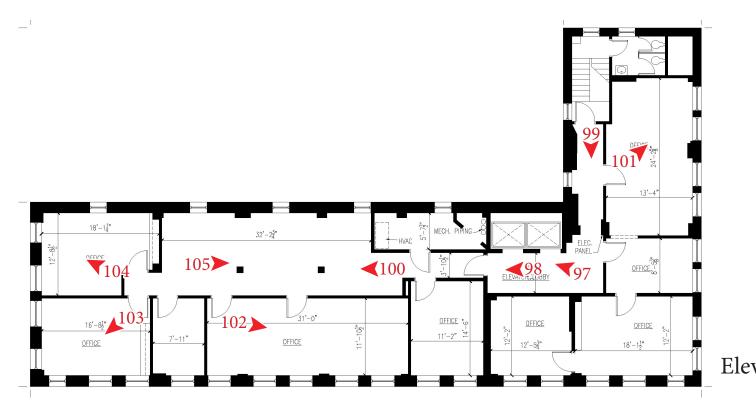
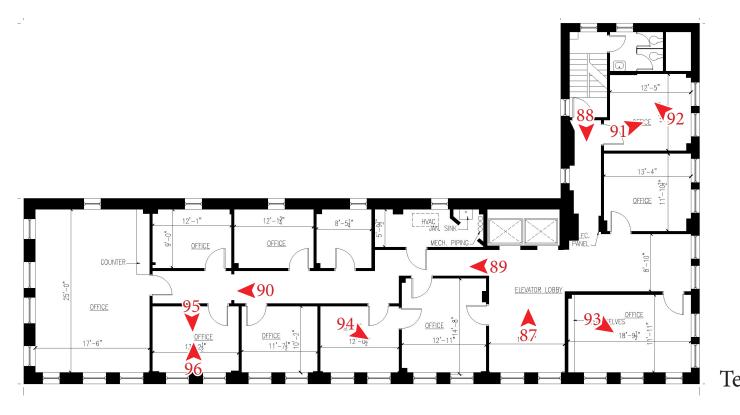
Tenth Floor Existing

National Park Service Part 1 Certification Photo Key Tenth and Eleventh Floor Plans

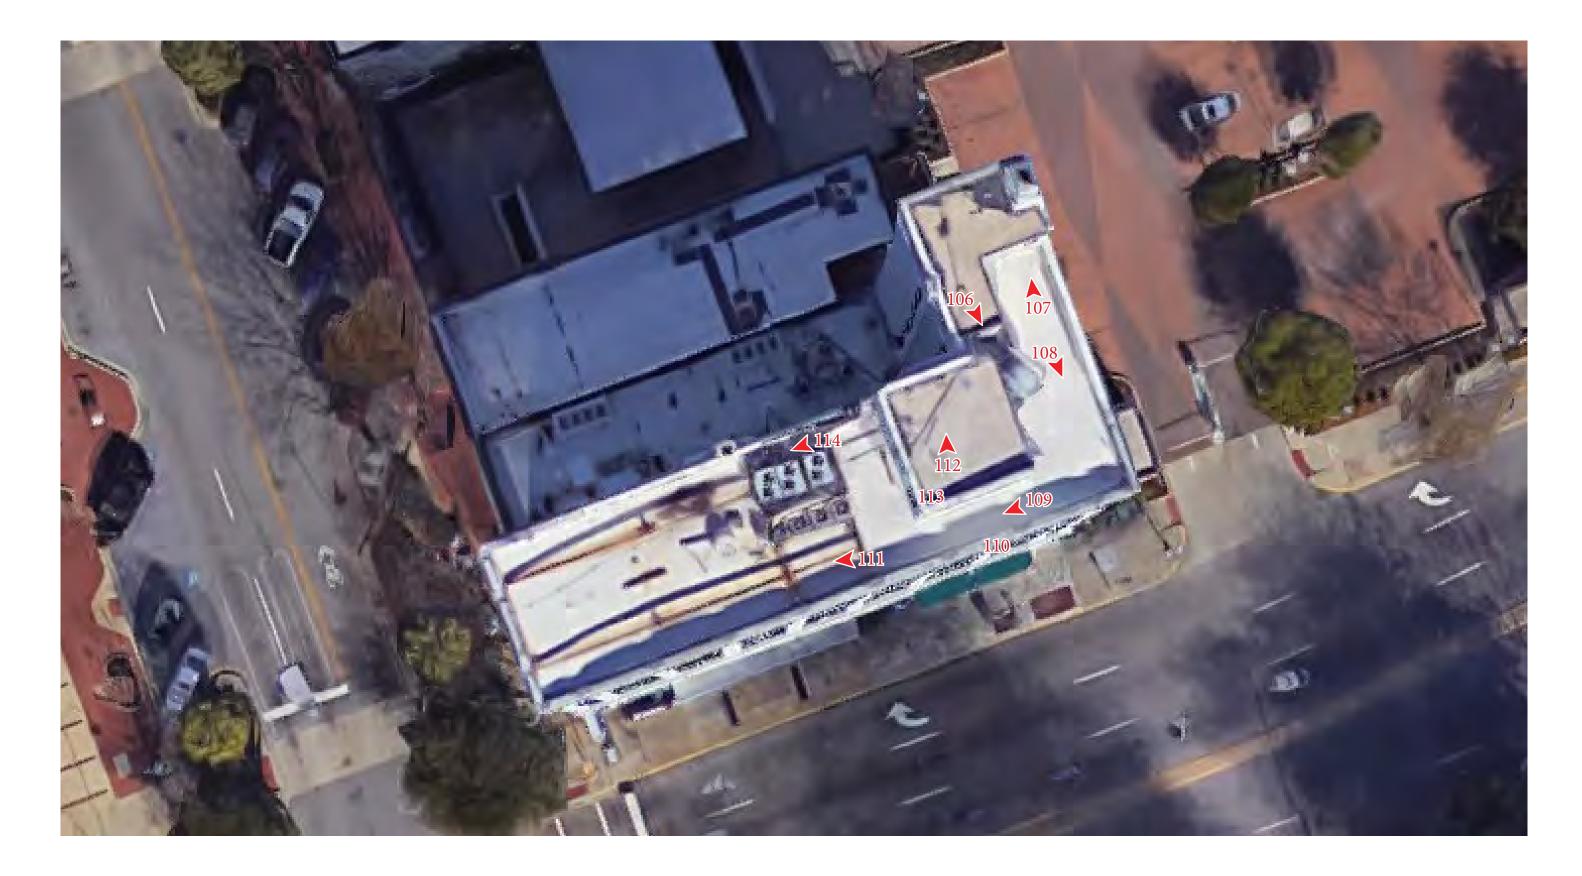
National Park Service Part 1 Certification Photo Key Existing Roof

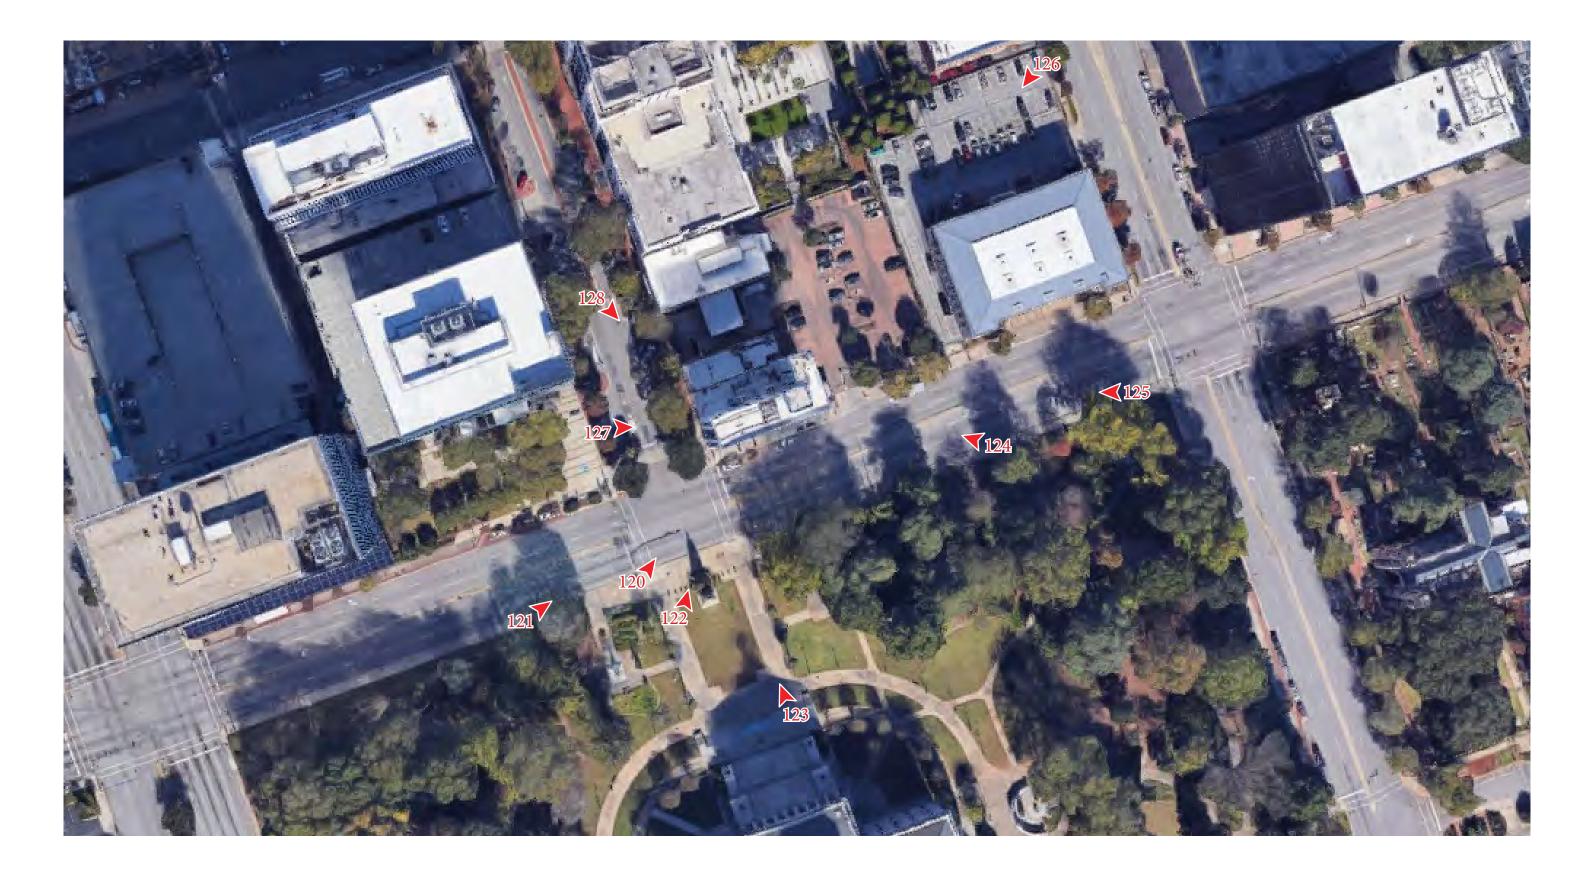
National Park Service Part 1 Certification Photo Key Rooftop Bar Mock-up

Based upon the mock-ups, staff estimates that perhaps one-half to one-third of the building will be visible, depending on the vantage point, more than what has been approvable in the past. Staff would recommend pulling the bar in more from all edges of the building and working on methods to make the rooftop bar more transparent. While the use of stucco visually references the original building, the use of more glass or a more open-air approach would help to minimize its presence. Generally streamlining the building more, such as combining windows to create larger voids (and reducing solid building material), minimizing or eliminating grid patterns on glass, and relating rooftop bar elements to the patterns of the building façade below would be recommended, along with pulling the bar in from the edges of the building.

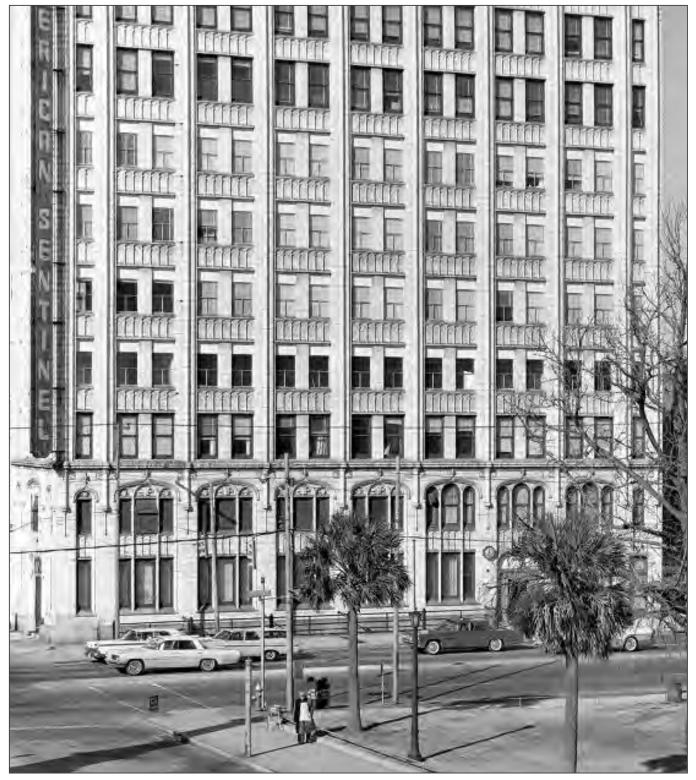
Historic Image H. 1962 photo of Gervais Street elevation. Photo shows a mix of original and replacement windows. *Courtesy of the Richland County library.*

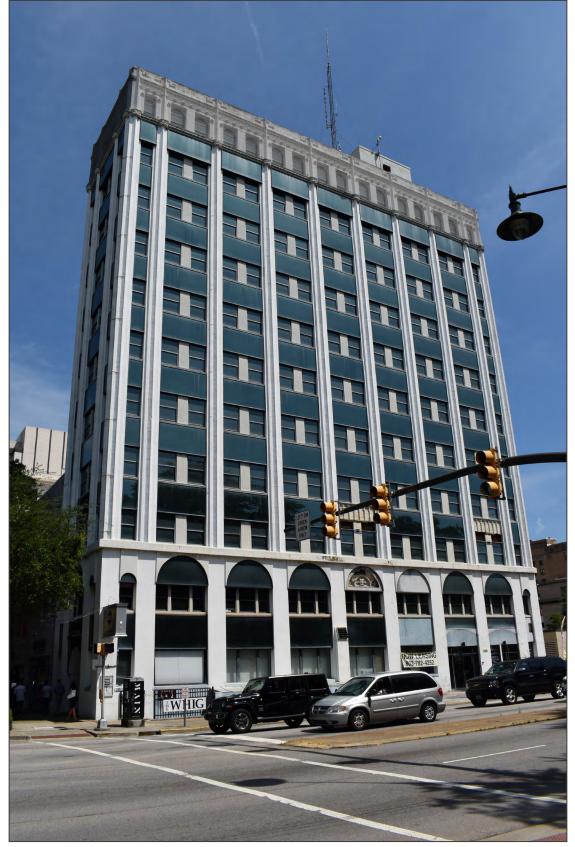
1. South elevation, view north

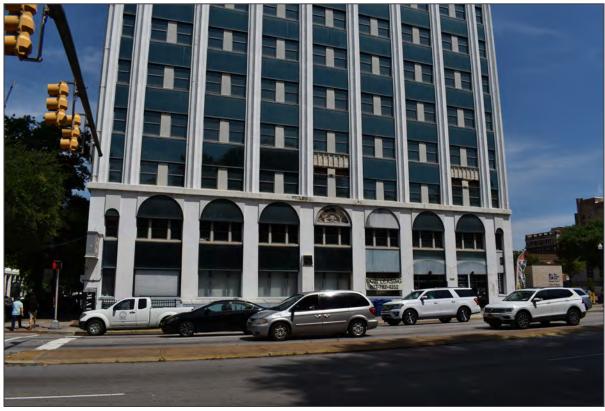
8. South elevation, bottom floors, view north

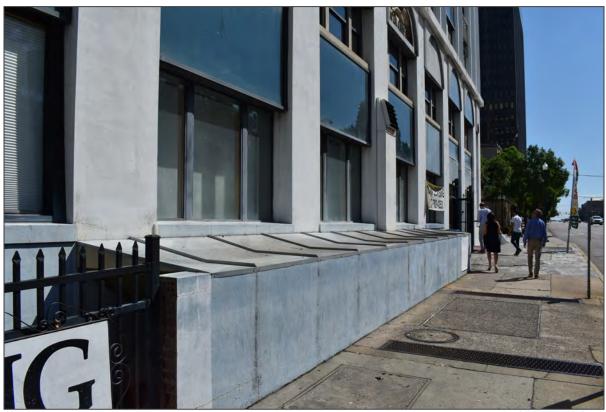
9. South elevation, first floor, view northeast

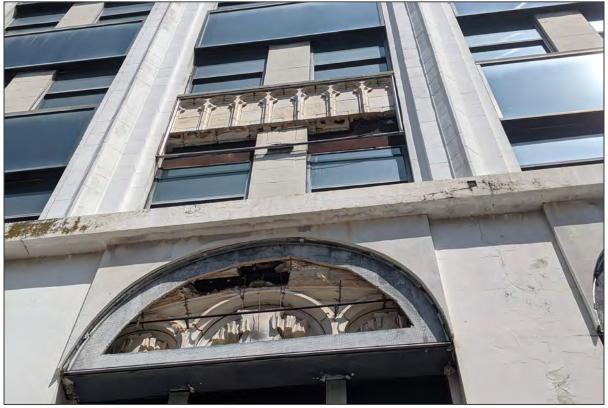
10. South elevation, historic terra cotta details

Where existing terra cotta panels/detailing exist, they will be retained. The terra cotta columns that vertically bisect the windows, and the terra cotta pilasters, have been painted at some point in time. It has been determined that removing the paint will damage the terra cotta further so the plan is to paint them to match the original finish on the unpainted terra cotta panels. Staff has been working on a color match with the applicants.

Fortunately, enough of the original terra cotta remains to allow for accurate reconstruction of missing elements with the exception of the arched panels, mentioned earlier. These will be handled with compatible yet distinct designs if not enough remains of the originals to duplicate. New sills to the existing panels will be made of concrete but will mimic the finish qualities of the terra cotta. Specification/drawings showing the profiles, installation methods, and materials of the infill pieces will be required but can be handled at staff level. Original windows on the west and south elevations were removed in the 1960s and replaced with shorter windows which accommodated the glass panels. With the removal of the glass panels, new 1/1 clad wood windows will be installed and will be inset, sized, and detailed to reflect the original windows. While storefront doors are shown in the plans, the description of the proposed doors in the Part 2 document submitted discuss doors with a historic appearance in a few locations on the building. This is a detail that staff can work with the applicants on.

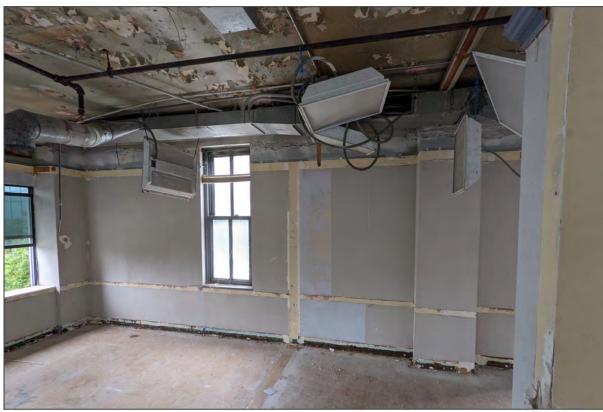
58. Fourth floor, historic hallway terrazzo flooring visible at left, view east

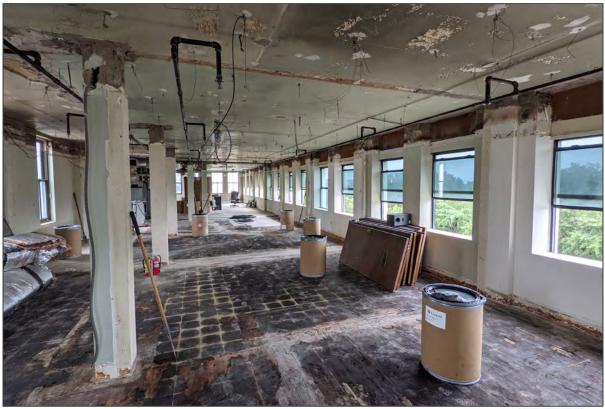
60. Fourth floor, historic hallway terrazzo at left, view north towards staircase

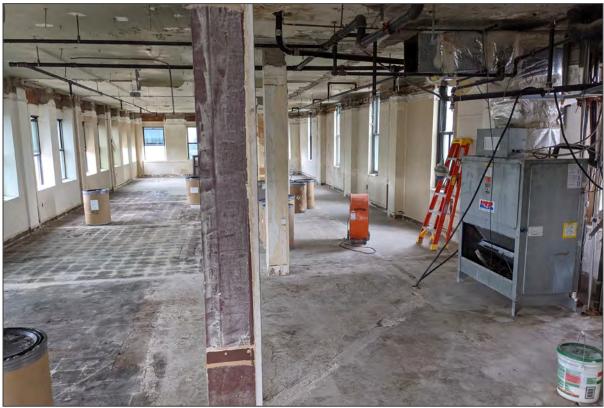
64. Sixth floor, historic wood flooring example

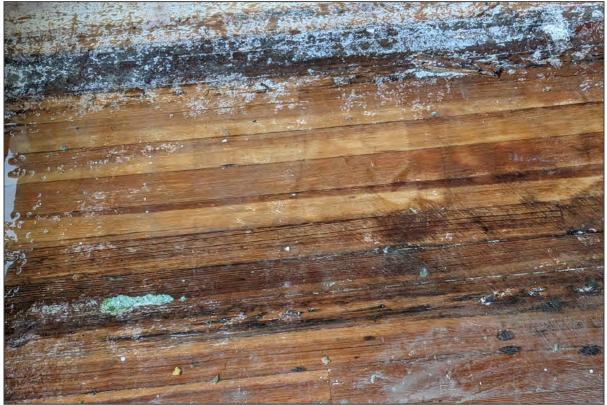
71. Eighth floor, historic flooring example

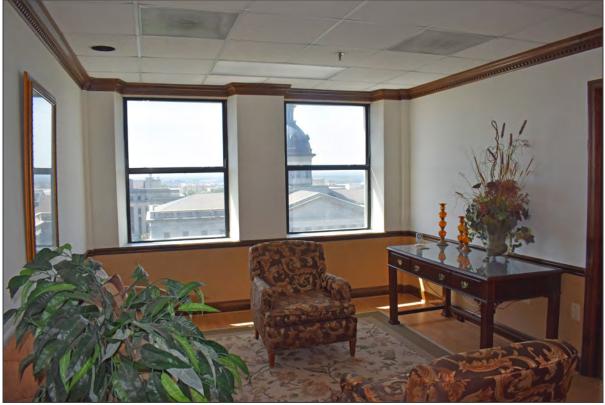
78. Ninth floor, typical upper floor office lobby example (non-historic finishes typical of the upper floors)

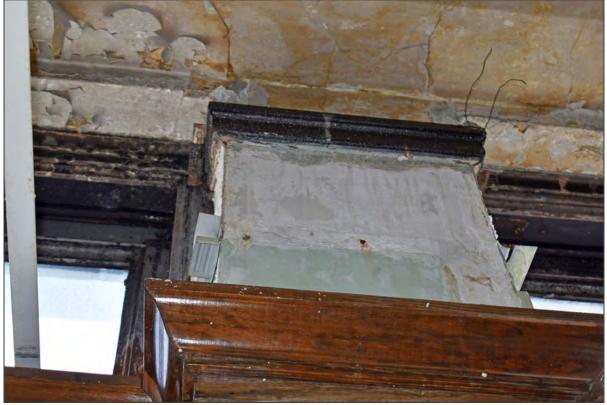
81. Ninth floor, northeast office, older molding visible above current drop-ceiling framing

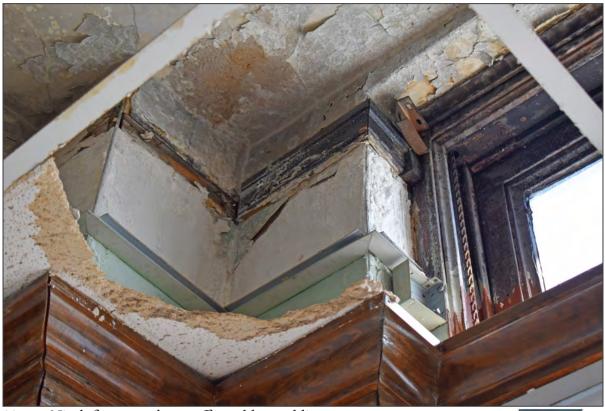
82. Ninth floor, northeast office, older molding

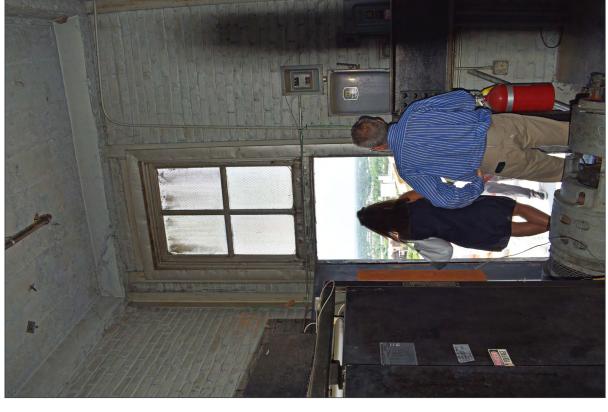
112. Roof, elevator mechanical room

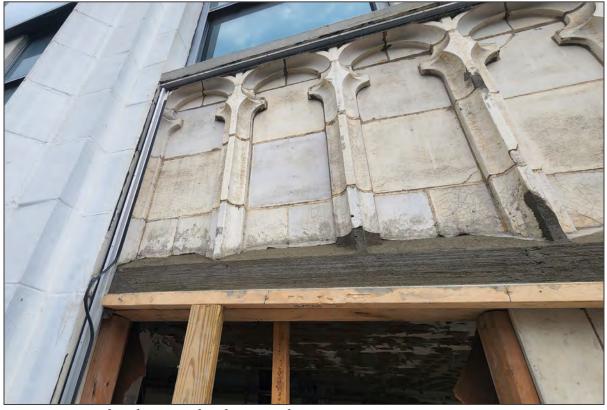
115. Example of replacement window header. Decorative tiles are original, header at the bottom is replacement painted to match.

The current owners plan to retrofit the building as a hotel and have already removed the glass panels in order to bring back the original architecture of the building as much as possible. Underneath the glass, the terra cotta panels largely remain, although their sills were removed when the glass panels were installed. The owner and his team have carefully gone through several explorations with City and SHPO staff to decide the correct repair of the panels and determining what the final materials, finishes, and coloring should be for the infill repair sections. They are also removing replacement windows to install correctly sized windows for the original openings.

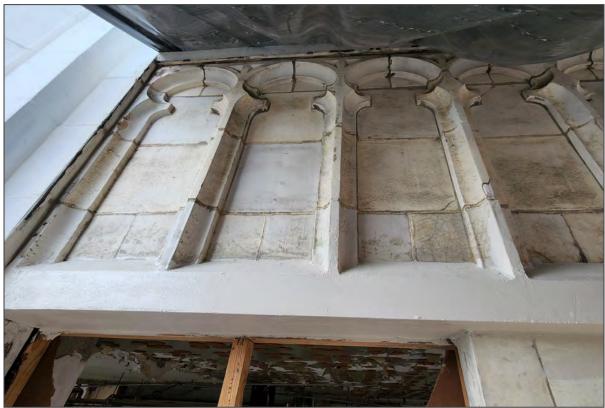
116. Proposed replacement header example.

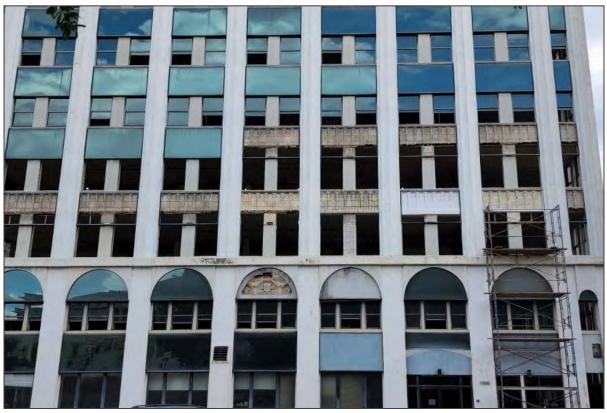
117. Replacement header example, painted.

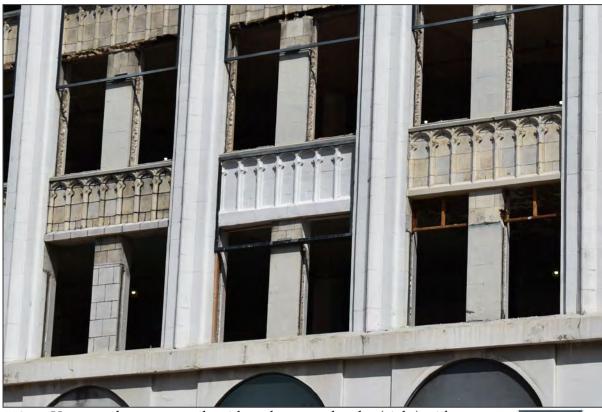
118. Uncovered terra cotta tiles, with test replacement panel second from right.

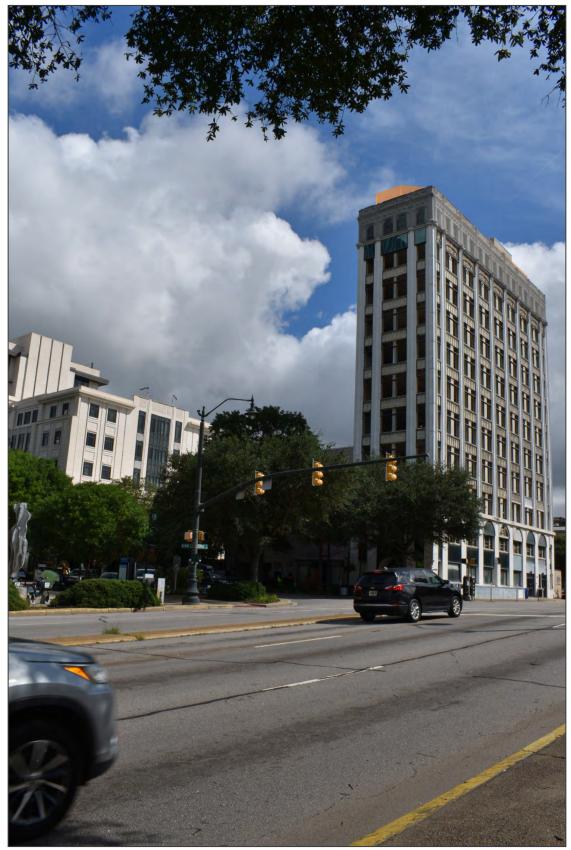
120. Rooftop Bar Mock-up (highlighted in orange), view northeast

The owners are also proposing a rooftop bar and have constructed a frame outlining the structure to demonstrate heights, distance from the edge of the building, etc. Additionally, the building next door, 1202 Main, will be incorporated into the project; the interior wall between 1200 and 1202 Main will be opened to expand the hotel lobby into this space. Also, a new required elevator/stair tower is situated over and at the rear of 1202 Main Street with openings for access punched through at each floor on 1200 Main.

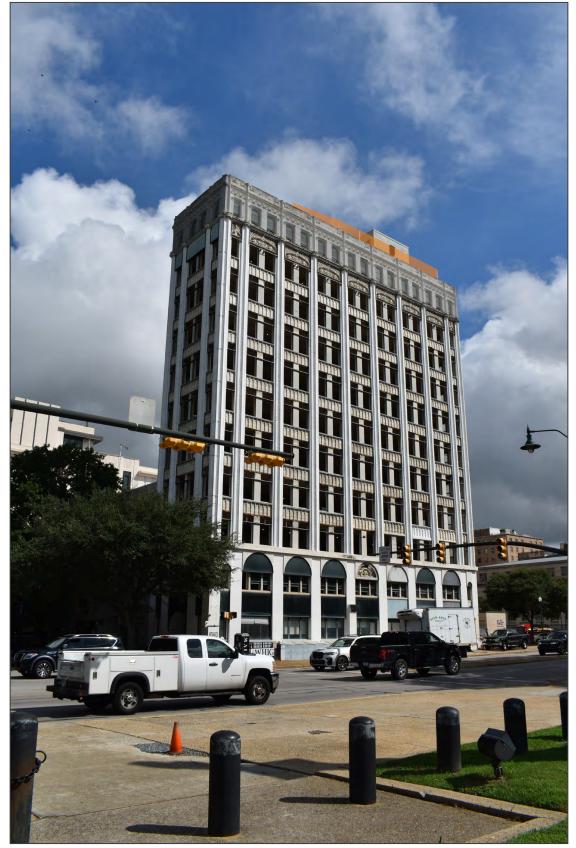
121. Rooftop Bar Mock-up (highlighted in orange), view northeast

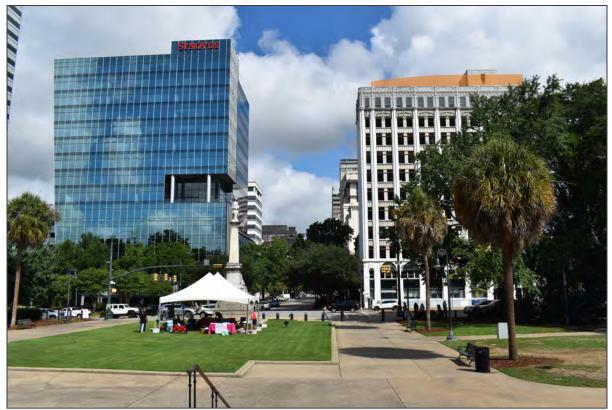
122. Rooftop Bar Mock-up (highlighted in orange), view northeast

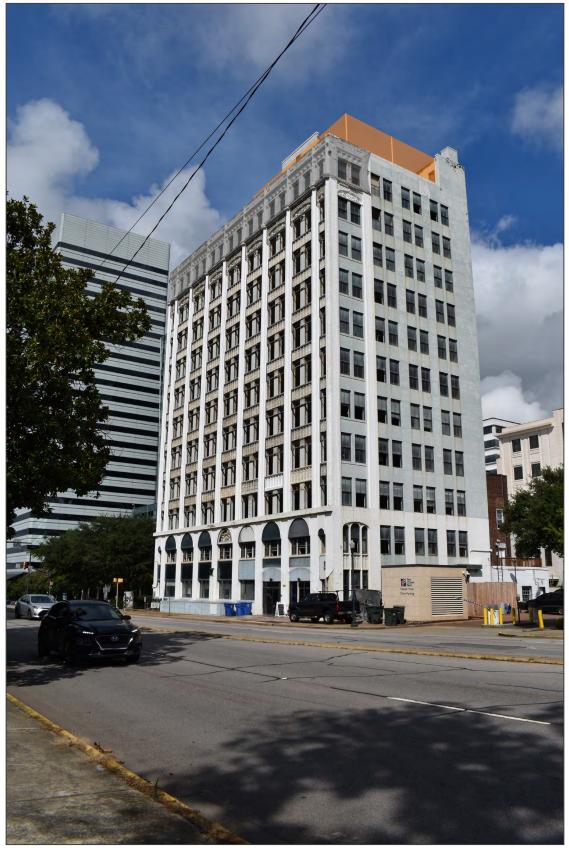
123. Rooftop Bar Mock-up (highlighted in orange), view northwest

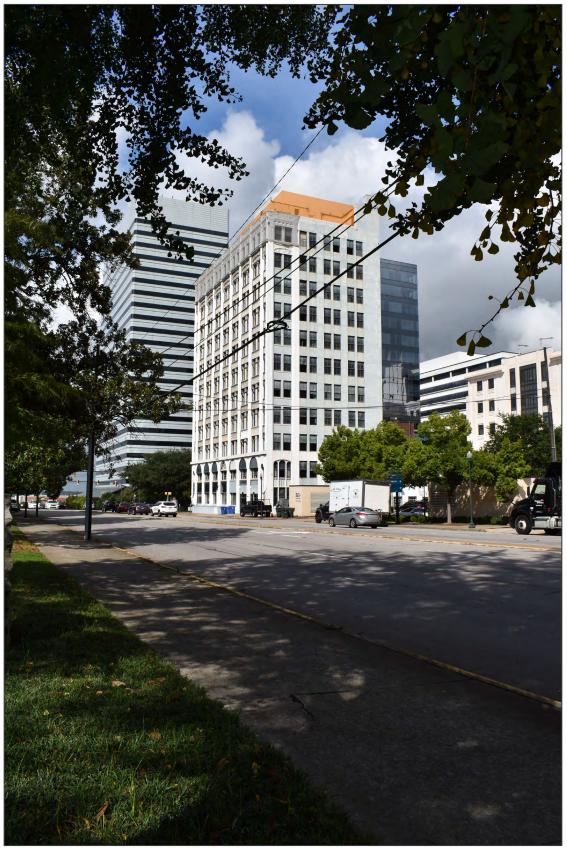
124. Rooftop Bar Mock-up (highlighted in orange), view northwest

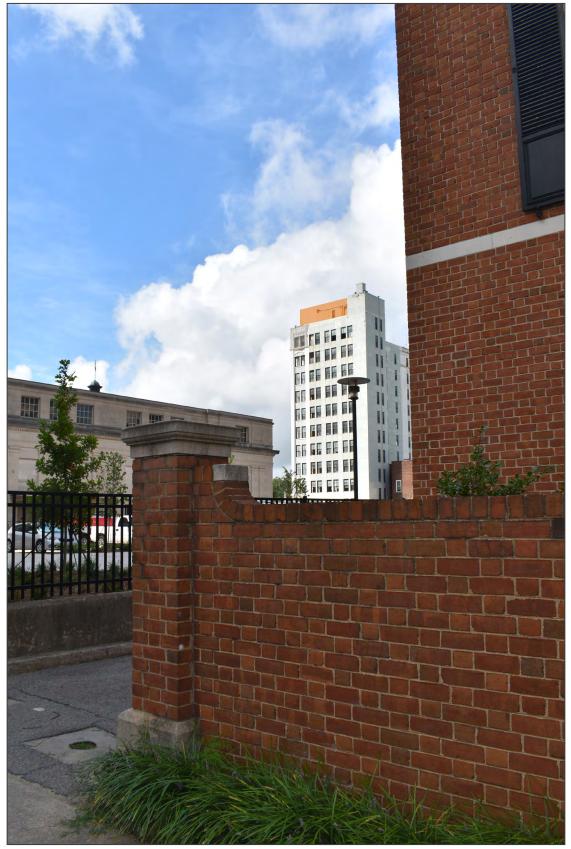
125. Rooftop Bar Mock-up (highlighted in orange), view east

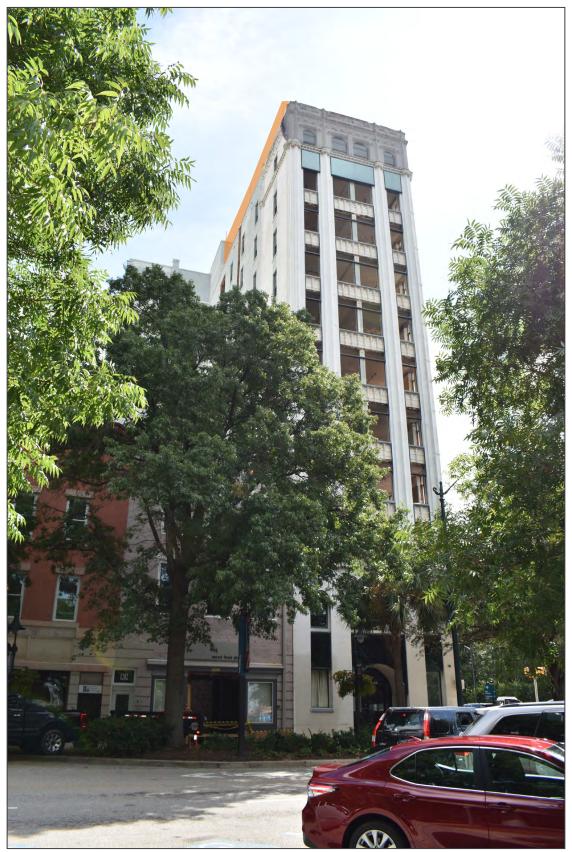
126. Rooftop Bar Mock-up (highlighted in orange), view southwest

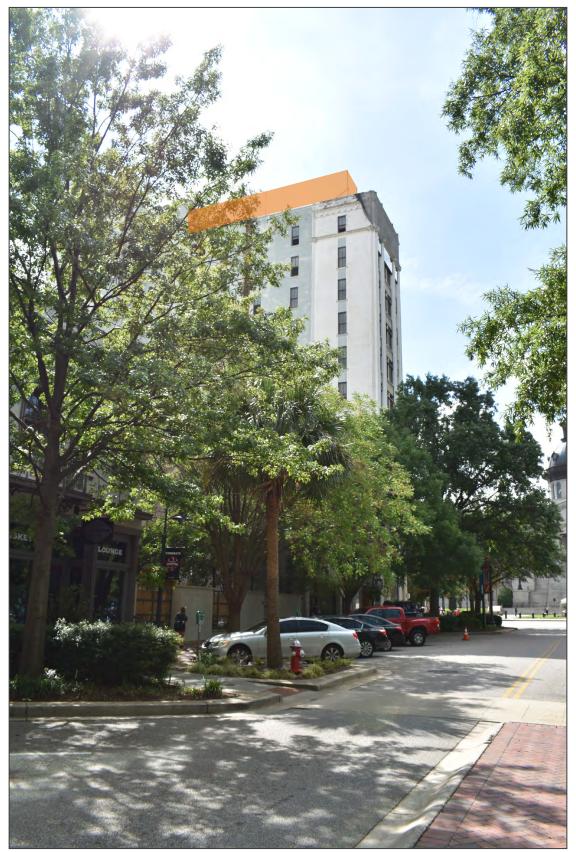
127. Rooftop Bar Mock-up (highlighted in orange), view west

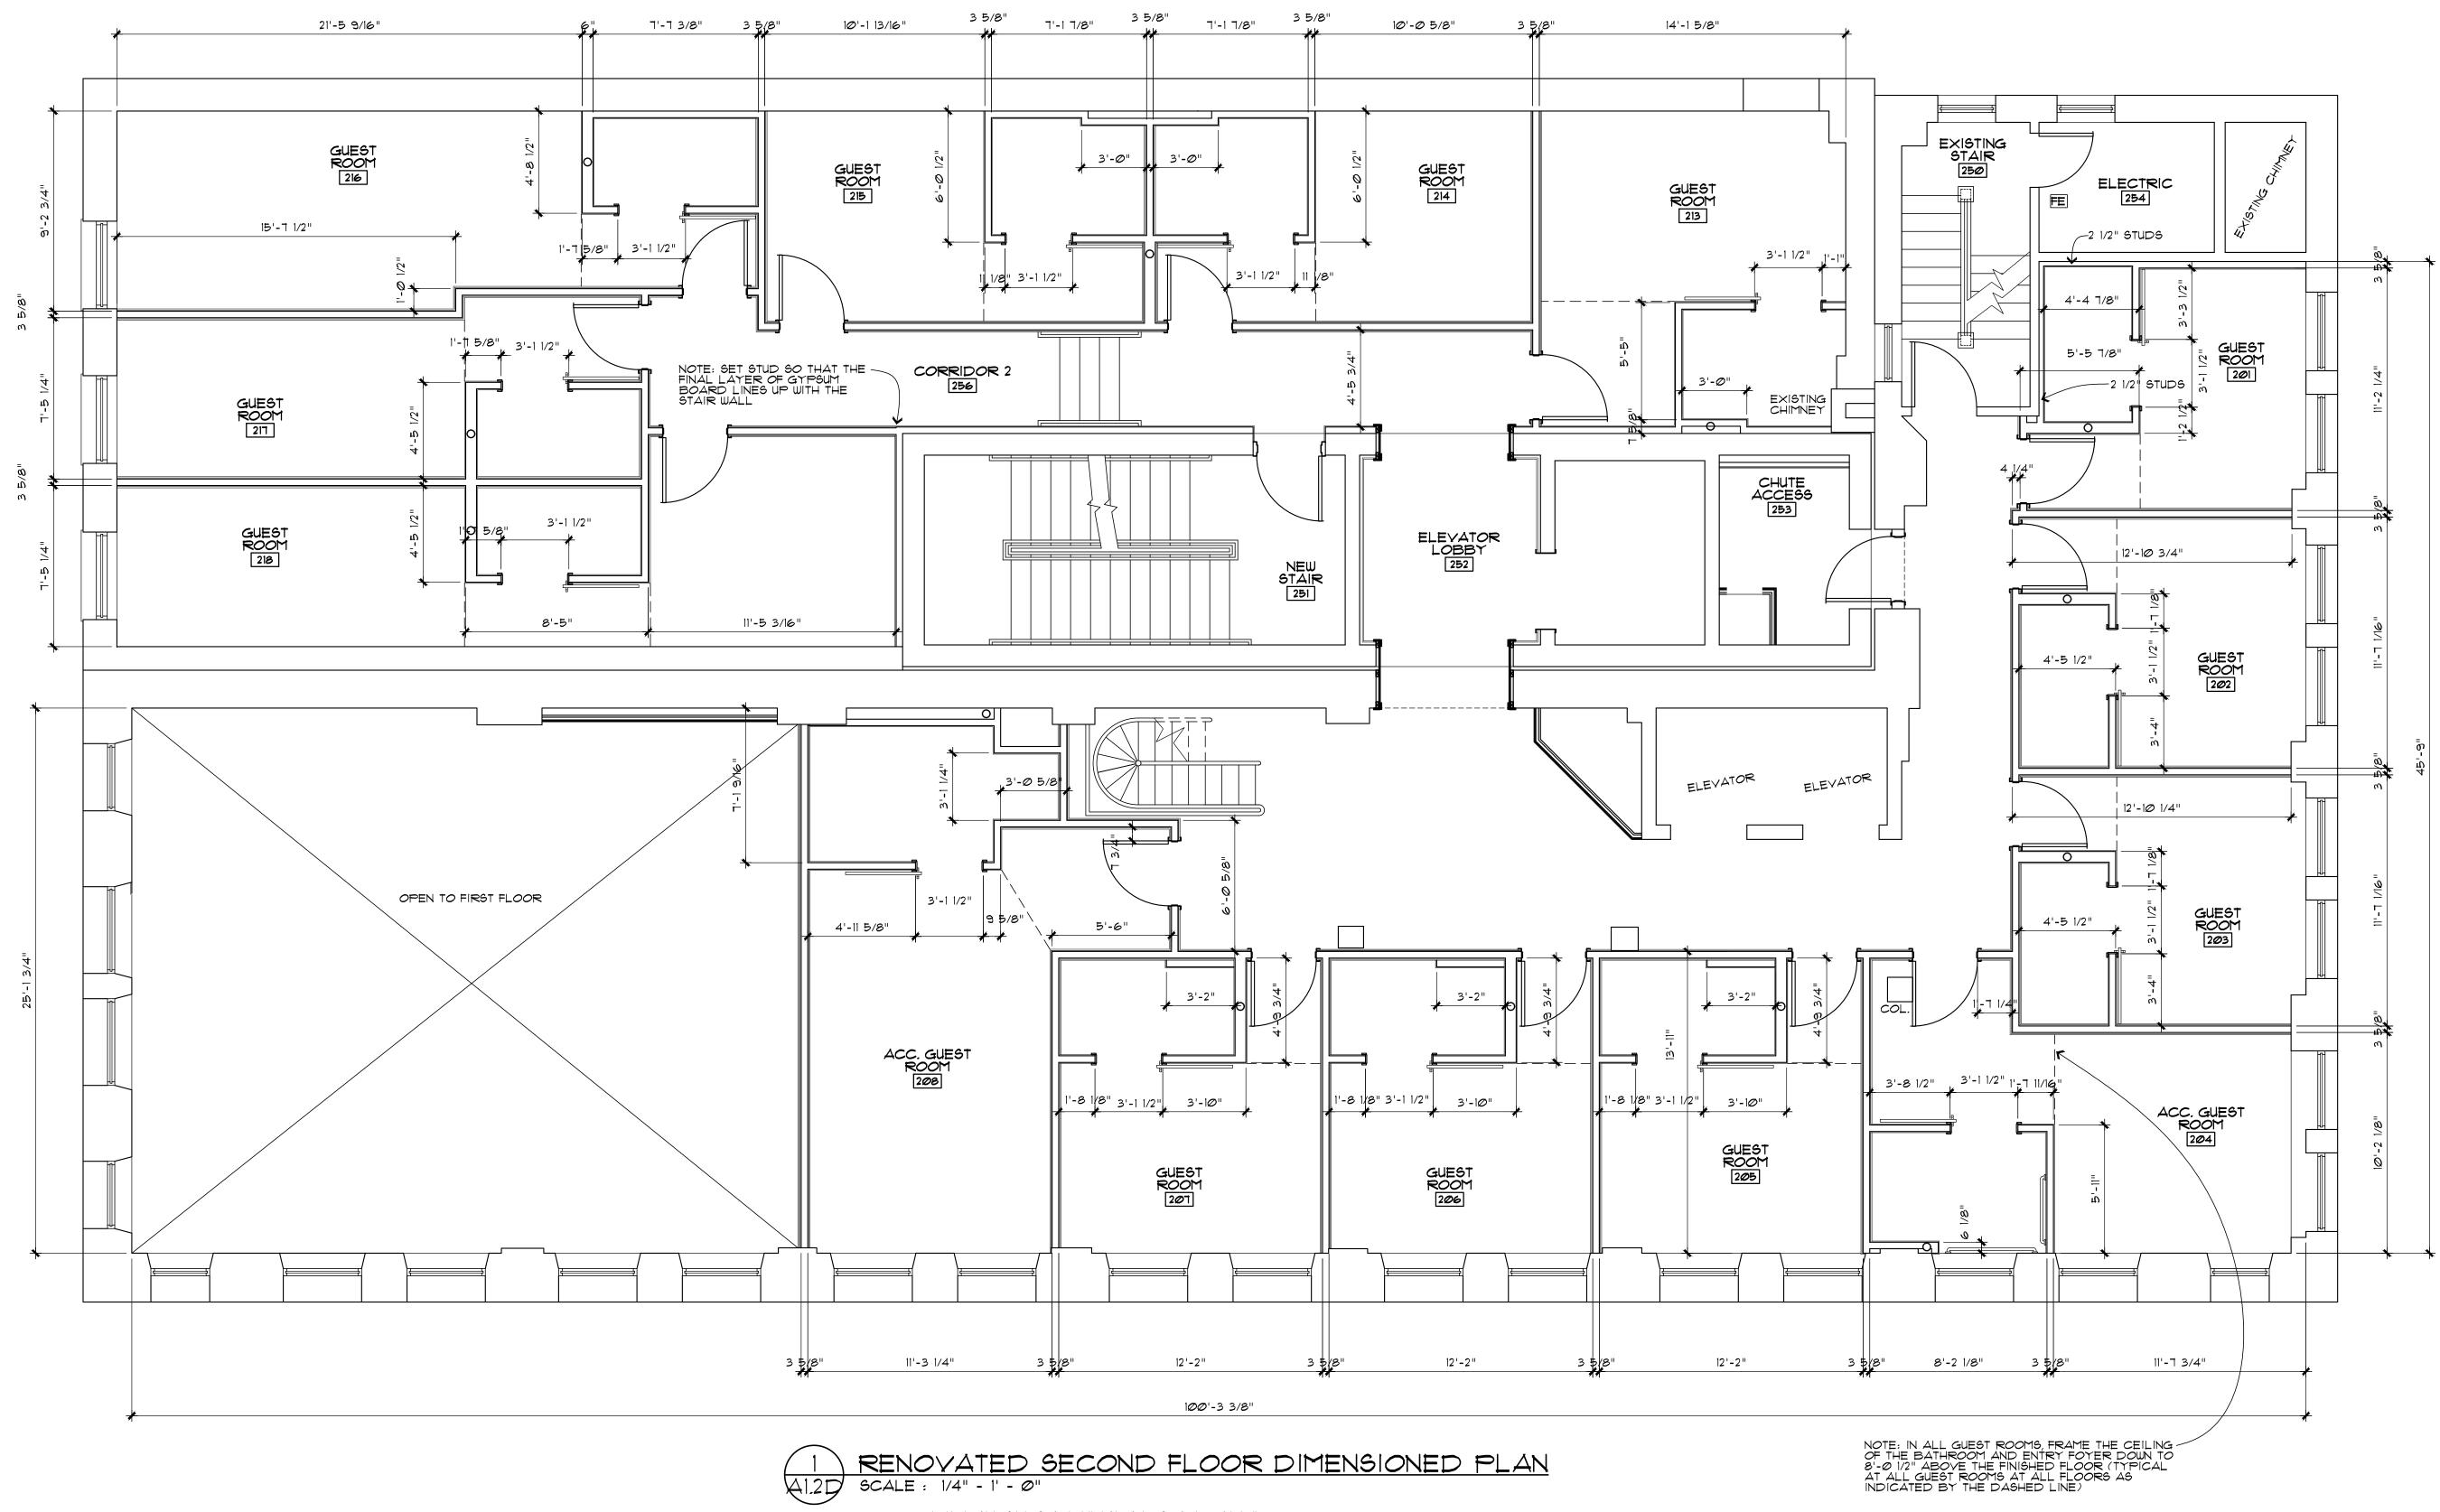
- NOTE 1: ALL STUDS ARE METAL AND SPACED AT 16" O.C. TYPICAL STUDS ARE 3 5/8" UNLESS NOTED OTHERWISE. EACH BATHROOM (EXCEPT ROOM 204) HAS ONE 6" STUD WALL LOCATION FOR SEWER PIPING. BATHROOM 201 HAS 2 1/2" STUDS WHERE INDICATED.
- NOTE 2: THE ASSUMPTION HAS BEEN MADE THAT THE PREFABRICATED SHOWER UNIT REQUIRES AN INSIDE FINISHED DIMENSION OF 4'-O" (OR 3'-O") FROM GYPSUM BOARD TO GYPSUM BOARD. THE CONTRACTOR SHALL VERIFY THE ACTUAL WIDTH OF THE SHOWER UNIT PRIOR TO THE FABRICATION AND INSTALLATION OF THE STUD WALLS.
