1200 Main Street National Register Structure TMS# 09013-07-08

#### DESIGN/DEVELOPMENT REVIEW COMMISSION DESIGN REVIEW DISTRICT HISTORIC AGENDA EVALUATION SHEET

ADDRESS:	1200/1202 Main Street
<u>APPLICANT:</u>	Rick Patel, owner
TAX MAP REFERENCE:	09013-07-08
<u>USE OF PROPERTY:</u>	Commercial
<b>REVIEW DISTRICT:</b>	National Register structure
NATURE OF REQUEST:	Request for preliminary certification for the Bailey Bill

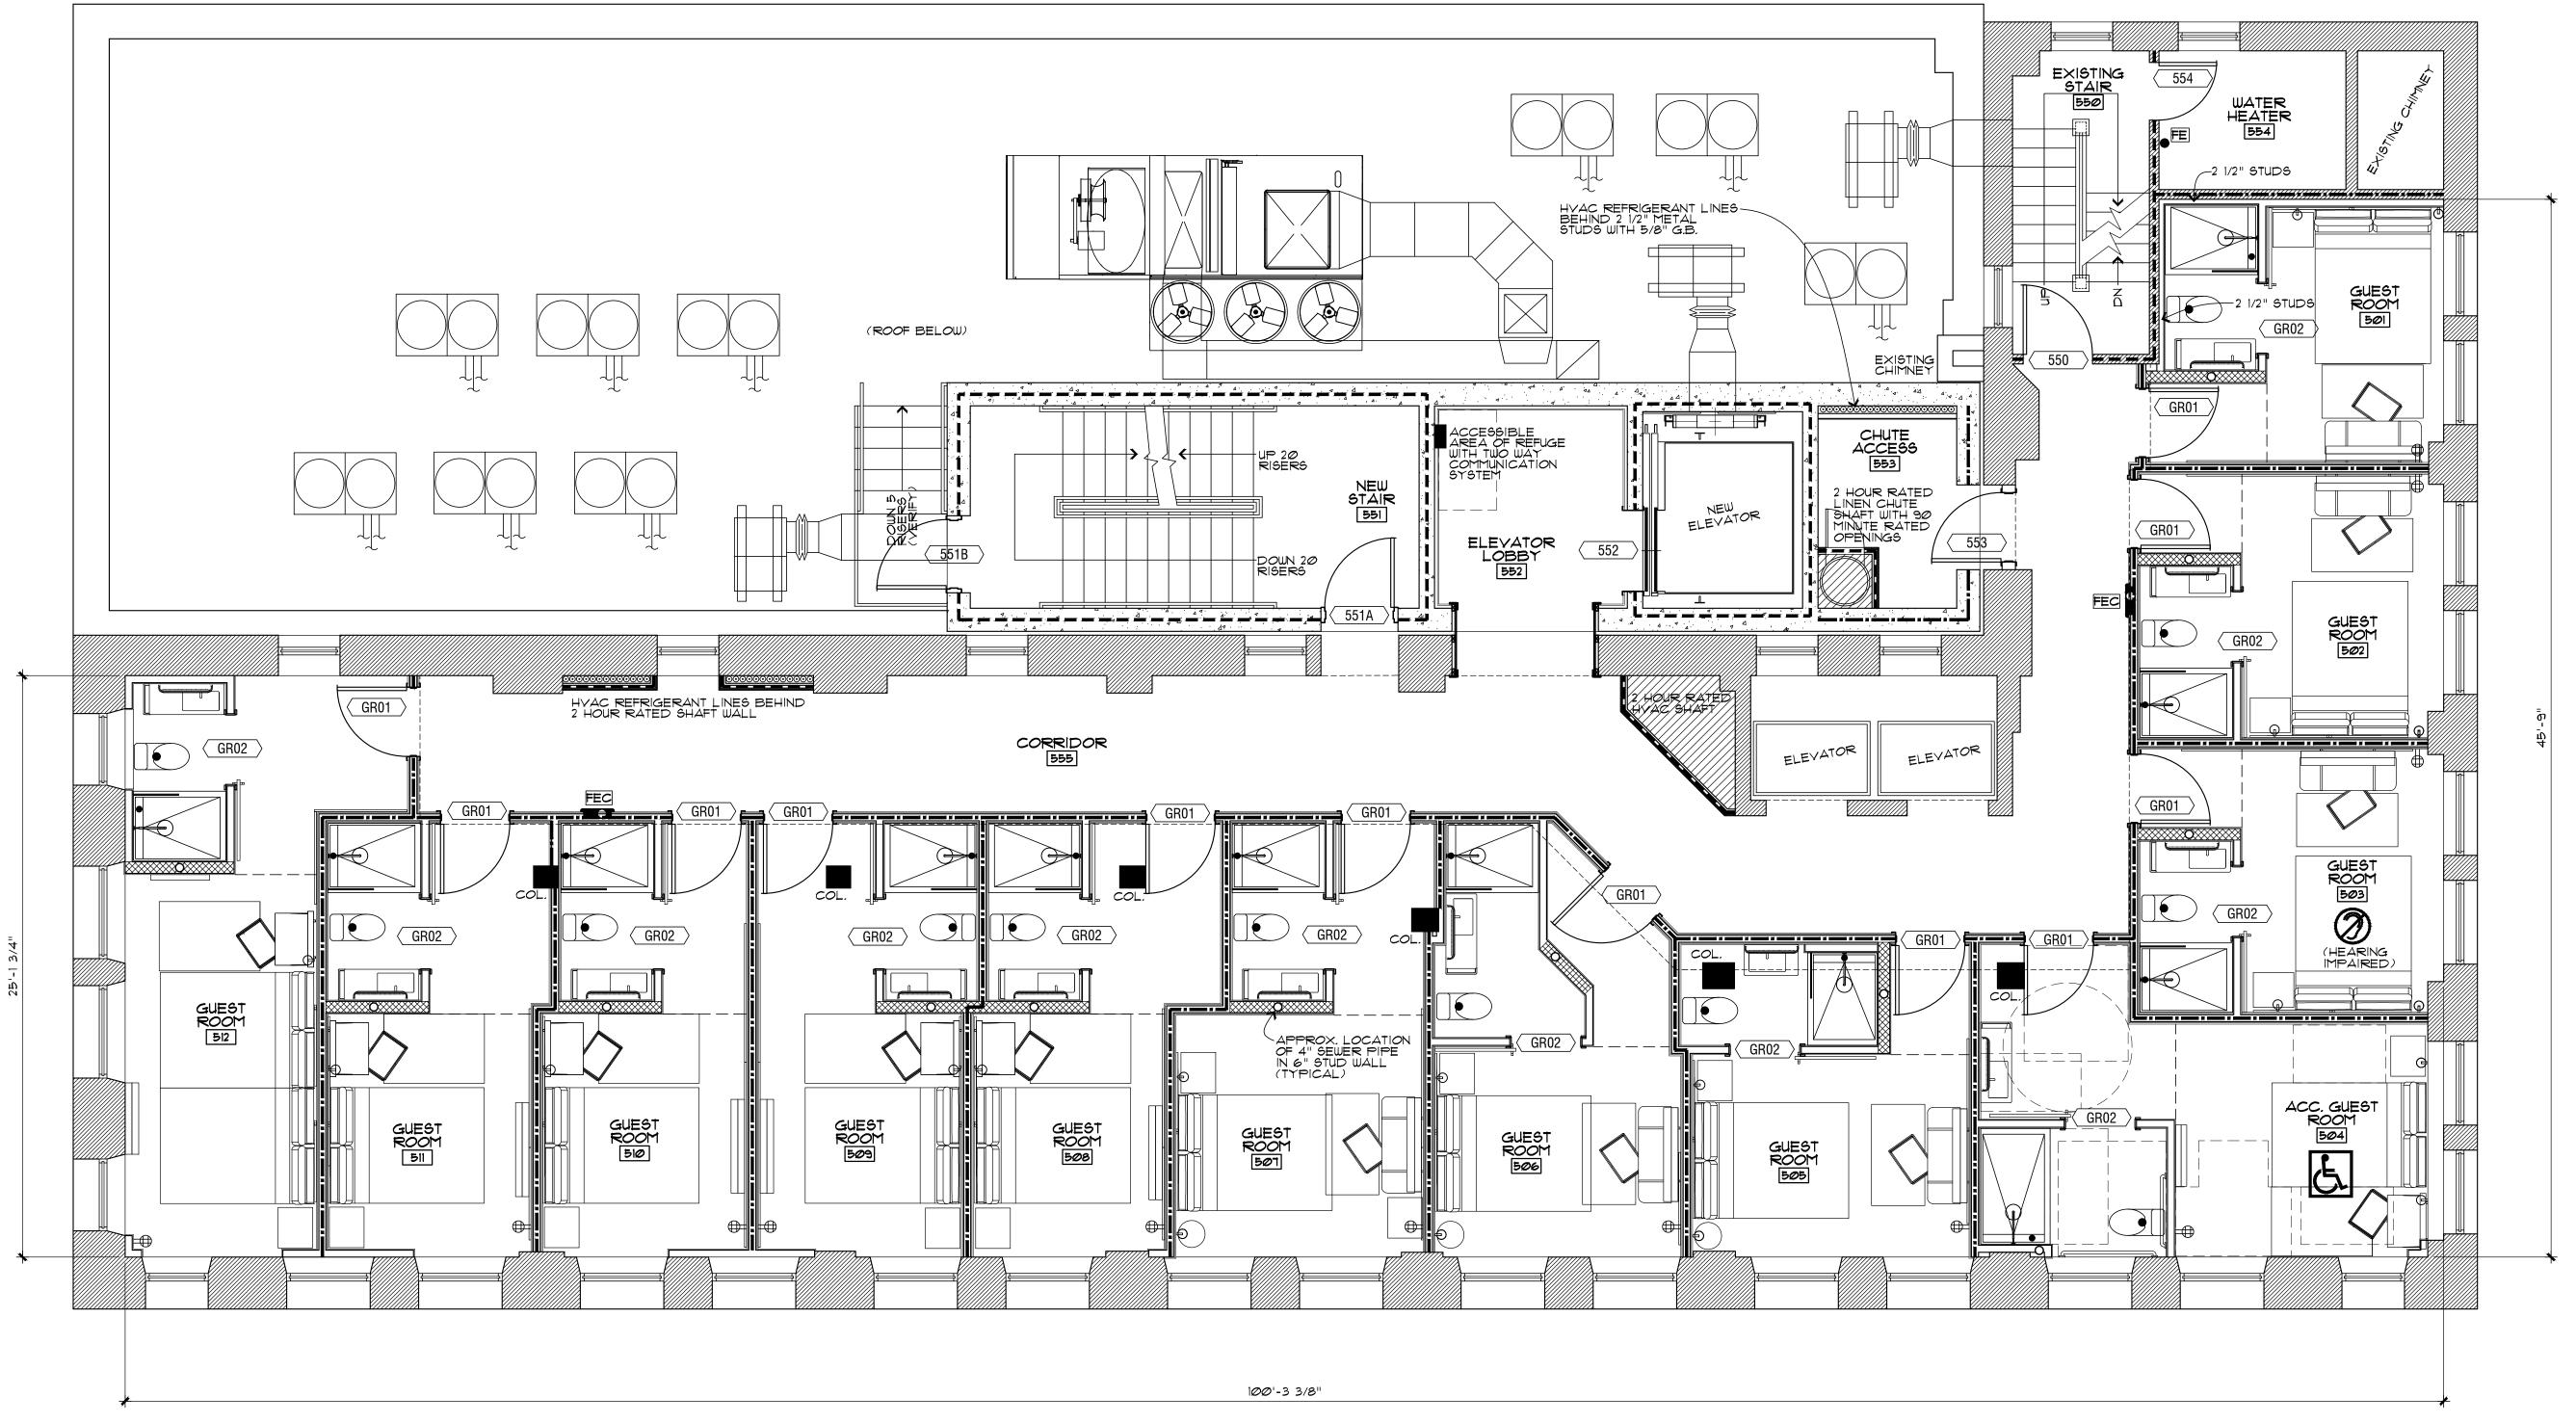
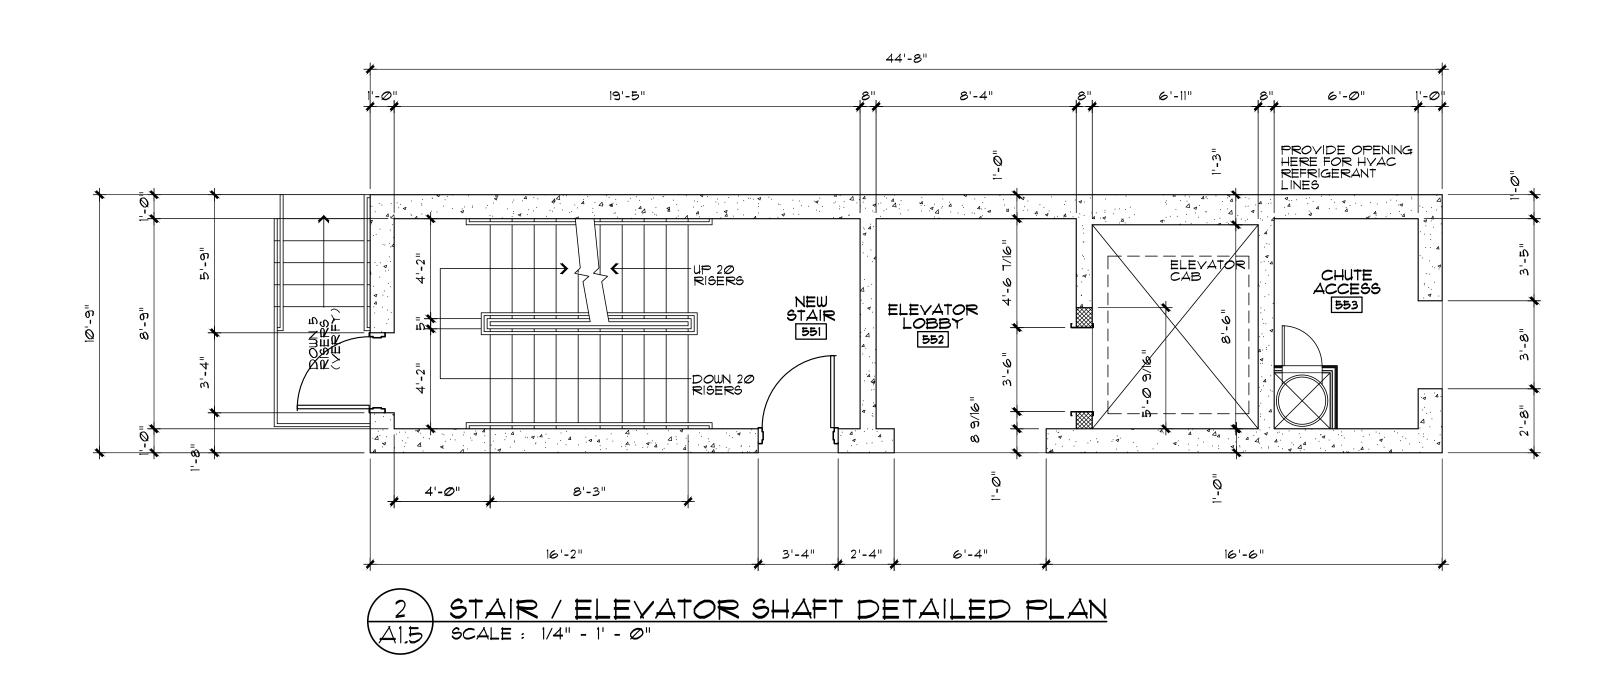
RENOVATED FIFTH FLOOR PLAN A1.5 SCALE : 1/4" - 1' - @" 4,087 +/- SQUARE FEET

NOTE: ALL STUDS ARE METAL AND SPACED AT 16" O.C. TYPICAL STUDS ARE 3 5/8" UNLESS NOTED OTHERWISE. EACH BATHROOM (EXCEPT ROOM 504) HAS ONE 6" STUD WALL LOCATION FOR SEWER PIPING. BATHROOM 501 HAS 2 1/2" STUDS WHERE INDICATED.

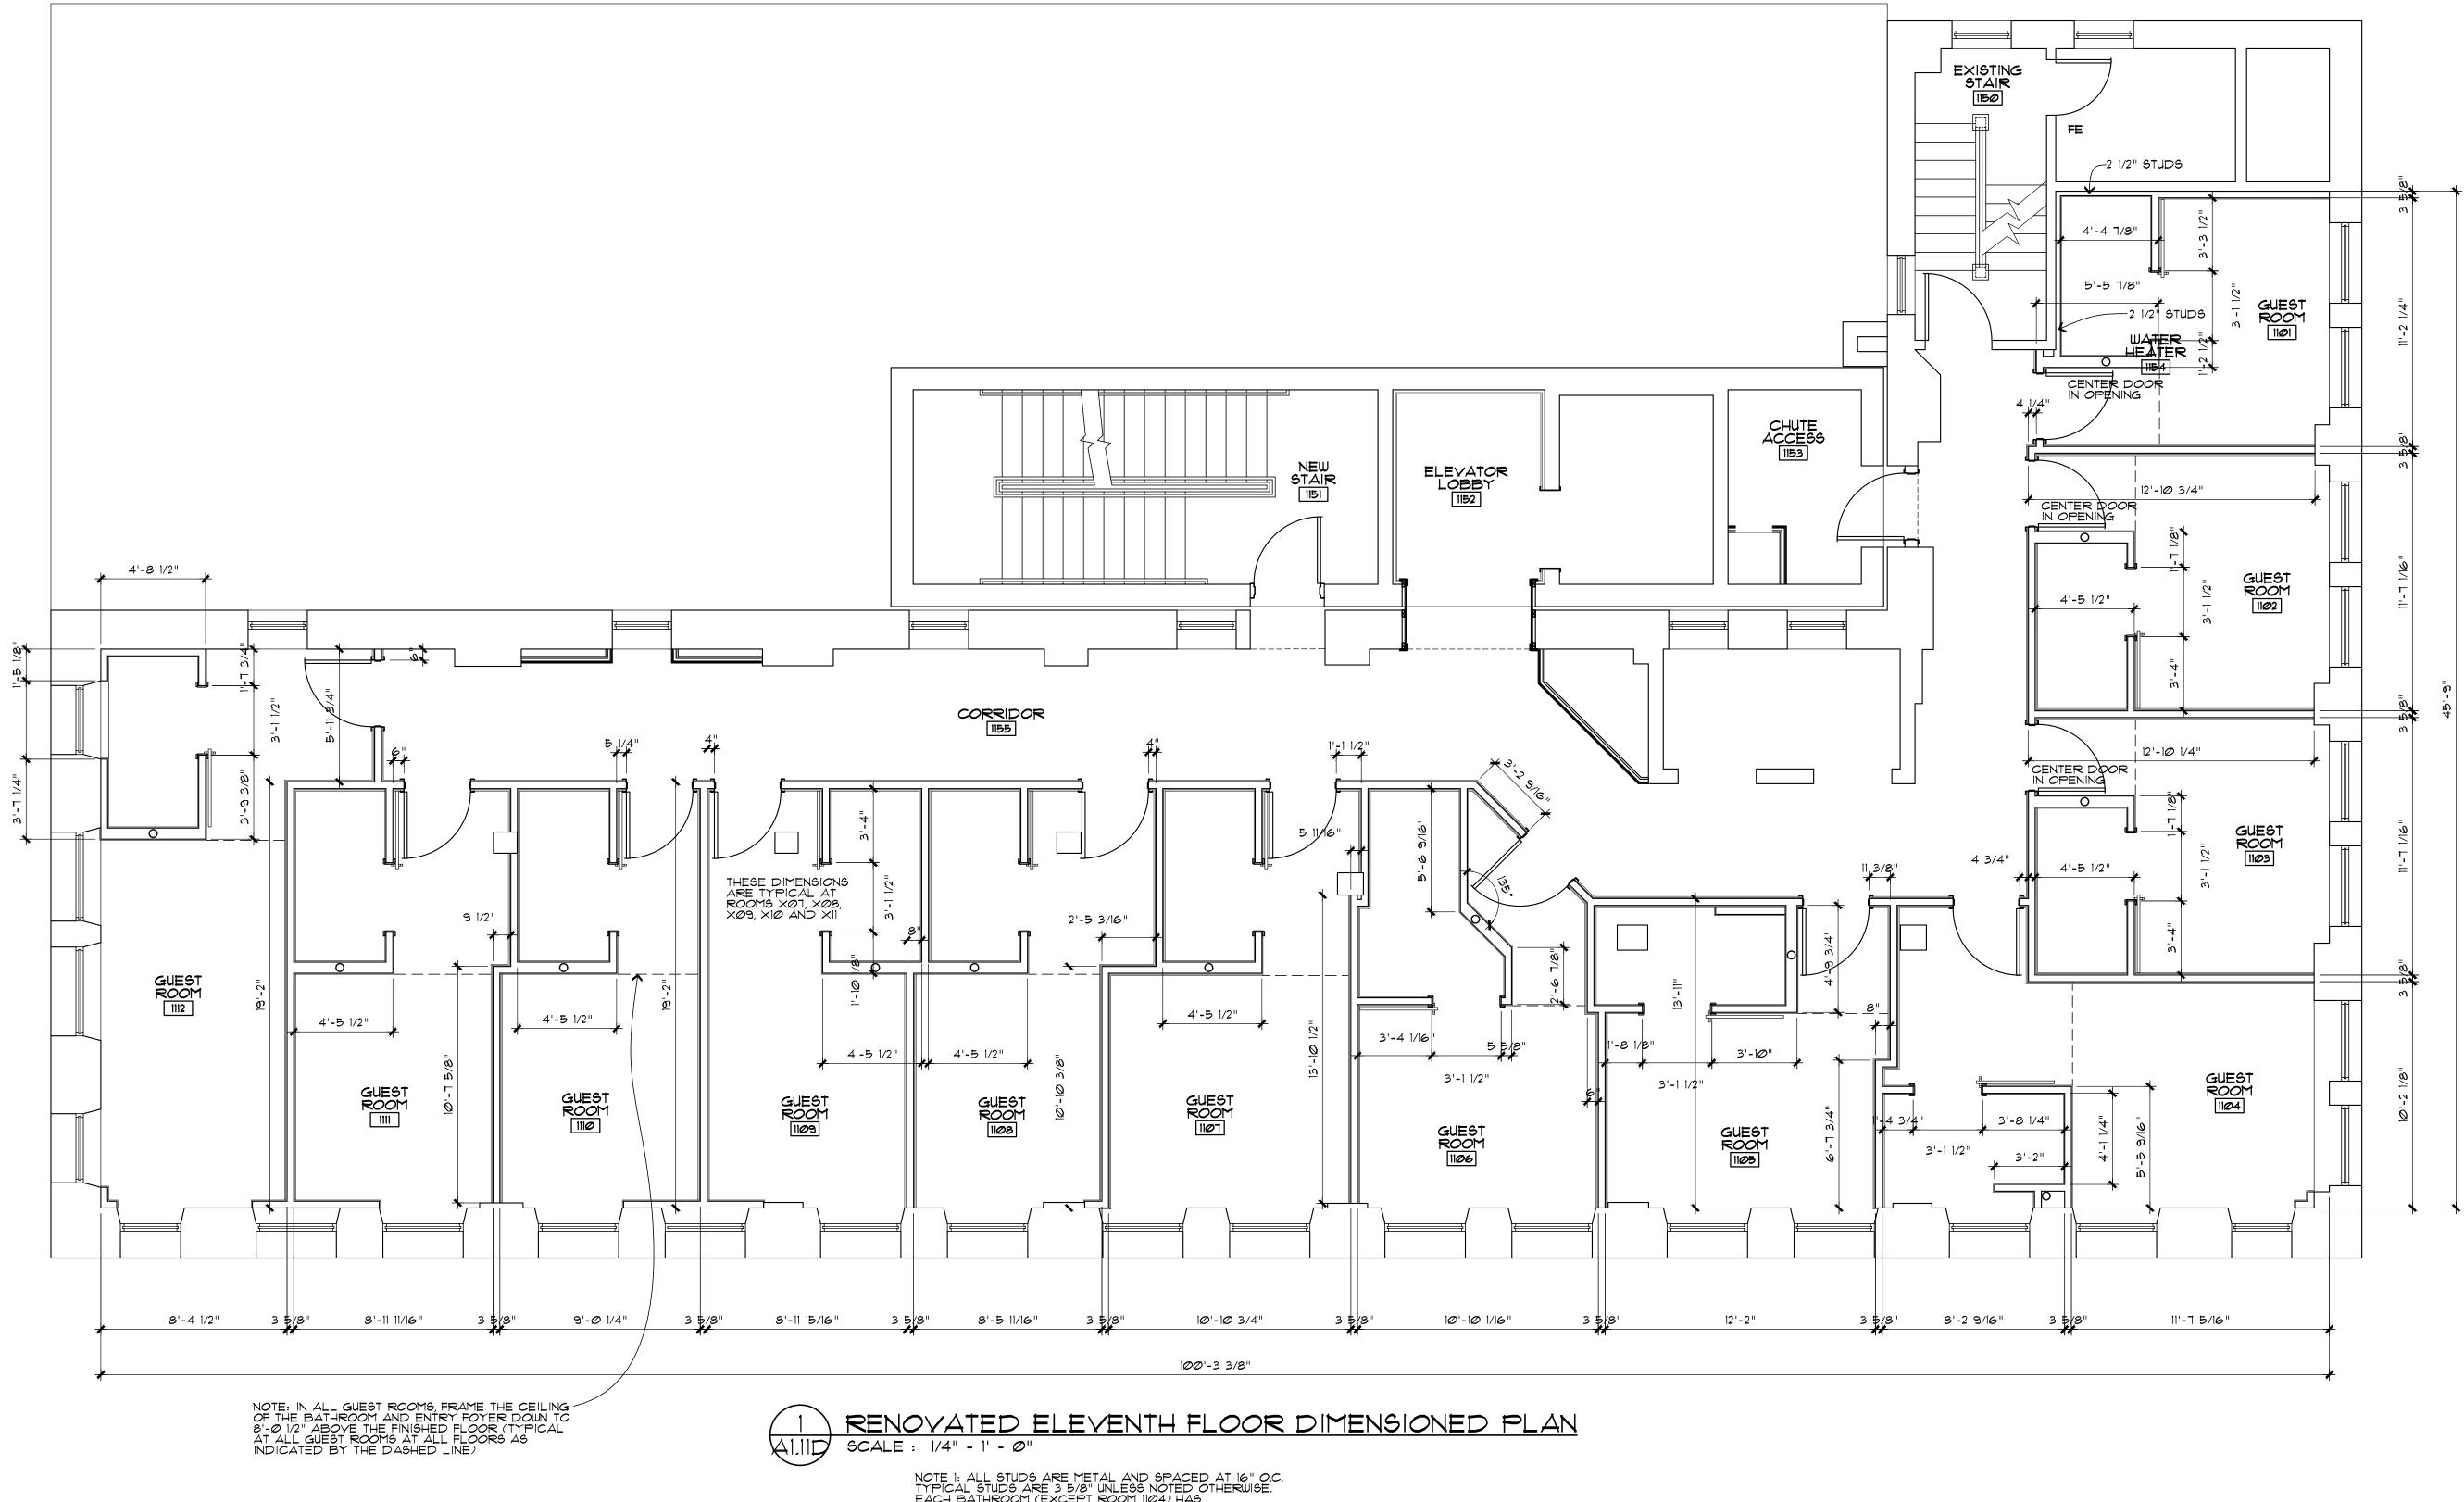
NOTE 1: ALL STUDS ARE METAL AND SPACED AT 16" O.C. TYPICAL STUDS ARE 3 5/8" UNLESS NOTED OTHERWISE. EACH BATHROOM (EXCEPT ROOM 1104) HAS ONE 6" STUD WALL LOCATION FOR SEWER PIPING. BATHROOM 1101 HAS 2 1/2" STUDS WHERE INDICATED. NOTE 2: THE ASSUMPTION HAS BEEN MADE THAT THE PREFABRICATED SHOWER UNIT REQUIRES AN INSIDE FINISHED DIMENSION OF 4'-Ø" FROM GYPSUM BOARD TO GYPSUM BOARD. THE CONTRACTOR SHALL VERIFY THE ACTUAL WIDTH OF THE SHOWER UNIT PRIOR TO THE FABRICATION AND INSTALLATION OF THE STUD WALLS.

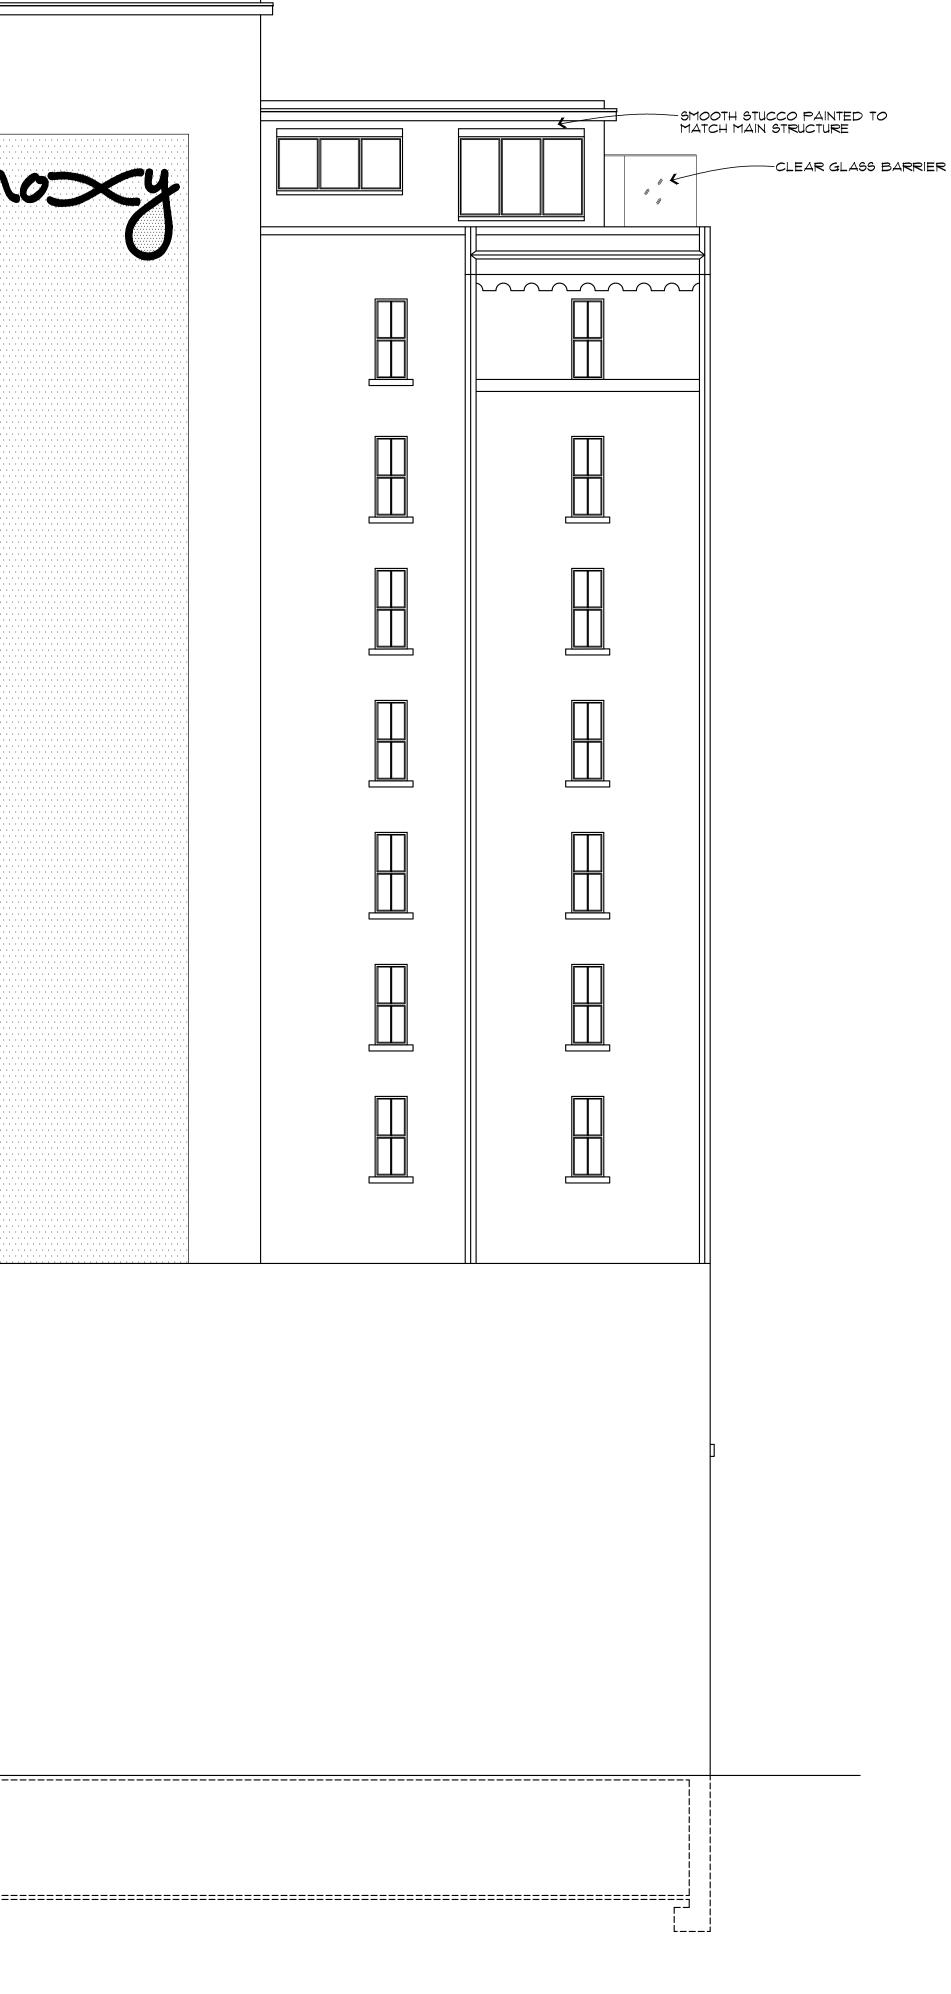
PROPOSED NORTH ELEVATION

*		
					SMOOTH CONCRETE PAINTED TO MATCH MAIN STRUCTURE	
12th FLOOR						
11th FLOOR						
10th FLOOR						
<u>9th FLOOR</u>						
<u>8th FLOOR </u>	FLOOR LEVEL	ABOVE GRADE PLANE				
<u> 1th FLOOR </u>	OCCUPIED	5/8" HEIGHT	58'-8 5/8"+/-			
<u>6th FLOOR</u>	- неіснт оғ ніснезт	148'-8				
5th FLOOR	12@'-10"+/					
4th FLOOR						
3rd FLOOR						
2nd FLOOR						
Ist FLOOR / LOBBY		-	*			
BASEMENT					Y Y Y Y Y Y Y Y Y Y Y Y Y Y Y Y Y Y Y Y

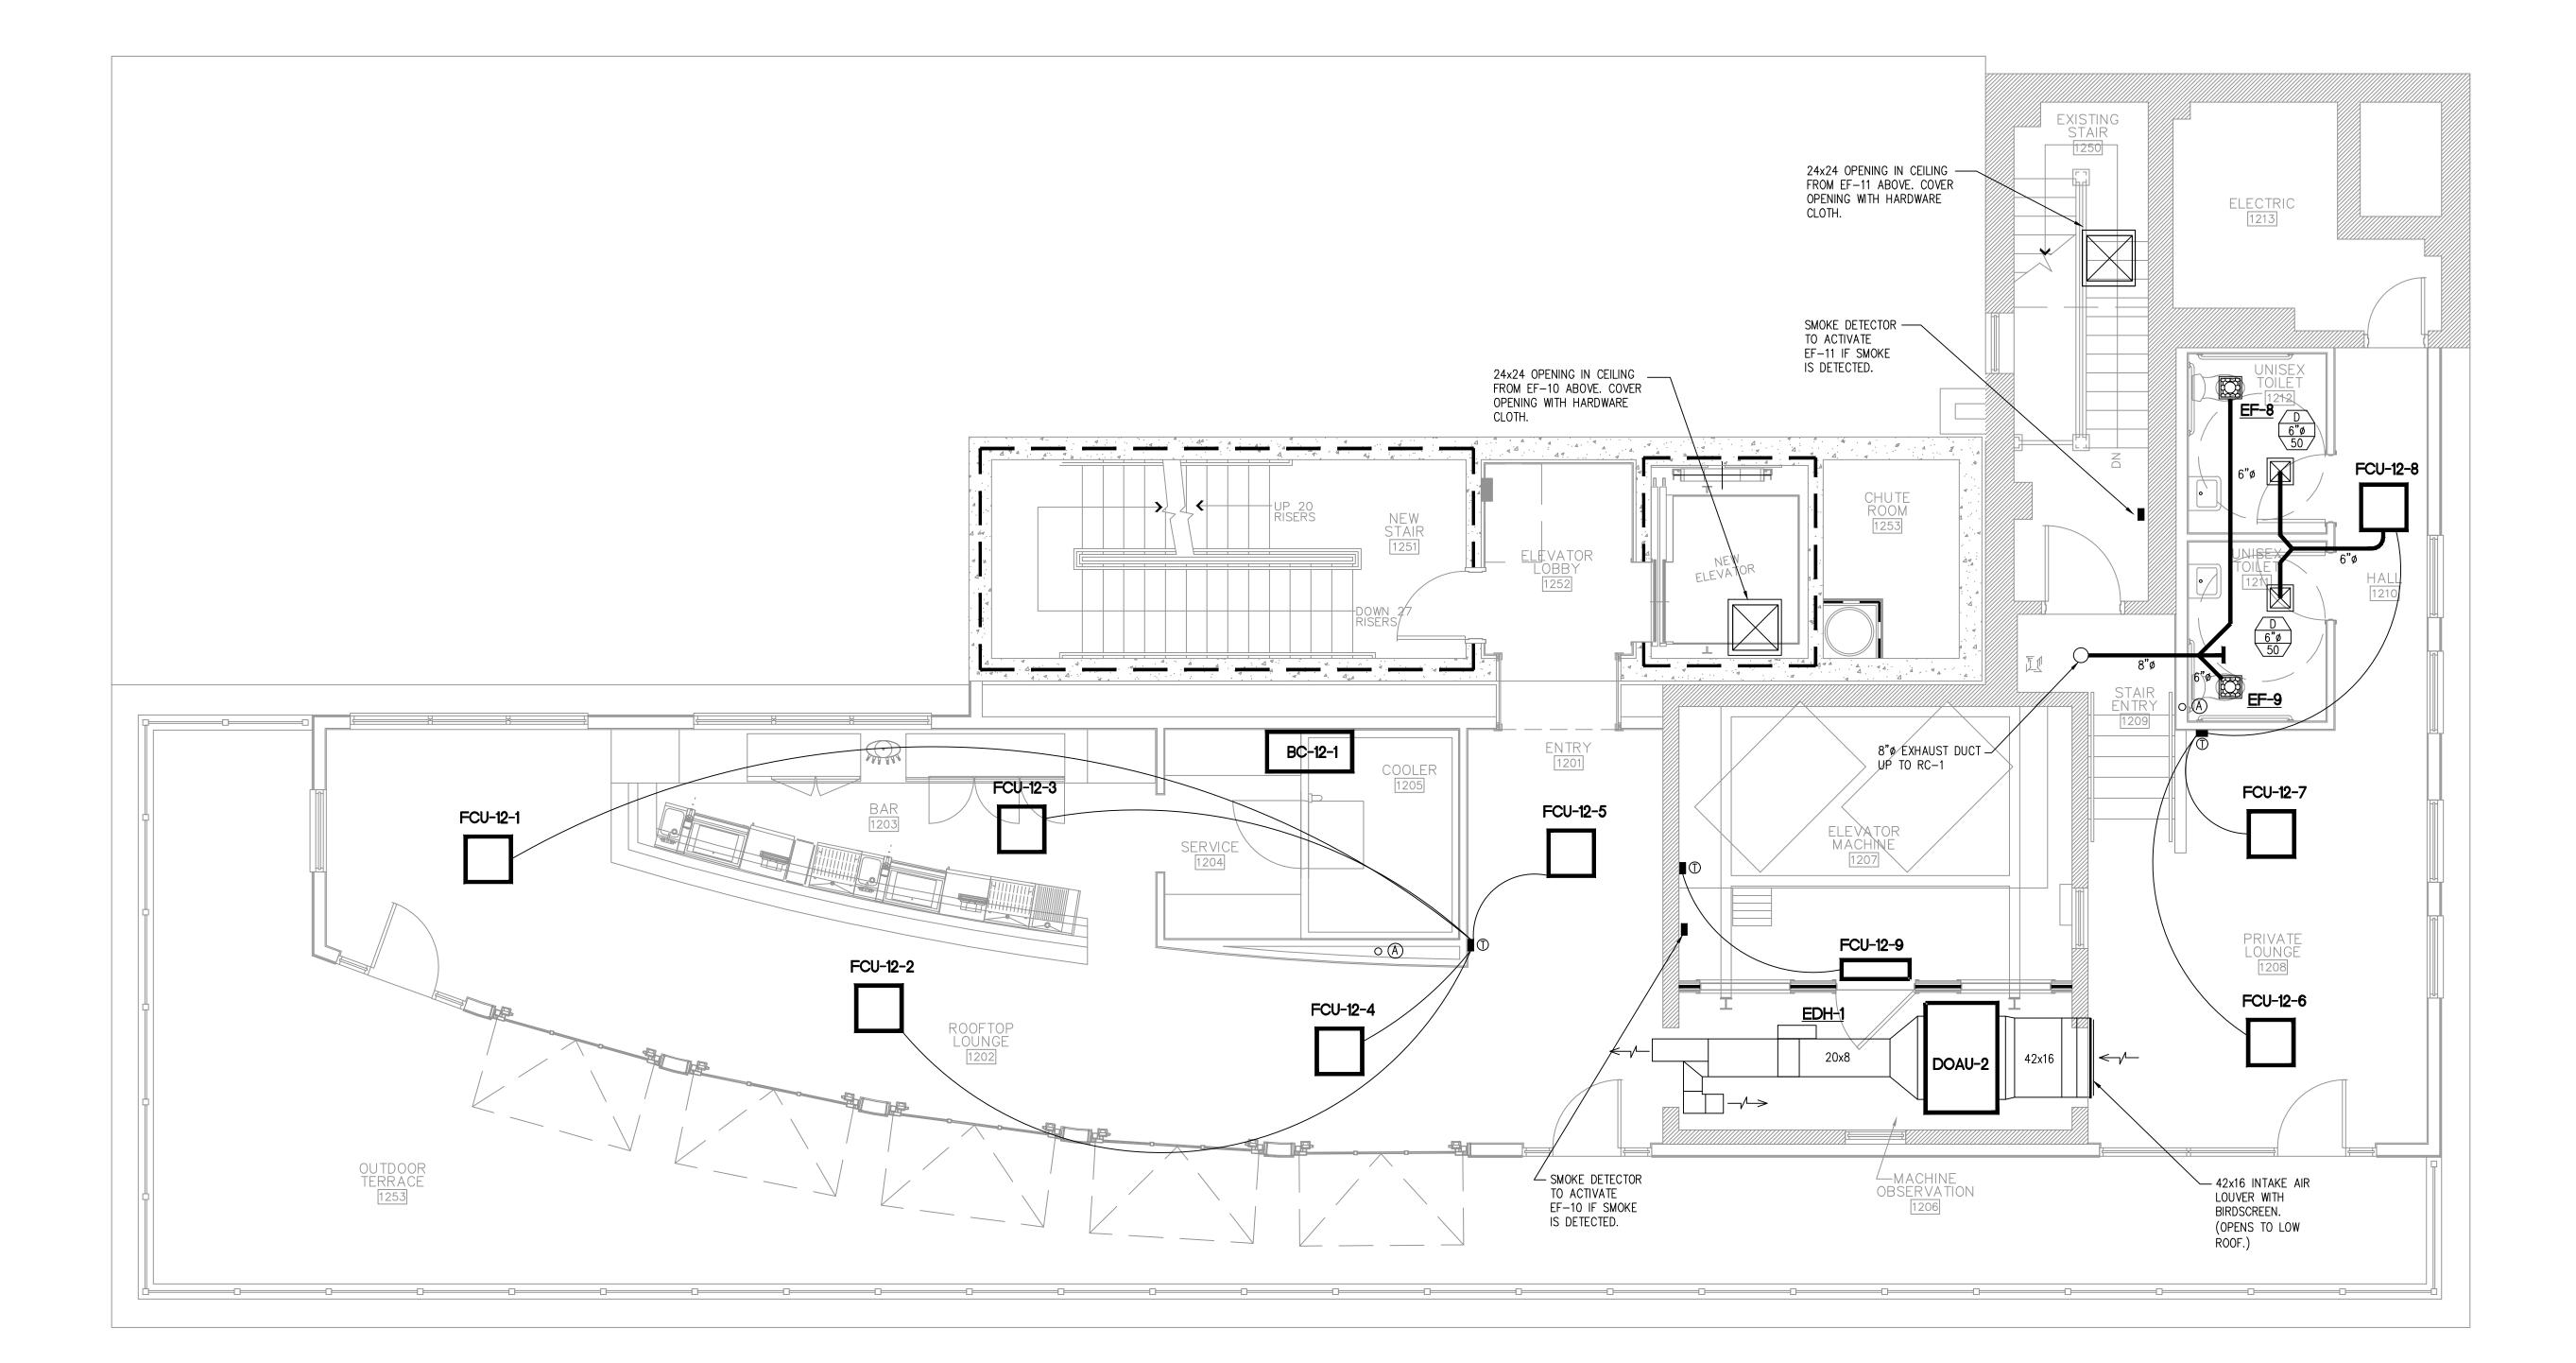
## <u>renovated hvac plan – twelfth floor</u> BUILDING SCALE: 1/4" = 1'-0"

A 1-1/4" CONDENSATE DRAIN FROM ABOVE, 1-1/4" CONDENSATE DRAIN DN TO FLOOR BELOW. B 1–1/4" CONDENSATE DN.
