D/DRC Case

**DESIGN/DEVELOPMENT REVIEW COMMISSION
DESIGN REVIEW DISTRICT
HISTORIC/CONSENT AGENDA
EVALUATION SHEET
Case #3**

ADDRESS: 1003 Elmwood Avenue

NATURE OF REQUEST: Request for preliminary certification for the Bailey Bill

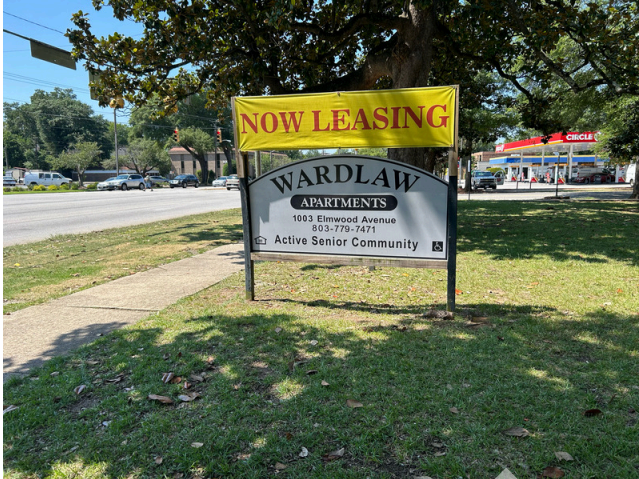
1. Site - site ID sign

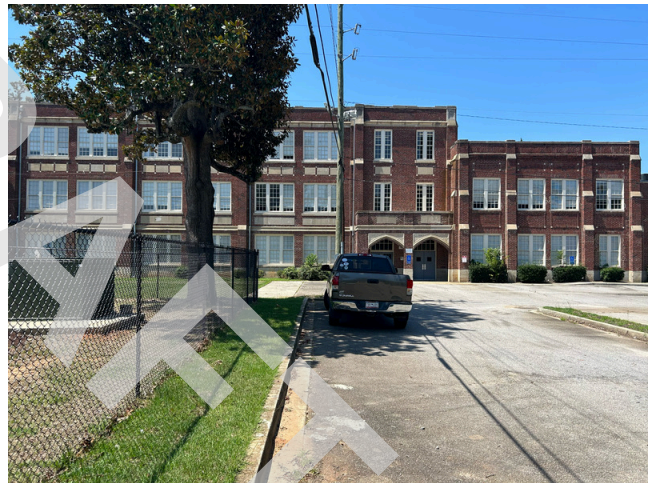
4. Exteriors - overview of east elevation

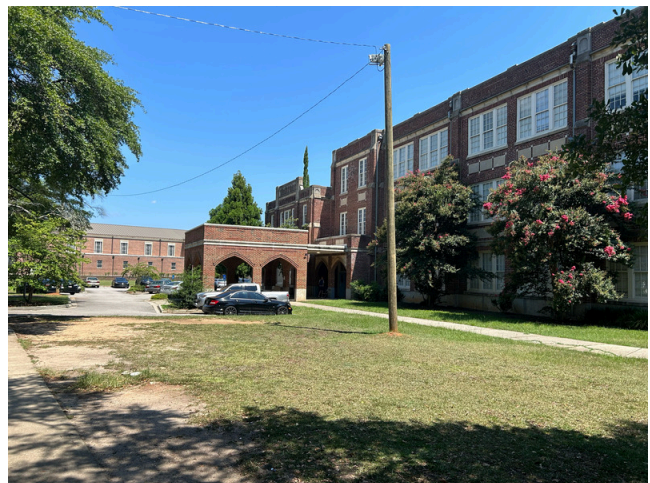
6. Exteriors - overview of west elevation

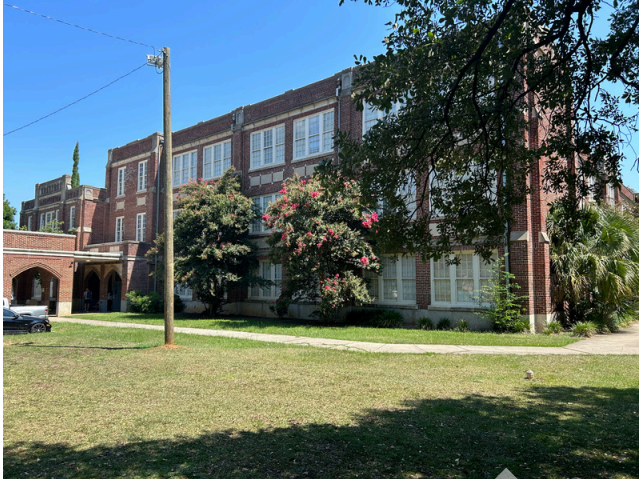
7. Exteriors - overview of west elevation

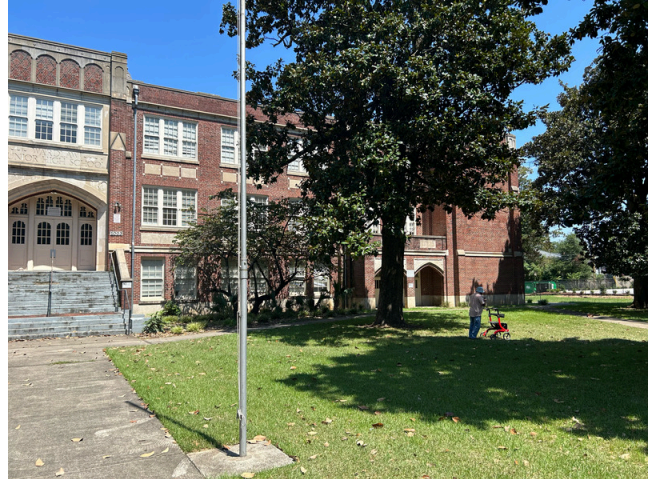
8. Exteriors - south elevation

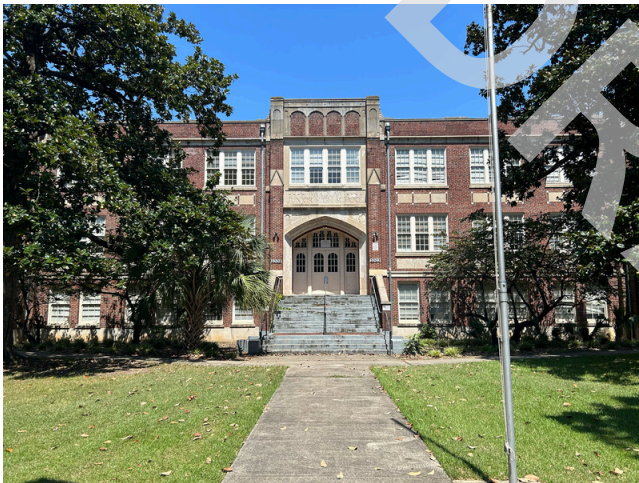
9. Exteriors - south elevation

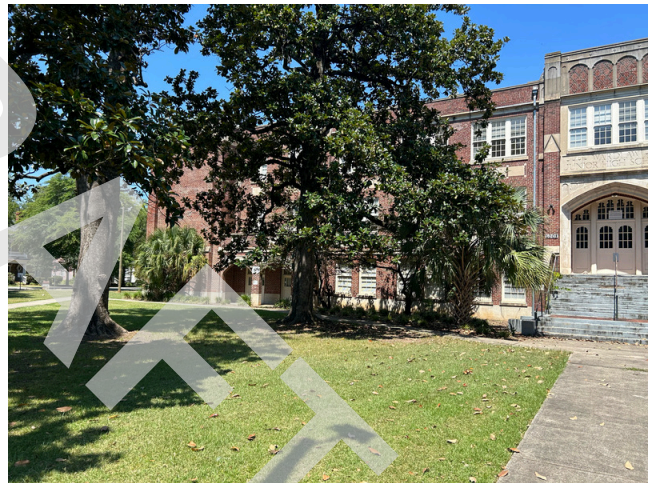
10. Exteriors - south elevation

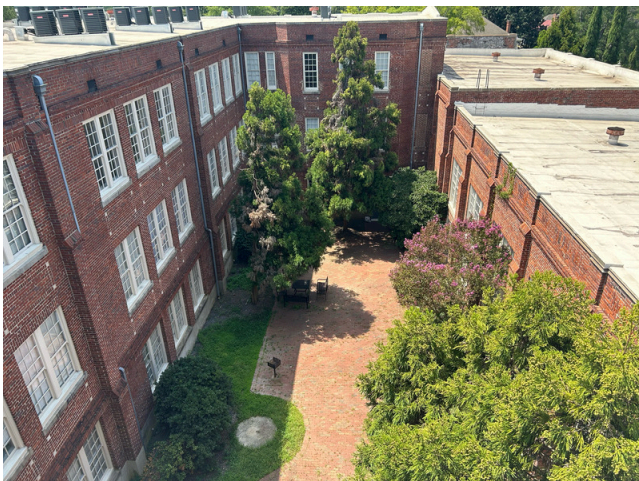
11. Site - central court yard

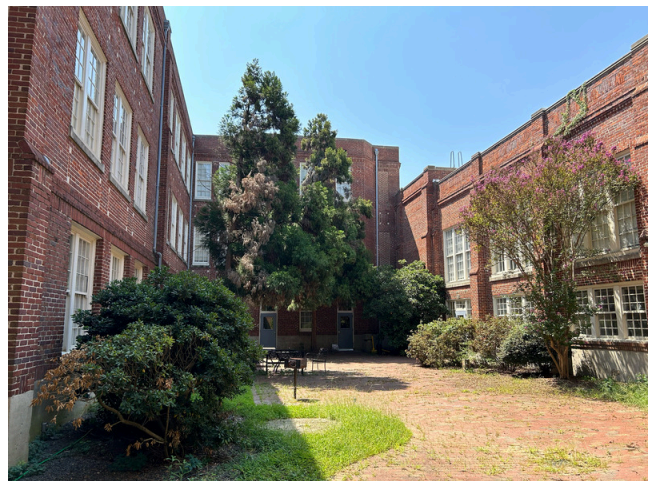
12. Site - courtyard

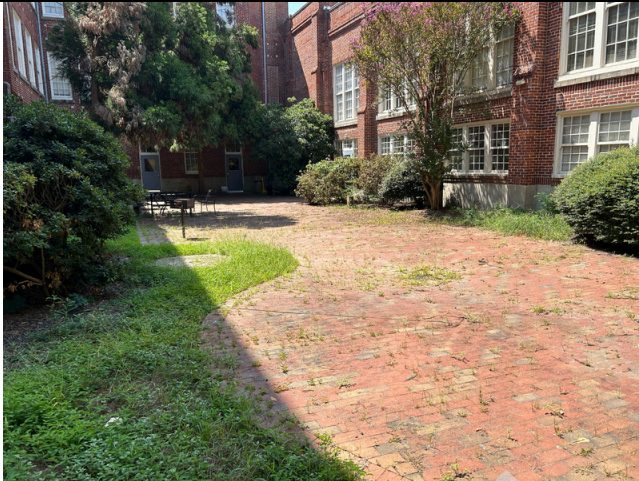
13. Site - courtyard

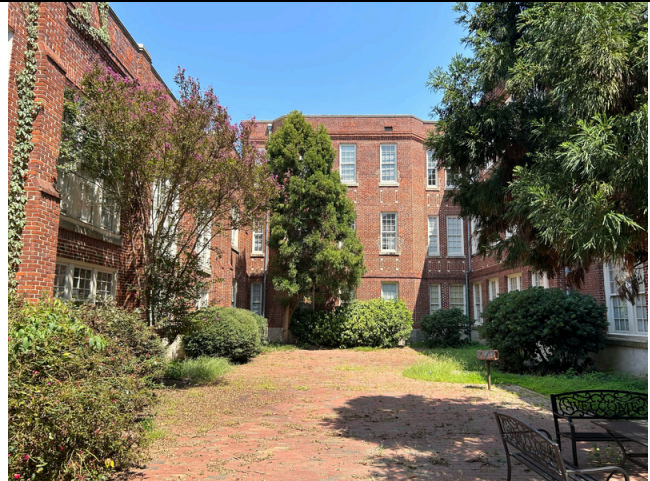
14. Site - courtyard

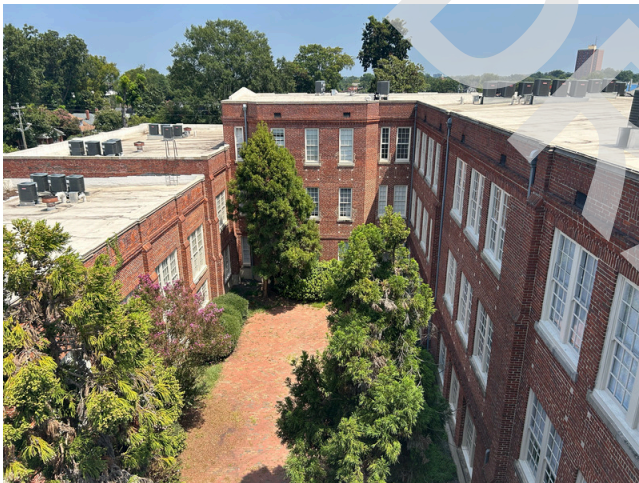
15. Site - courtyard

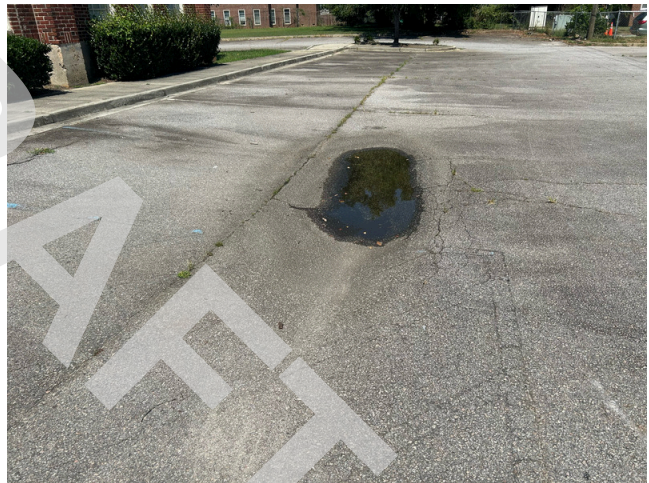
22. Site - bird bath at east elevation parking lot

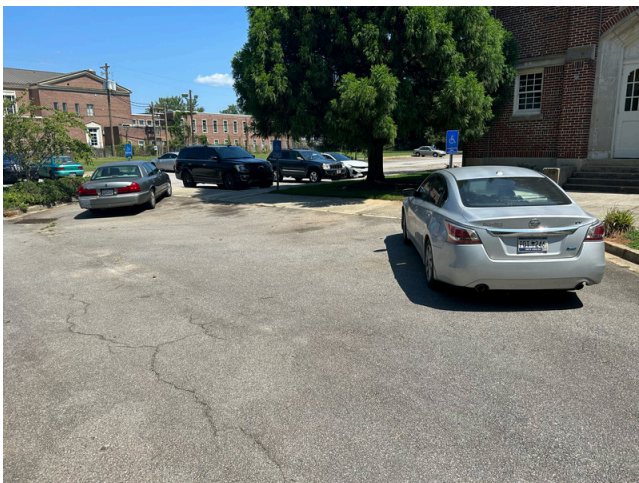
23. ADA - accessible parking at main entry

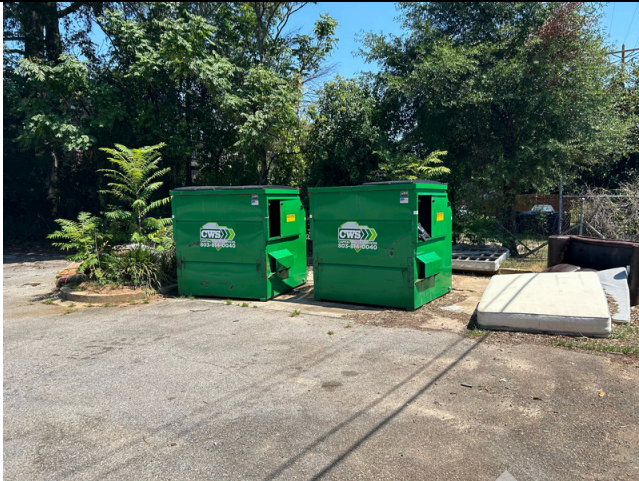
25. Site - dumpsters at east parking lot

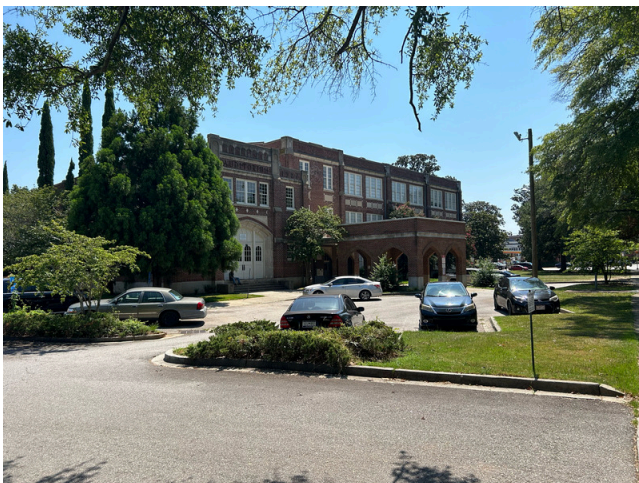
29. Site - parking at main entrance

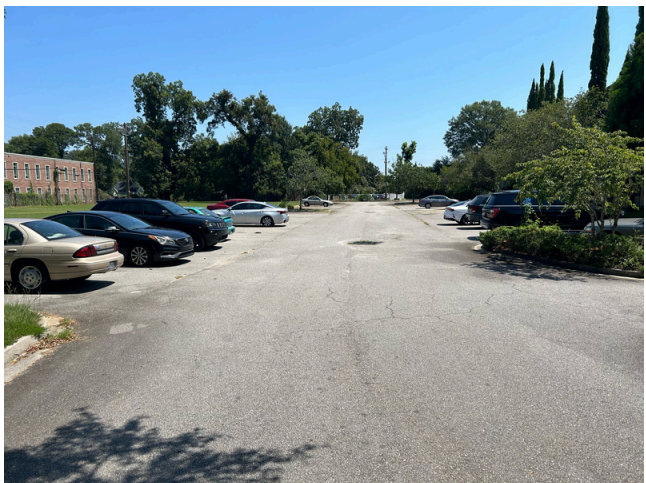
30. Site - parking at north elevation

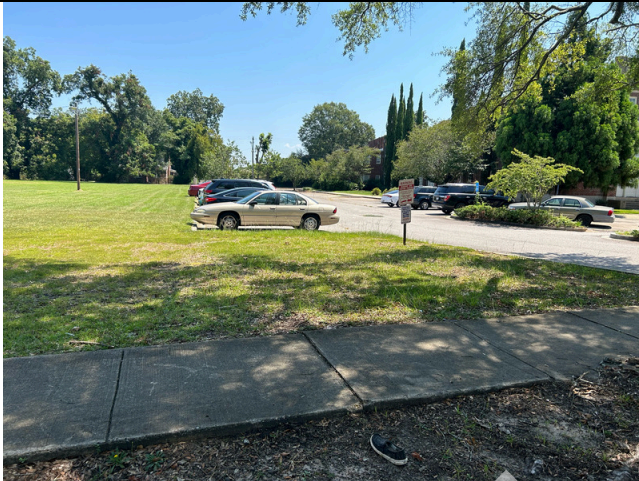
31. Site - parking at north elevation

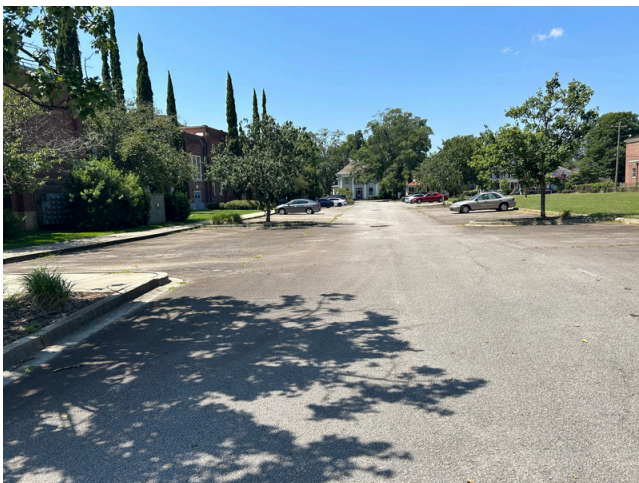
35. Site - parking lot at north elevation to west

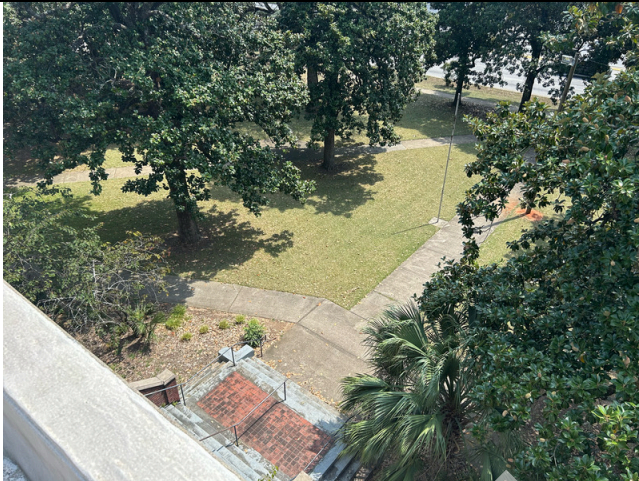
48. Site - storm drain
